03E-009 (1/11)

PART 573 Defect and Noncompliance Report¹

Generic name of the Item: Alternator Support Brace (Lower)

Generic name of the Item: Alternator Support Bracket (Upper)

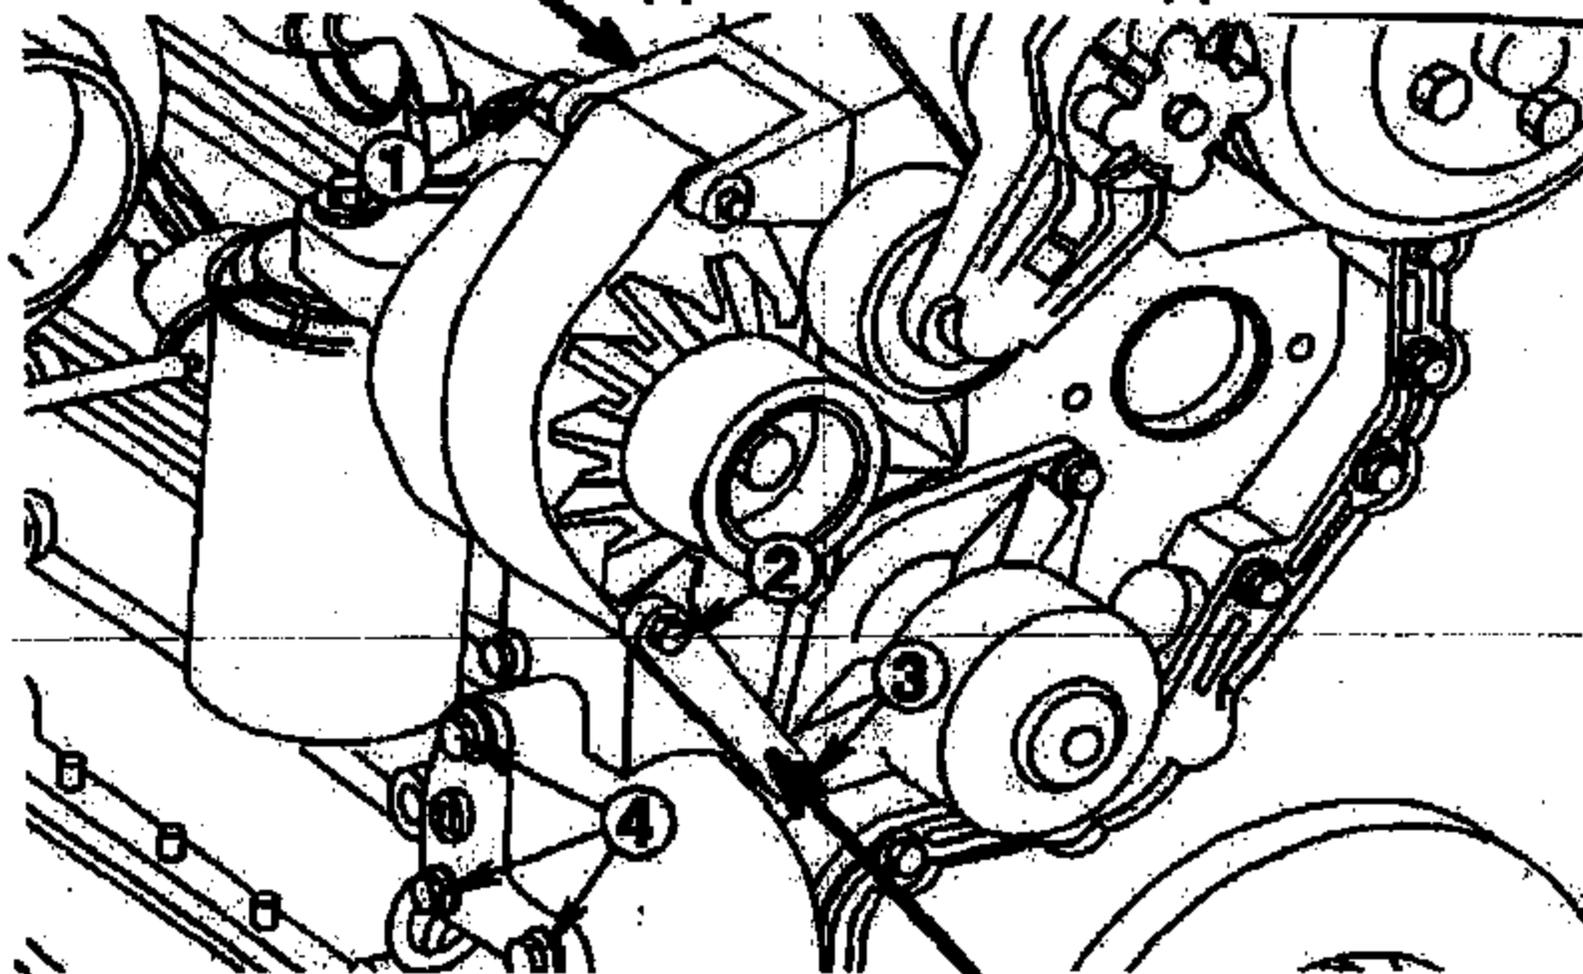
The combination of the old alternator bracket and alternator brace is not capable of holding some of the heavy alternators (>17 lbs.). In most of the failures this will lead to loosening of the mounting hardware (bolts) or breakage of the lower brace. This can release the alternator and let it fall. The damage will vary, depending on which side breaks first.

The root cause is due to OEM's installing alternators that are heavier than the support brackets are designed to carry, and the lack of instructions to the OEMs defining the weight limitations of the brackets.

Upper alternator support bracket

Lower alternator support brace

The remedy for current and future production is to install the updated upper alternator support bracket on engines produced. In addition, Cummins is conducting a service campaign to replace the existing upper alternator support bracket with the new design and replace the existing lower alternator support brace and all mounting hardware on units where the OEM has installed an alternator weighing 17 or more pounds.

The remedy used in the service campaign is an updated upper alternator support bracket that has been redesigned to support alternators with a gross weight of 17 pounds or more. We have also established OEM instructions defining weight limitations.
