GENERAL MOTORS NORTH AMERICA
Structure & Safety Integration

File In Section: Product Recalls
Bulletin No.: 03002
Date: February, 2003

SUBJECT: 03002 – MID-FRAME CROSS MEMBER TEAR

MODELS: 2003 CHEVROLET 2500 SERIES AVALANCHE, SUBURBAN
2003 GMC 2500 SERIES YUKON XL

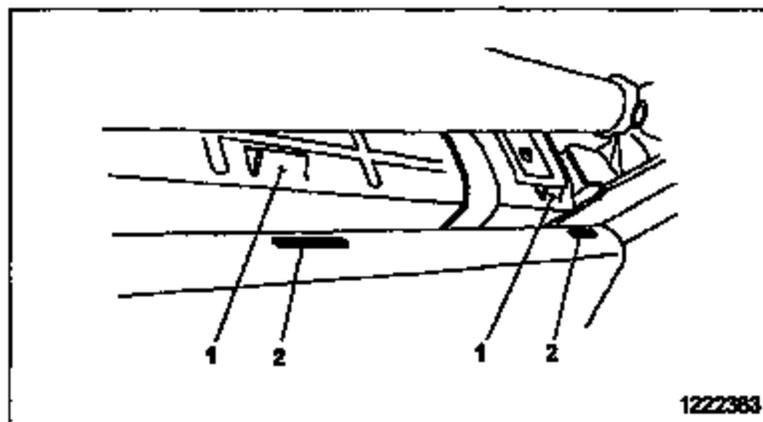
The illustration below shows the shield being positioned under the fuel tank prior to attachment. Only two of the three slots (2) and tabs (1) are shown. The third slot and tab are located further to the rear of the shield.

2. Position the fuel tank shield under the fuel tank and route the left rear corner of the shield up between the cables and the outboard side of the frame rail.

3. Raise or lower the shield as necessary to hook the slots (2) located along the inboard edge of the shield onto the three metal tabs (1) located on the inboard side of the fuel tank.
4. Raise the outboard side of the shield up to the bottom of the left frame rail and support in place.
5. To attach the shield, install the three bolts through the holes in the shield and into the EXISTING holes in the BOTTOM of the frame rail. Tighten to 12 Nm (106 lb in).
6. Lower the vehicle as necessary to install the fourth bolt through the rear hole in the shield and into the existing hole in the outboard side of the frame rail behind the left rear tire. Tighten to 12 Nm (106 lb in).
7. Lower the vehicle.
8. Install the GM Recall Identification Label.
