The following information is submitted pursuant to the requirements of 49 CFR 573.5 as it applies to a determination by General Motors of a noncompliance involving certain 2003 model year Cadillac Escalade, Chevrolet Tahoe/Suburban, and GMC Yukon/Yukon XL model vehicles.

# Recall Bulletin

File In Section: Product Recalls  
Bulletin No.: 03004  
Date: February, 2003

**SUBJECT:** 03004 – LEFT REAR DOOR UPPER HINGE WELD

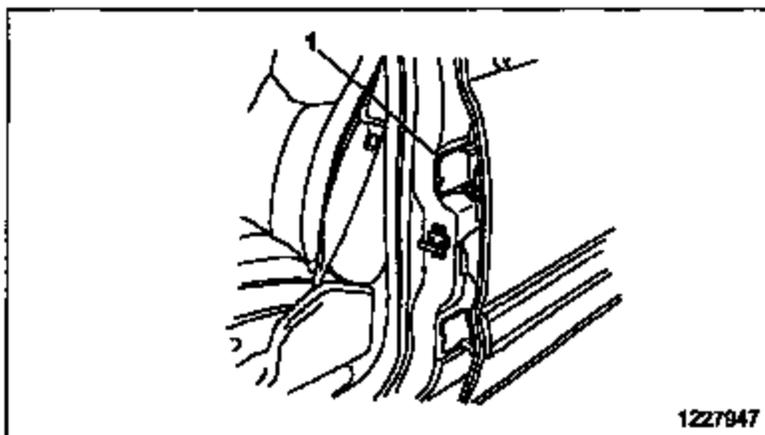
The following service procedure is for inspecting the welds that attach the left rear side door upper hinge (1) to the body "B" pillar sheet metal. If you find that the two rear welds are missing from the upper hinge, or smaller than the others, perform the repair procedure included.

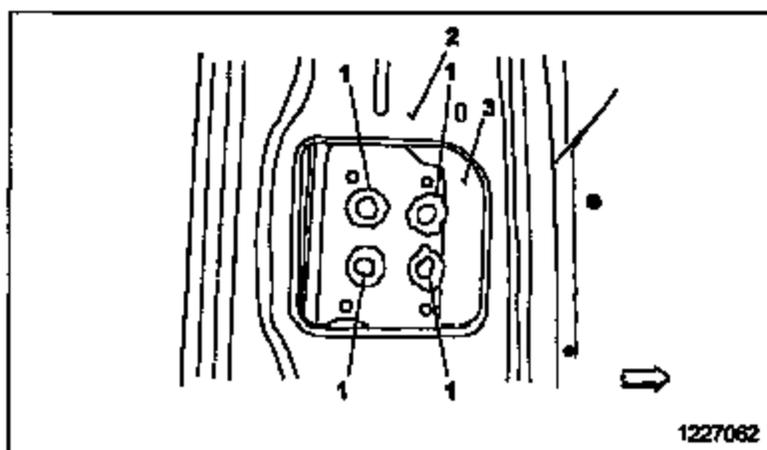
5. From inside the vehicle, look through the opening in the center pillar sheet metal directly behind the upper hinge.
- If there are four welds (1) present and ALL four are approximately the same size, NO repair is required. Proceed to step 14 to reassemble the vehicle.
  - If ONE of the REAR welds is missing, or is a lot smaller in size than the others, NO repair is required. Proceed to step 14 to reassemble the vehicle.
  - If TWO of the REAR welds are missing, or if the two rear welds are a lot smaller than the front welds, then a repair is required.

The next steps should only be performed if the two rear welds are BOTH missing or are a lot smaller in size than the others. Also, you only have to repair one of the two rear welds.
