Recall Bulletin

File In Section: Product Recalls
Bulletin No.: 03002
Date: February, 2003

SUBJECT: 03002 – MID-FRAME CROSS MEMBER TEAR

**MODELS: 2003 CHEVROLET 2500 SERIES AVALANCHE, SUBURBAN
2003 GMC 2500 SERIES YUKON XL**

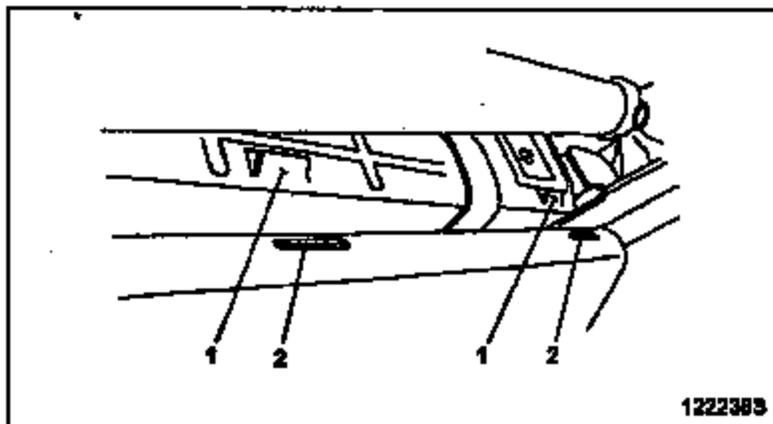
The illustration below shows the shield being positioned under the fuel tank prior to attachment. Only two of the three slots (2) and tabs (1) are shown. The third slot and tab are located further to the rear of the shield.

2. Position the fuel tank shield under the fuel tank and route the left rear corner of the shield up between the cables and the outboard side of the frame rail.

3. Raise or lower the shield as necessary to hook the slots (2) located along the inboard edge of the shield onto the three metal tabs (1) located on the inboard side of the fuel tank.
4. Raise the outboard side of the shield up to the bottom of the left frame rail and support in place.
5. To attach the shield, install the three bolts through the holes in the shield and into the EXISTING holes in the BOTTOM of the frame rail. Tighten to 12 Nm (108 lb in).
6. Lower the vehicle as necessary to install the fourth bolt through the rear hole in the shield and into the existing hole in the outboard side of the frame rail behind the left rear tire. Tighten to 12 Nm (108 lb in).
7. Lower the vehicle.
8. Install the GM Recall Identification Label.
