Safety Defect and Noncompliance Report Guide for Equipment
PART 573 Defect and Noncompliance Report⁴

Generic name of the item: Upper and Lower Fixed Fabricated Torque Rods
Chalmers

Make: Suspensions **Model:** 1000 and 800 Series

Noncompliance of weld penetration of eye to the tube.

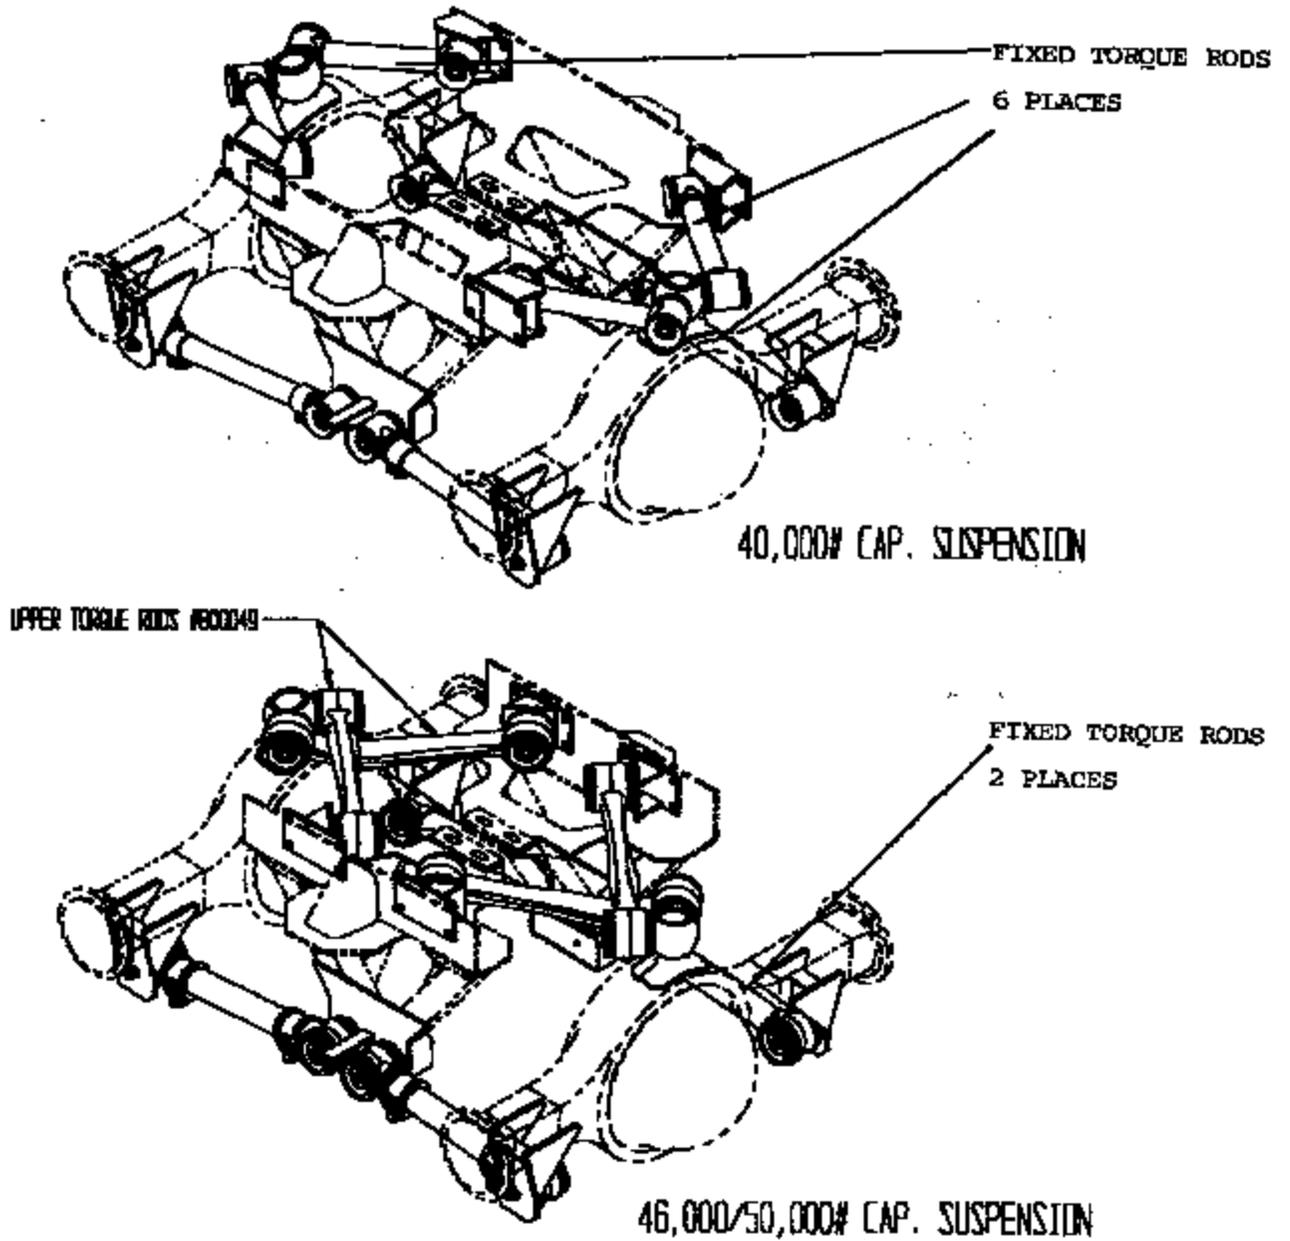
FIGURE 4

Other information which characterizes/distinguishes the items of equipment to be recalled:
See Figure 4 for location of Fixed Torque Rods.

TORQUE ROD INSTALLATION
