IC Corporation

SAFETY RECALL 05524

VIN # (or List of VINs repaired)
Recall Campaign #05524
SUBJECT (Bus Control Arm Bracket)
Facilities Repair Labor Rate
Labor Operation Number
Your Tax ID Number

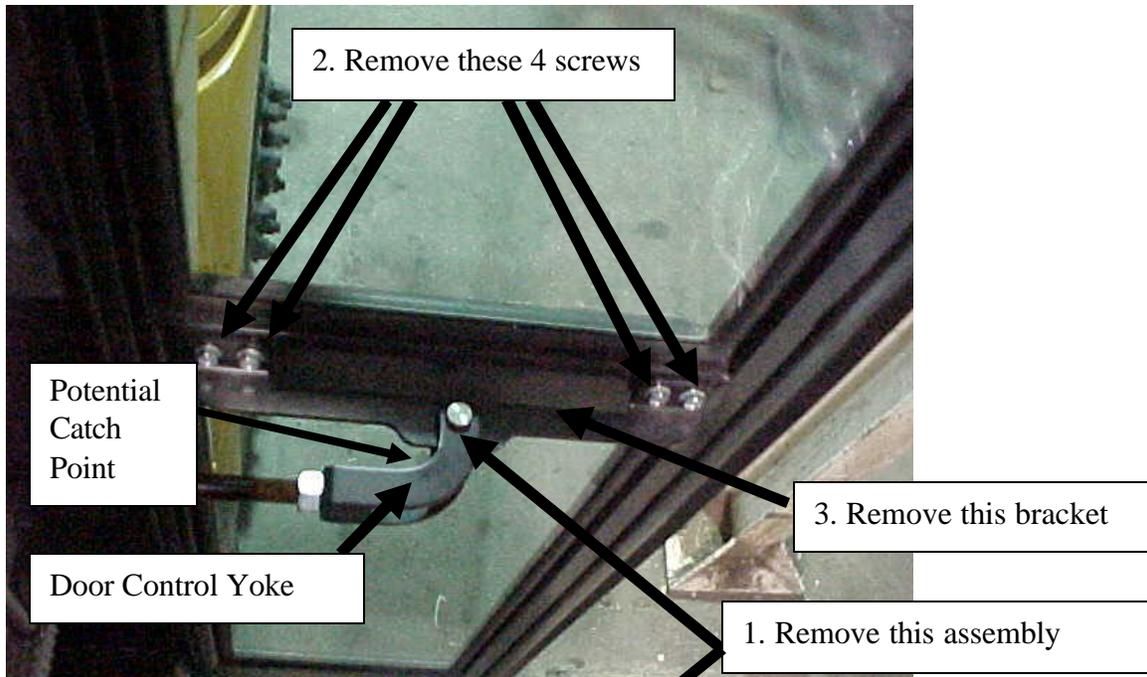
Figure 1. Old Bracket and Assembly

The door control bracket for the manual door control arm does not meet the guidelines in the NHTSA handbook for door entrance and handrail design.

There is a bracket mounted on the door that the door control yoke is attached to (See Figure 1, Potential Catch Point.) Certain small objects, including, but not limited to, coat tie strings with draw string clips or other objects attached thereto, could get caught in this catch point. Should this happen, and the driver does not properly observe the person exiting the bus, the person may exit the bus with the string caught between the bracket and the yoke. The door may be closed and the bus moved, causing possible injury or death to the passenger exiting the bus.

1. Remove the door control yoke from the old bracket.
 - a. Remove the snap retainer at the bottom of the assembly.
 - b. Pull the clevis pin.
 - c. Be sure to note the order in which all parts are removed so they can be replaced in the correct orientation.
2. Remove the 4 screws that hold the bracket to the door. These screws are screwed into tapped holes. Do not damage the threads of the tapped hole.
3. Once the 4 bolts are removed, the old bracket can be removed.
