Subject: 05113B - Product Safety Recall  
Safety Belt Buckle Inoperative  
Service Procedure Revised

Models: 2003-2006 Chevrolet Express  
2003-2006 GMC Savana

File In Section: Product Recalls  
Bulletin No.: 05113B  
Date: June 2006

**SUBJECT:** SAFETY BELT BUCKLE INOPERATIVE

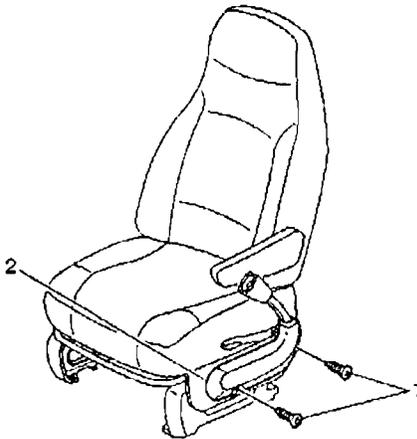
Seat Belt with Pre-Tensioner

**Important:** Front seat belts with a pre-tensioner are not involved in this recall. The remaining seat belts in the vehicle must be inspected.

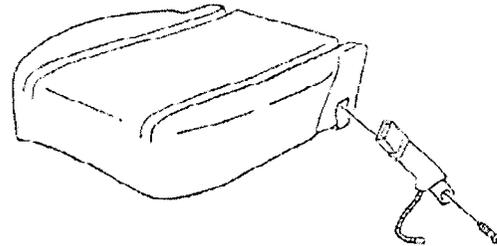
Seat Belt Without a Pre-Tensioner

**Important:** This procedure is to be performed on all seat belts (front and rear) without a pre-tensioner. Seat belts with a pre-tensioner are not involved.

1. Install the seat belt latch into the buckle.
2. Check for proper latching and unlatching.
  - o If the seat belt buckle will not latch or unlatch, the buckle assembly requires replacement.
  - o If the seat belt buckle latches and unlatches correctly, the seat belt buckle cover requires replacement.
3. Repeat Steps 1 and 2 for all remaining non-pre-tensioner seat belts in the vehicle, including rear seats.

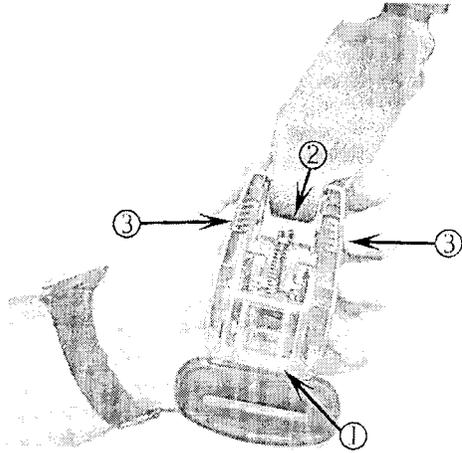
1742799

- 1 - Front of Buckles
- 2 - Rear of Buckles
- 3 - Clip Location

6. Remove the buckles cover.
