Subject: Safety Recall BLG (Interim B2G) - Remedy Available
Certain 2004 and 2005 Model Year ES 330 and RX 330 and Certain 2006 Model Year RX 400h Vehicles
1MZ-FE/3MZ-FE V6 Engine Crankshaft Pulley

CRANKSHAFT PULLEY REPLACEMENT

**CERTAIN 2004 – 2005 MODEL YEAR ES330 & RX330
CERTAIN 2006 MODEL YEAR RX400h**

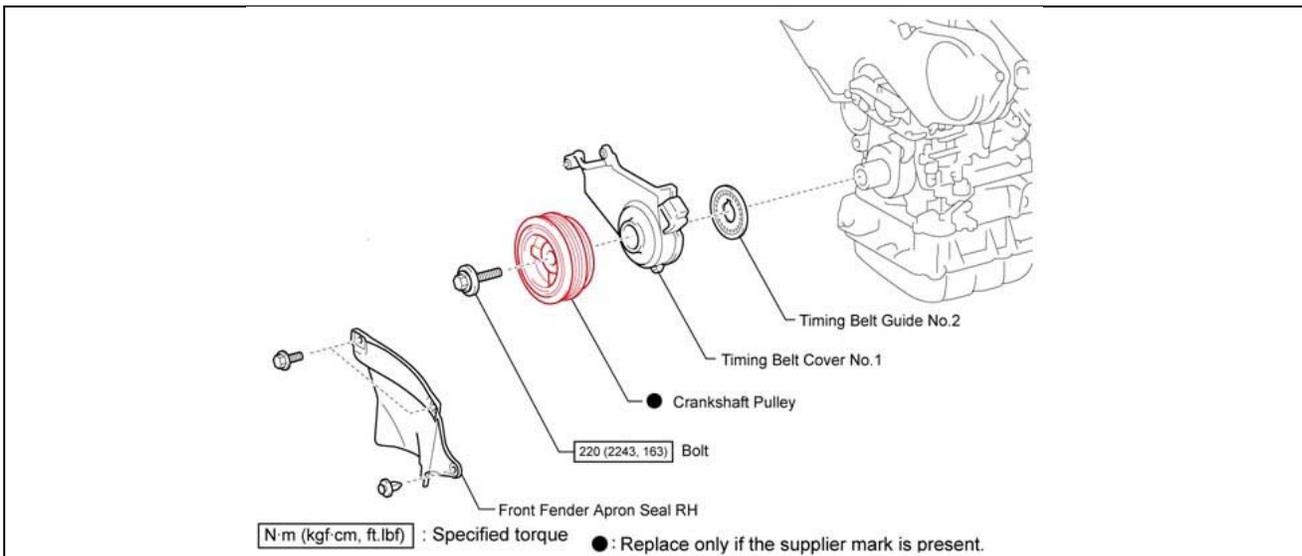
IV. BACKGROUND

In certain 2004 and 2005 model year ES 330 and RX 330 and certain 2006 model year RX 400h vehicles equipped with a 1MZ-FE or 3MZ-FE V6 engine, the amount of adhesive agent applied between the outer ring and the torsional rubber damper (inner ring) in the crankshaft pulley may be inadequate. If the adhesive is insufficient, there is a possibility that the outer ring may become misaligned and it may not properly rotate with the inner ring, causing noise and/or illumination of the discharge warning light. In some cases, the belt for the power steering pump may become detached from the pulley. The driver may notice a sudden increase in steering effort. A sudden increase in steering effort could increase the risk of a crash.

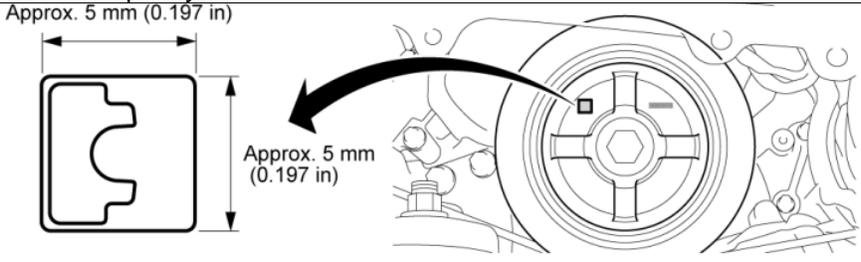
<p style="text-align: center;">Crankshaft pulley mark</p> <p style="text-align: center;">The mark position will vary depending on where the engine stops.</p>	
INSPECTION RESULT	ACTION REQUIRED
Mark present	Proceed to STEP B. INSPECT THE TIMING BELT COVER No. 1
Mark NOT present	The vehicle IS NOT affected. The campaign is complete.

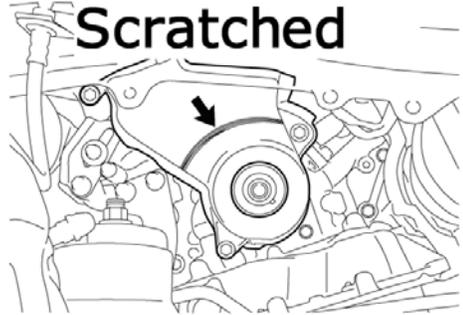
NOTE: If the crankshaft pulley inner and outer ring have begun to separate, damage may occur to the timing belt cover and timing belt.

Replace the crankshaft pulley, timing belt cover No. 1, and both drive belts.

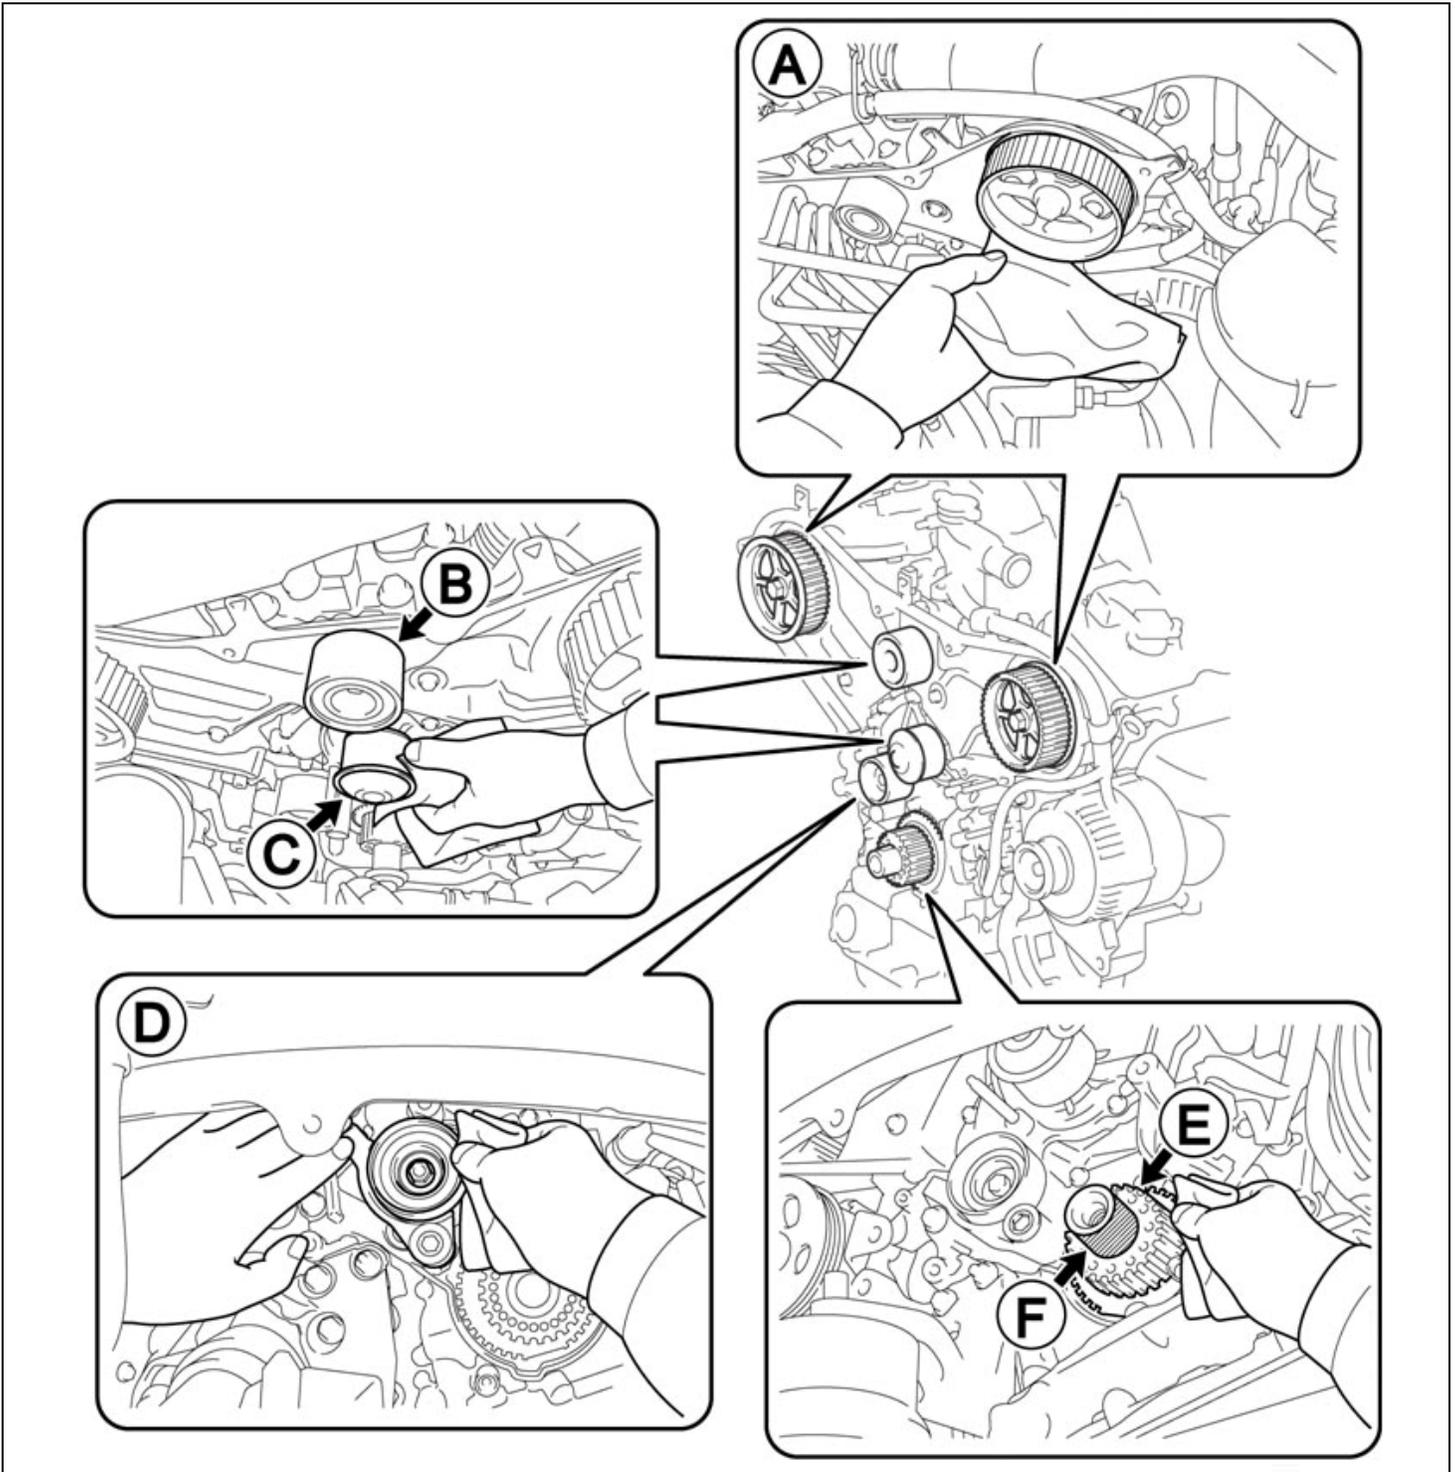
- If the crankshaft pulley inner and outer ring have begun to separate, damage may occur to the timing belt cover and timing belt. Follow these steps to confirm the timing belt pulleys are free of debris from the possibly damaged components.
- Confirm there is no metal debris on the crankshaft sensor pickup wheel.

- 1) Confirm all idler pulleys turn smoothly.
- 2) Clean all pulleys using a shop cloth soaked in brake cleaner.
- 3) Use an air gun to confirm all pulleys are clean and free of debris.

Confirm there is no metal debris on the crankshaft sensor pickup wheel.

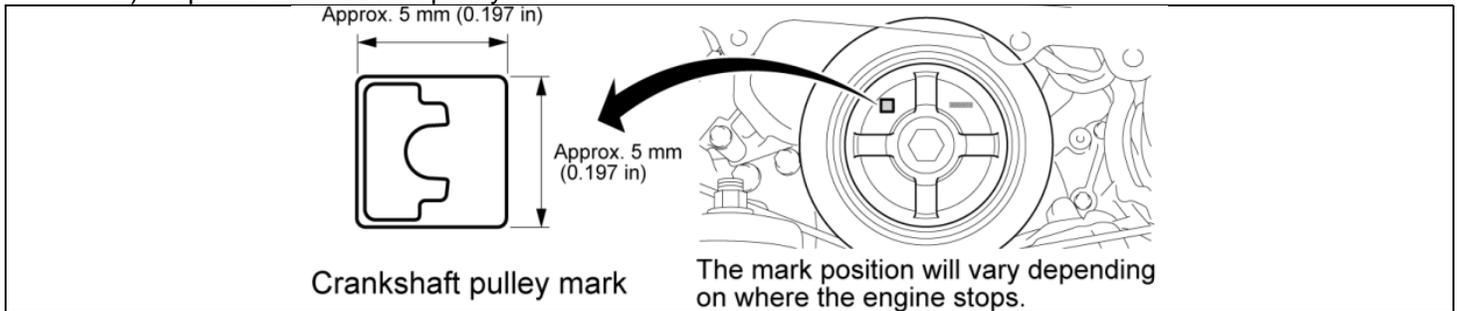
A. INSPECT THE CRANKSHAFT PULLEY

INSPECTION RESULT	ACTION REQUIRED
Mark present	Proceed to STEP B. INSPECT THE TIMING BELT COVER No. 1
Mark NOT present	The vehicle IS NOT affected. The campaign is complete.

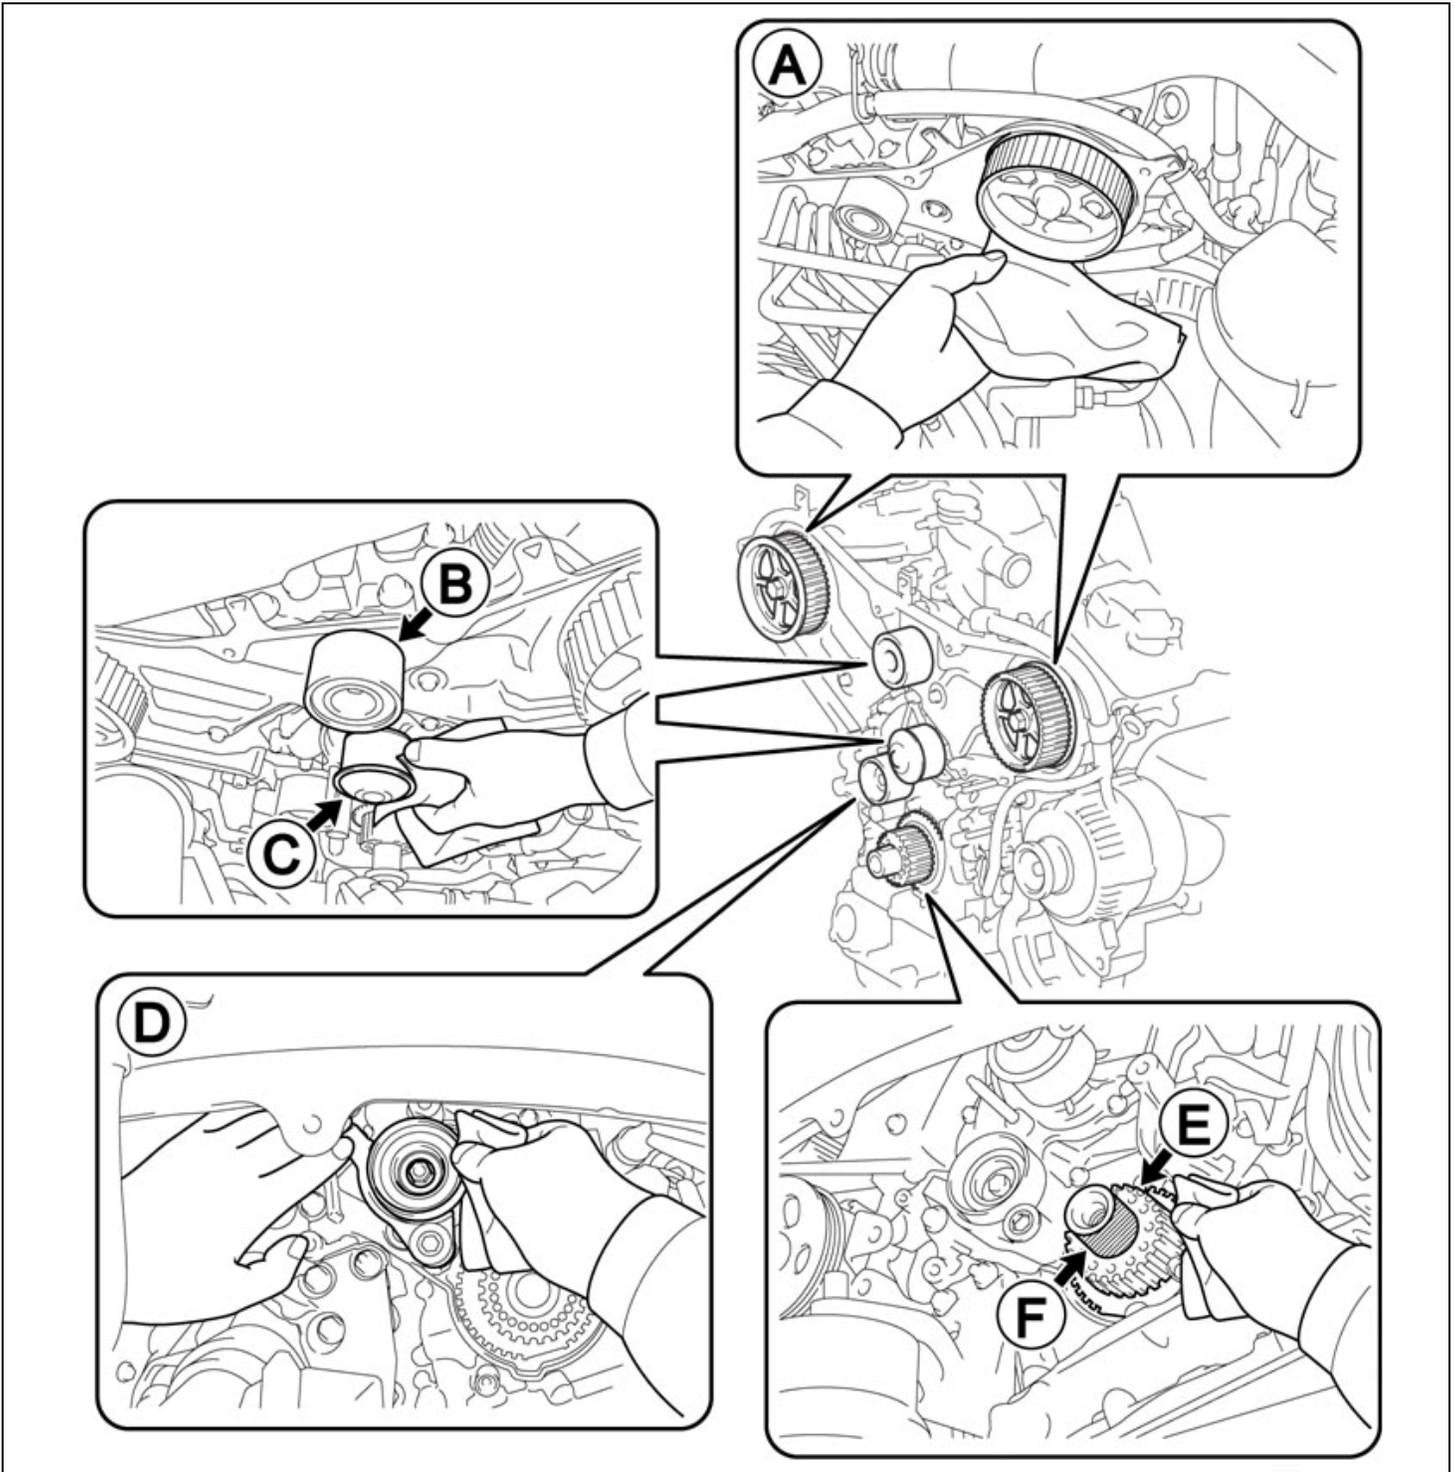
- If the crankshaft pulley inner and outer ring have begun to separate, damage may occur to the timing belt cover and timing belt. Follow these steps to confirm the timing belt pulleys are free of debris from the possibly damaged components.
- Confirm there is no metal debris on the crankshaft sensor pickup wheel.

- 1) Confirm all idler pulleys turn smoothly.
- 2) Clean all pulleys using a shop cloth soaked in brake cleaner.
- 3) Use an air gun to confirm all pulleys are clean and free of debris.

Confirm there is no metal debris on the crankshaft sensor pickup wheel.
