Re: Reinke Manufacturing Company, Inc. Part 573 Report Submission

## **PART 573 Defect and Noncompliance Report**

This report serves as Reinke Manufacturing Company, Inc.'s ("Reinke") notification to the U.S. Department of Transportation, National Highway Traffic Safety Administration that a defect related to motor vehicle safety exists in certain intermodal chassis. Reinke decided that this defect existed in these vehicles on April 24, 2012.

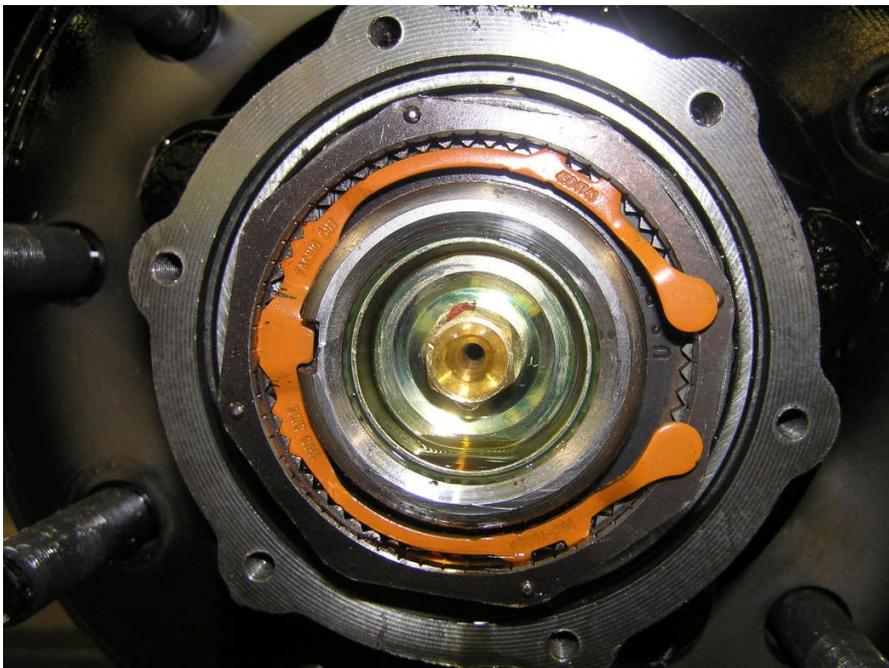
**Locking ring installed correctly.**

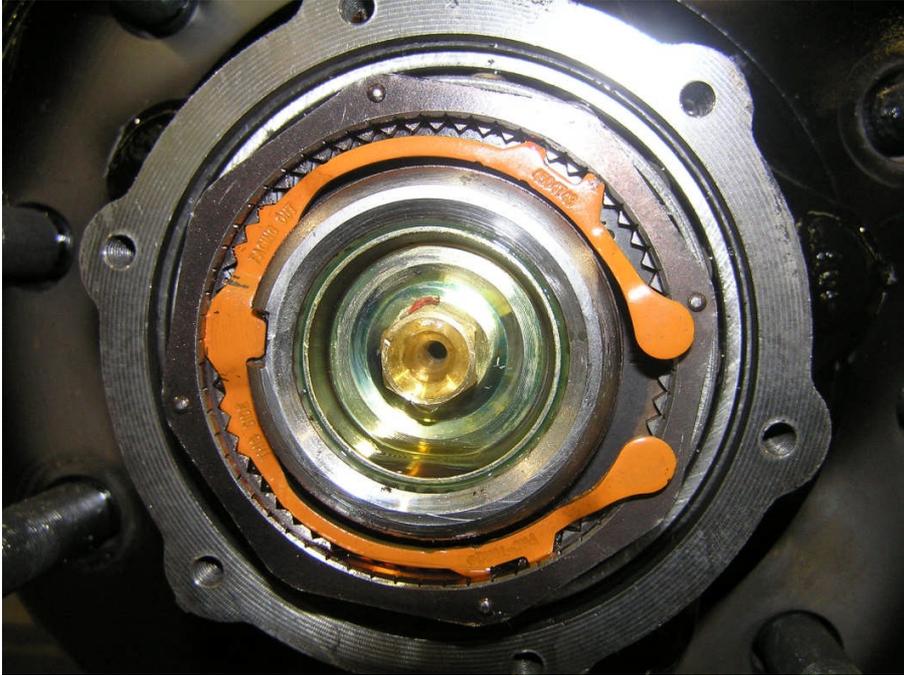
**Locking ring installed incorrectly.**

It is believed that the first defect was caused by lack of or improper installation of the locking ring during manufacture by Power Products. Based on inspection and through cooperation with the manufacturer, Power Products, it is believed that the lack of or improper installation of the locking ring on the Power Products axle may cause wheel separation.

The units identified in this Part 573 report should be removed from service and inspected using the procedure attached as Exhibit A. Reinke through Power Products will provide a \$75.00 per wheel end labor reimbursement for the inspection and any necessary retorquing and repairs, plus supplies to include oil and gaskets. If a replacement part is necessary, the owner should contact Tysen Hisson with Reinke Manufacturing, Inc. who will contact Power Products who will send the necessary replacement parts at no charge.

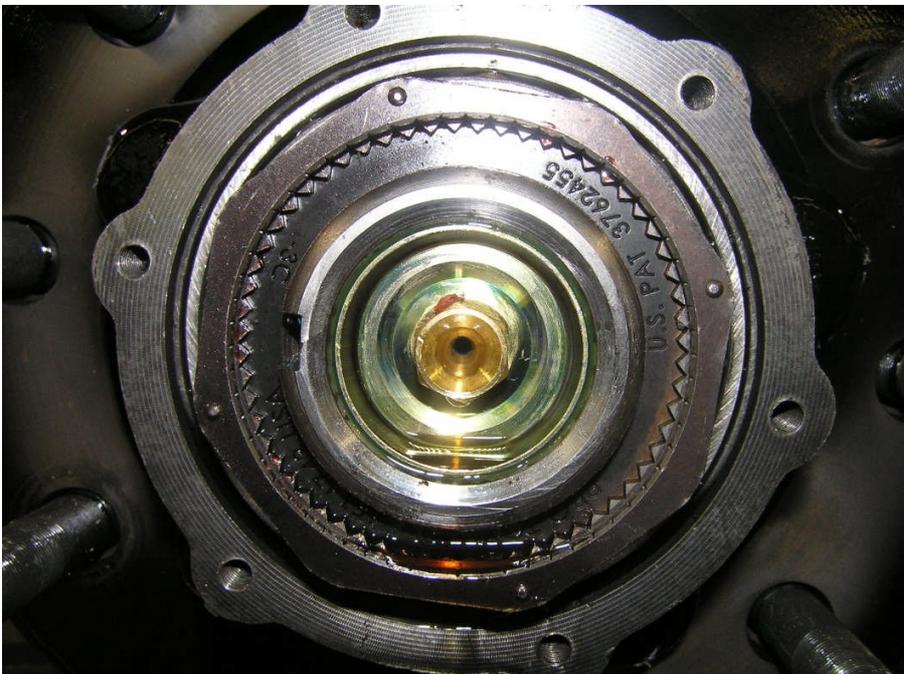
**Missing locking ring.**

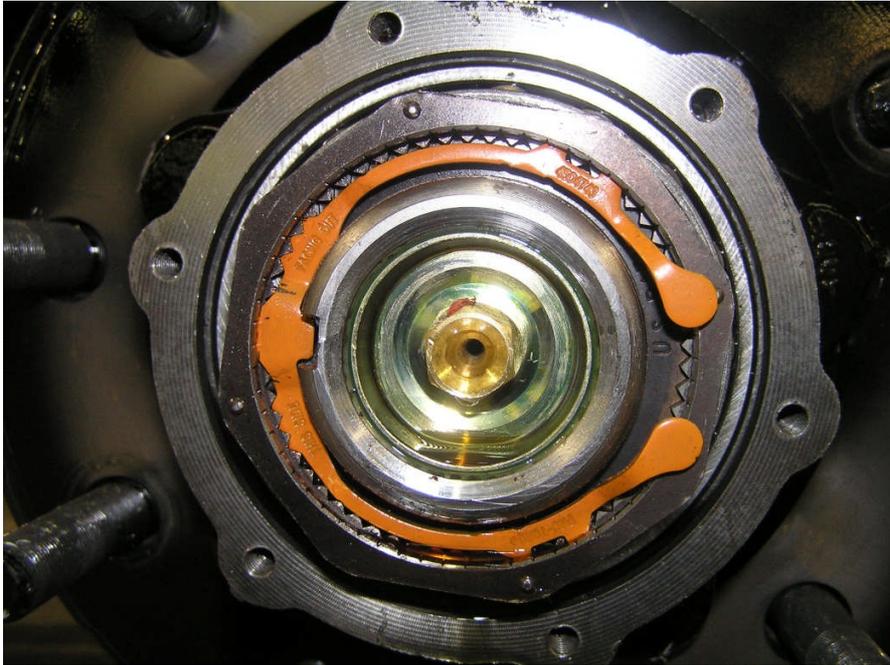
Locking ring:  
Remedied locking ring.

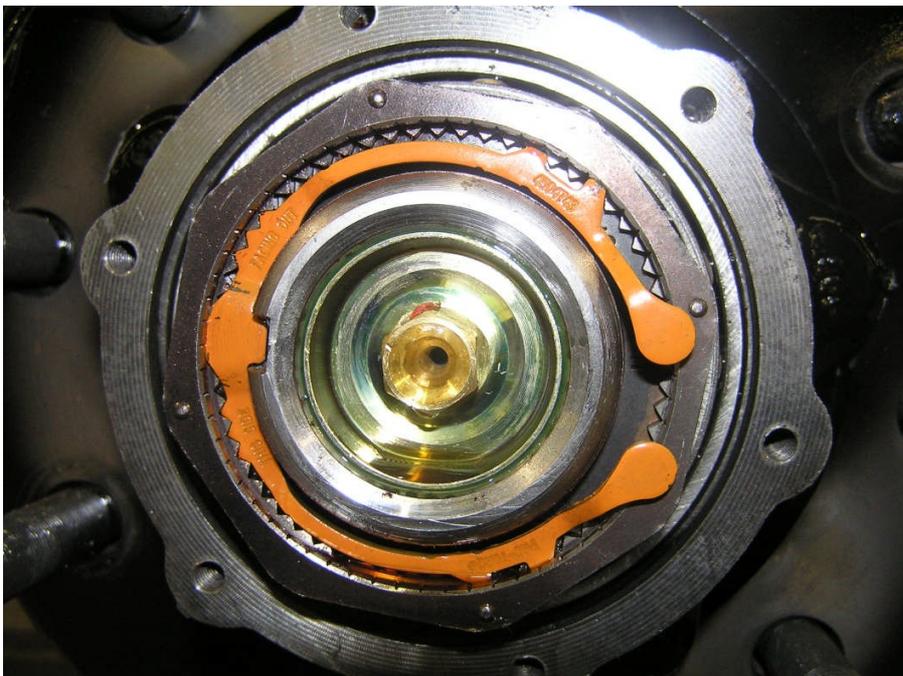
Recalled locking ring.

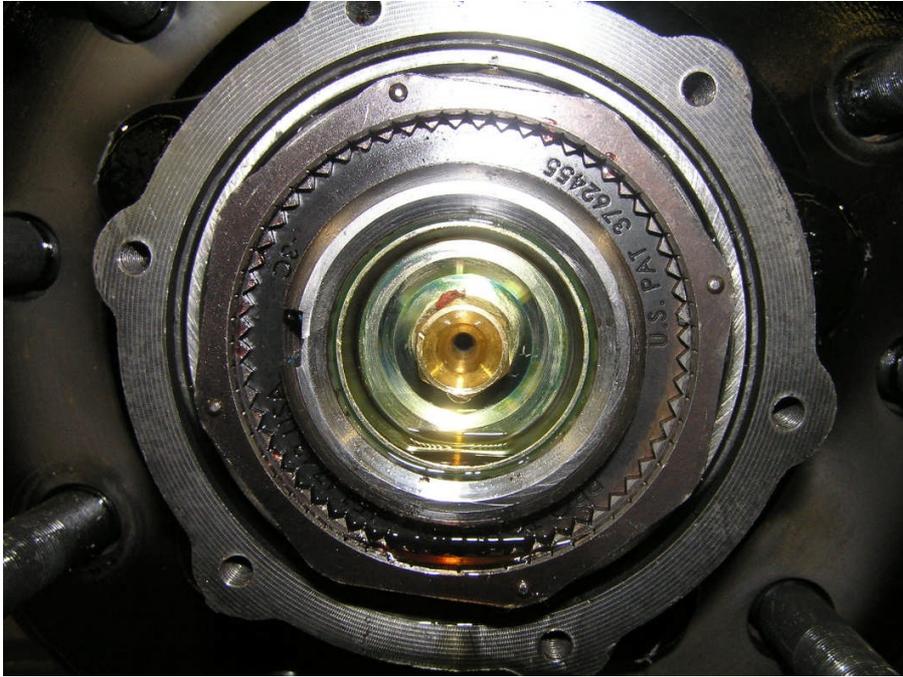
**Recalled locking ring.**
