AMERICAN SUZUKI MOTOR CORPORATION

12V-231
(5 Pages)

May 18, 2012

5. Description of Defect

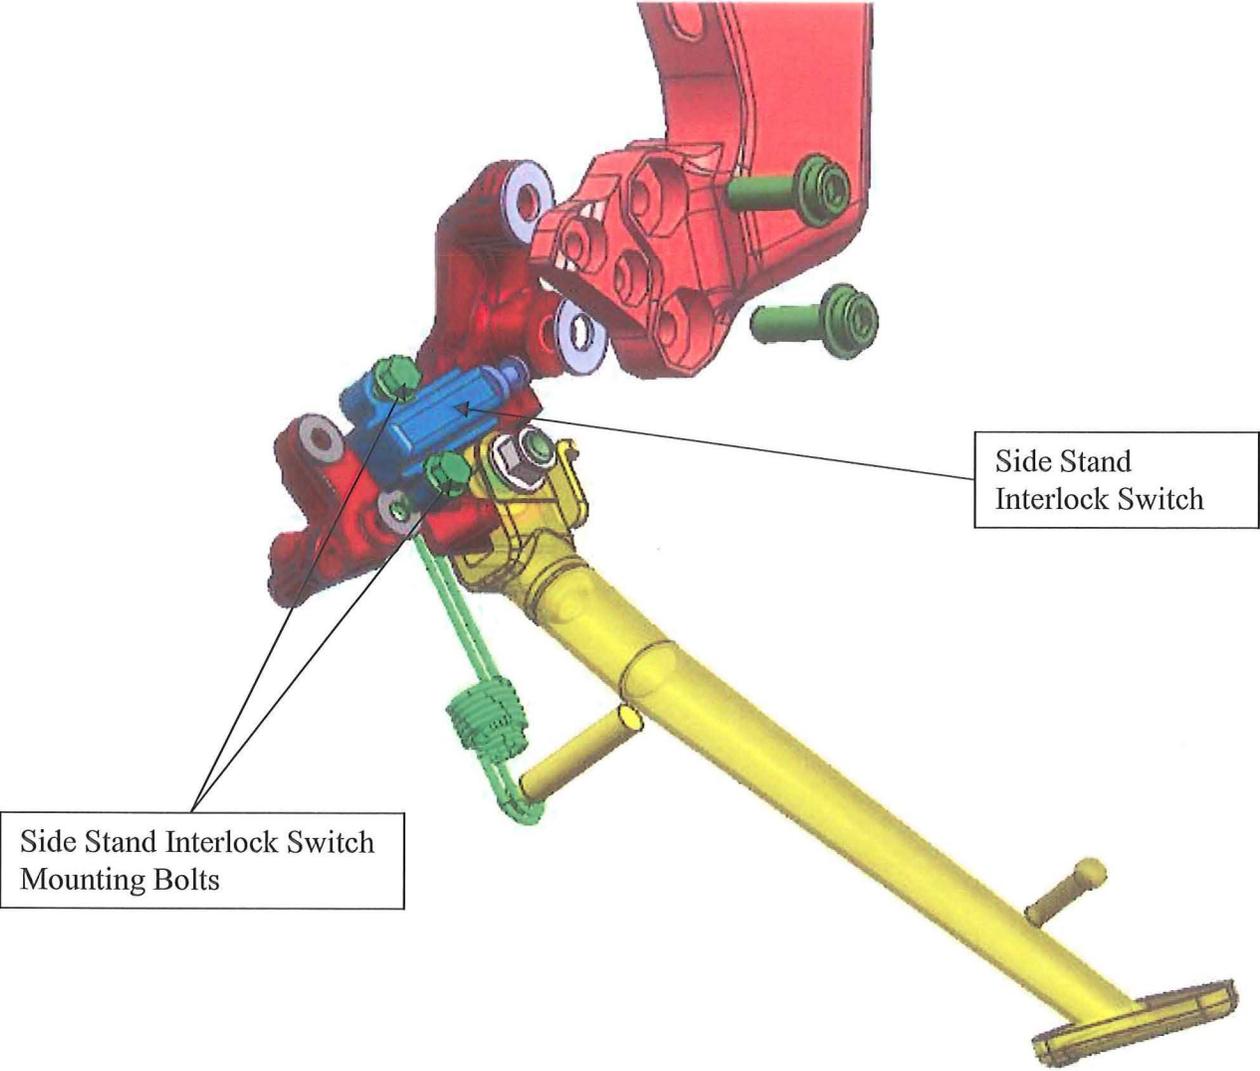
Location of Side Stand Interlock Switch

The defect involves the side stand interlock switch, which is provided to cut off the ignition circuit when the side stand is down and the transmission is in any gear other than neutral. Attached is an illustration showing the location of the side stand interlock switch.

The flange-head bolts used to mount the side stand interlock switch on the side stand bracket have a small-diameter flange that bears against the surface of the switch body, which is made of a zinc alloy. Because of the small diameter of the bolt flanges and small bearing surface of the bracket, compression buckling of the bolt side and bracket side of the switch body can occur and the bolts may loosen. Vibration can cause the bolts to turn and they can eventually come out. If a bolt comes out while riding, the body of the interlock switch can rotate, allowing the switch plunger to come out, cutting off the ignition circuit. This will cause the engine to stop running, increasing the risk of a crash.

Suzuki dealers will replace side stand interlock switch flange-head attachment bolts with bolts which have a larger-diameter flange and which are pre-coated with an adhesive material. Also, washers will be added to the interlock switch attachment seats and to the side stand bracket attachment seats.
