12V-231
(5 Pages)
Amended

AMERICAN SUZUKI MOTOR CORPORATION

5. Description of Defect

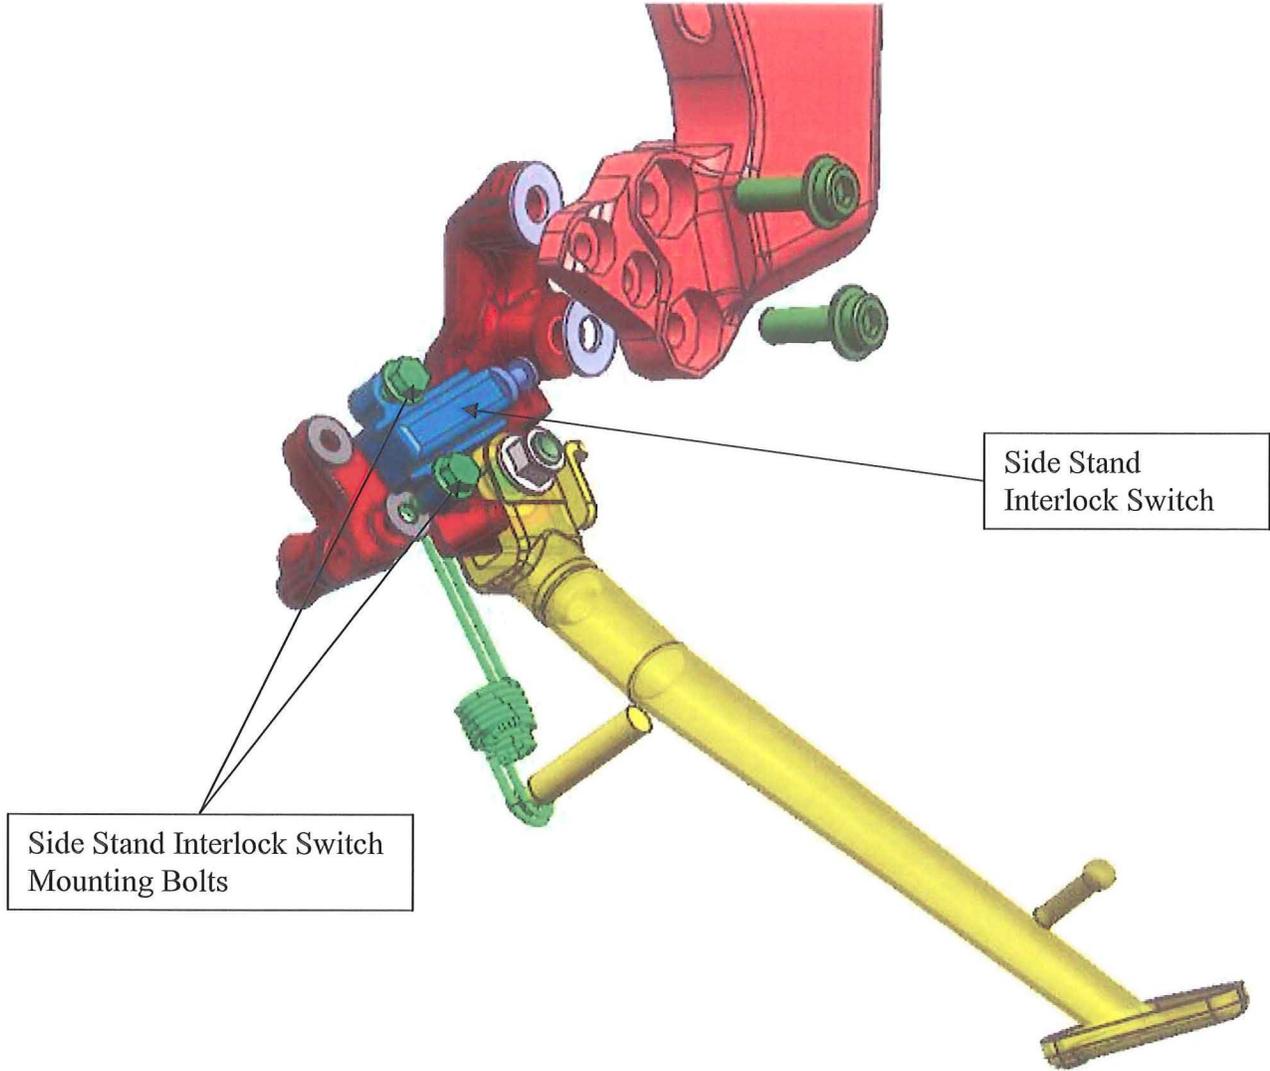
Location of Side Stand Interlock Switch

The defect involves the side stand interlock switch, which is provided to cut off the ignition circuit when the side stand is down and the transmission is in any gear other than neutral. Attached is an illustration showing the location of the side stand interlock switch.

The flange-head bolts used to mount the side stand interlock switch on the side stand bracket have a small-diameter flange that bears against the surface of the switch body, which is made of a zinc alloy. Because of the small diameter of the bolt flanges and small bearing surface of the bracket, compression buckling of the bolt side and bracket side of the switch body can occur and the bolts may loosen. Vibration can cause the bolts to turn and they can eventually come out. If a bolt comes out while riding, the body of the interlock switch can rotate, allowing the switch plunger to come out, cutting off the ignition circuit. This will cause the engine to stop running, increasing the risk of a crash.

Suzuki dealers will replace side stand interlock switch flange-head attachment bolts with bolts which have a larger-diameter flange and which are pre-coated with an adhesive material. Also, washers will be added to the interlock switch attachment seats and to the side stand bracket attachment seats.
