Service Bulletin

MOTORCYCLE DIVISION
GS/GSX/GSXR NO. 224
DATE: 05/23/2012

SAFETY RECALL CAMPAIGN

**Sidestand Switch Bolt
Replacement Campaign: 2A29**

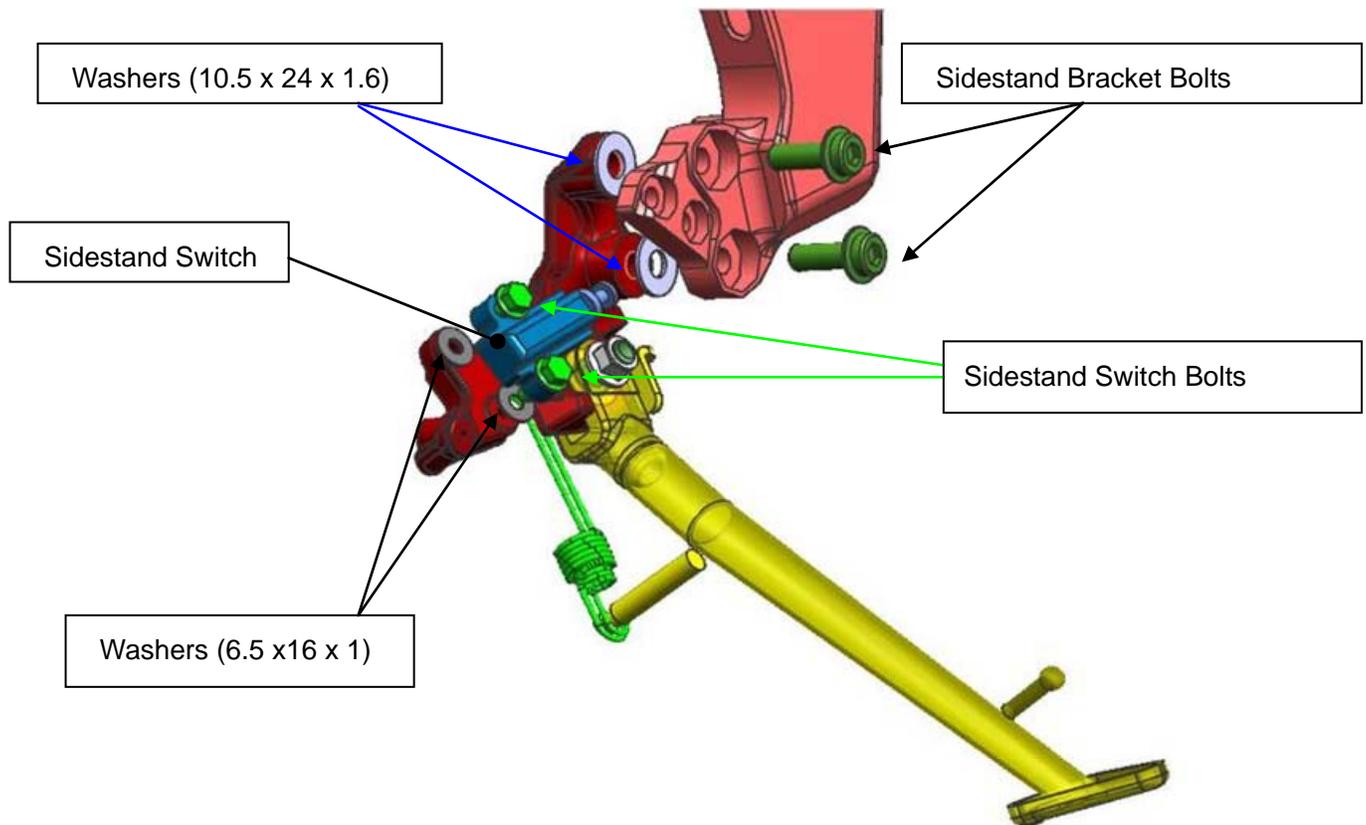
37800-47811-RX0 Sidestand Switch Bolt Set

- Sidestand Switch Bolt x 2 pcs
- Sidestand Bracket Bolt x 2 pcs
- Washer (10.5 x 24 x 1.6) x 2 pcs
- Washer (6.5 x 16 x 1) x 2 pcs
