Daimler Trucks North America
Nasser Zamani
Senior Manager
Compliance and Regulatory Affairs

**RE: Defect Information Report – Supplemental Report No. 1
12V-235, FL-551B, Western Star Battery Disconnect Switch Power Cable Routing
Dealer Notice**

Subject: Western Star Battery Disconnect Switch Power Cable Routing

Models Affected: Specific Western Star 4900 standard cab height vehicles manufactured November 10, 2008, through May 7, 2009, with a Detroit Diesel DD15 engine and a battery disconnect switch inside the cab.

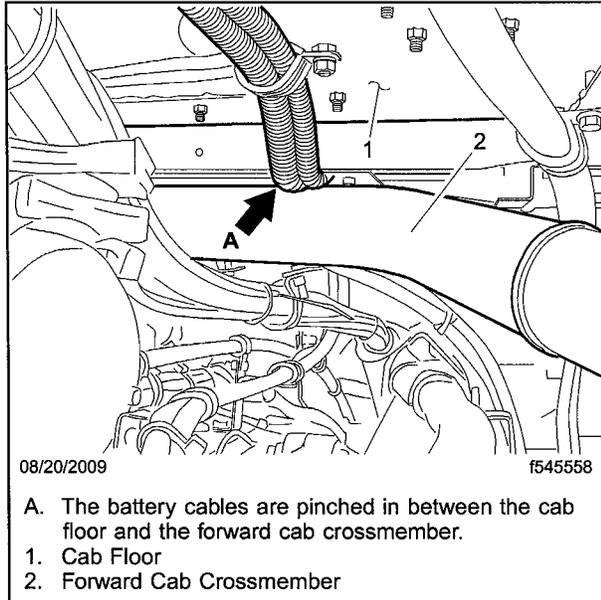
Fig. 1, Incorrect Cable Installation

2. Shut down the engine, apply the parking brake, and chock the tires.
3. Disconnect the batteries at the negative terminals, and open the hood.
4. Inspect the battery cables. On affected vehicles, the battery cable is routed on the inboard side of the windshield washer bottle. See **Fig. 1**.
