Safety Defect and Noncompliance Report Guide for Equipment
PART 573 Defect and Noncompliance Report

Generic name of the item: *ProLo Roof Hatch*

Function: *Bus roof escape hatch*

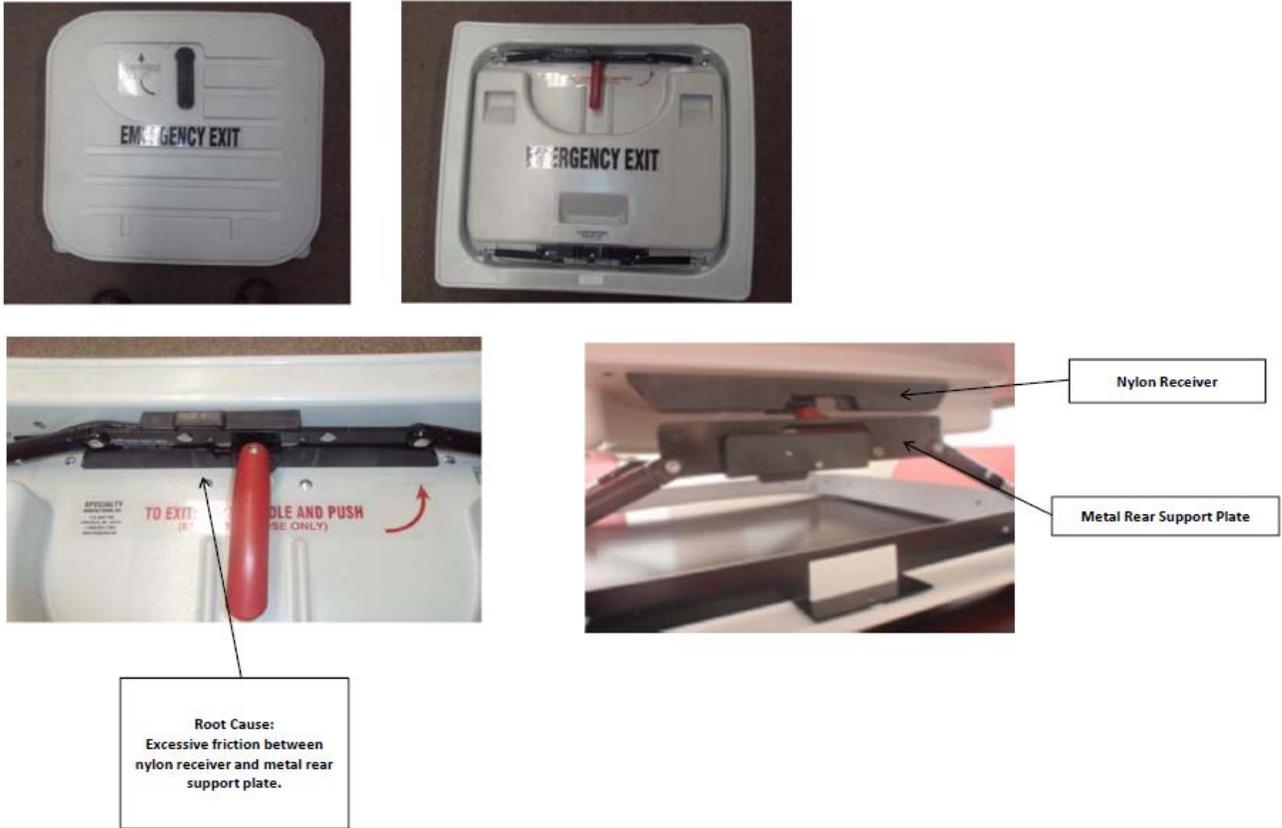
Increased friction between the 009327 Rear Plate Assembly and the 008956 Nylon Receiver results in an opening force on ProLo roof hatches that may exceed FMVSS 217 standards.

Continued wear of the tools over time for both the 008956 Nylon Receiver and the 009327 Rear Plate Assembly produced by SMI, combined with a change in suppliers for the 008956 Nylon Rear Pop-Up Support.

The force required to open the roof hatch may exceed the FMVSS 217-specified 40-pound maximum by forces ranging from 1 to 25 pounds with the average being 7 pounds.

The two walls of the remedy 008956 Nylon Receiver are parallel on the remedy component producing a minimum slot width of 0.200". (The slot width on the recalled component narrows toward the center of the part and the part may be bowed along the length, exacerbating the interference with the 009327 Rear Plate Assembly.)

Replacement of the 008956 Nylon Receiver resolves interference issues.
