**RE: Defect Information Report – Supplemental Report No. 4
11V-514, FL-614, Rack and Pinion Steering Pinion Bearings
Dealer Notice**

Subject: Rack and Pinion Steering Pinion Bearings

Models Affected: Specific Freightliner Cascadia, Century Class S/T, Classic XL, Columbia, and Coronado vehicles manufactured November 1, 2004, through June 15, 2010, with a ThyssenKrupp rack and pinion steering system.

June 2012
FL614AB
NHTSA #11V-514
Transport Canada #11-367

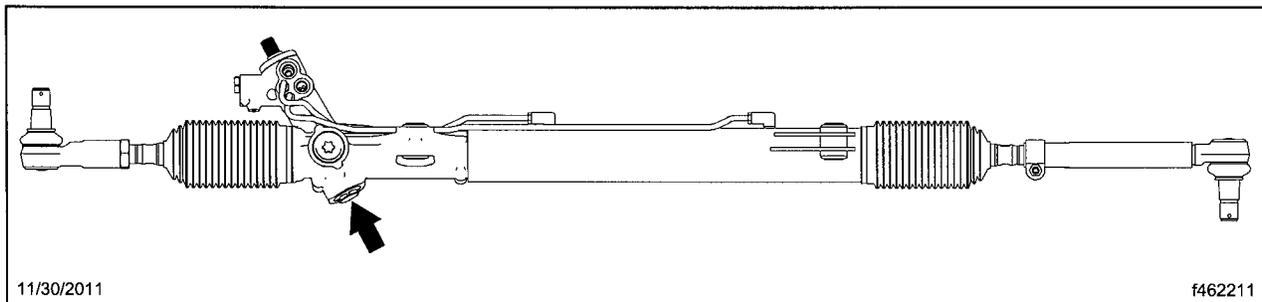
Fig. 1, Ball Bearing Access Cover Location

- Check the ball bearing access cover for indications that the cover has been staked at three equidistant points, See **Fig. 1**. If the ball bearing access cover has been staked, no work is needed.
- Check the part number of the rack and pinion gear. If the part number is either A14-18907-000 or A14-18907-001, no work is needed.
- If the repair has not been previously completed, proceed to the next step.

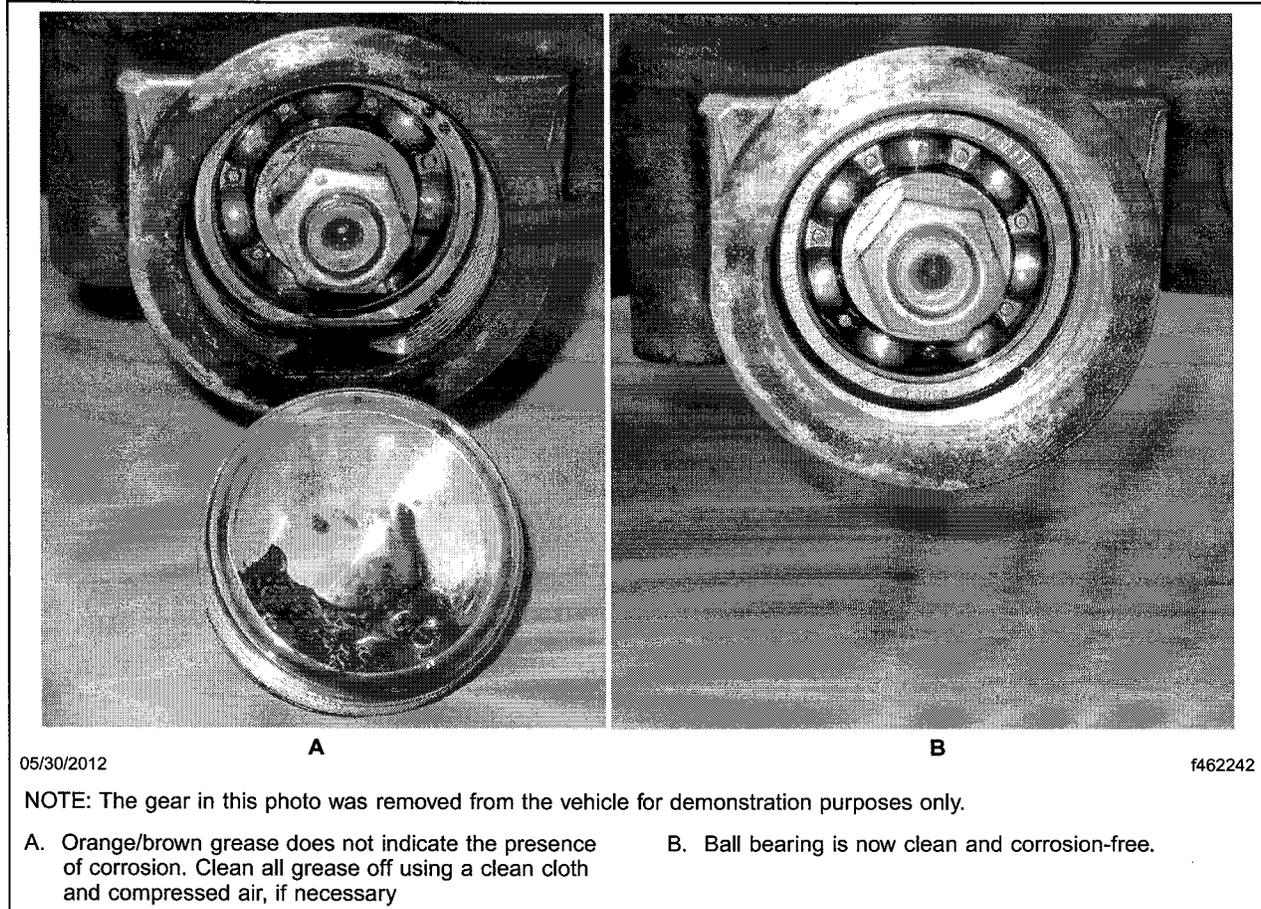
Fig. 2, Grease Removal from Ball Bearing

NOTE: Wipe all grease away before inspecting for corrosion. The presence of orange/brown grease is not an indicator of corrosion.

7. Using a clean cloth, remove all liquid and grease from the ball bearing. If necessary, use compressed air to remove excessive grease. See **Fig. 2** for an example of a sufficiently clean ball bearing.

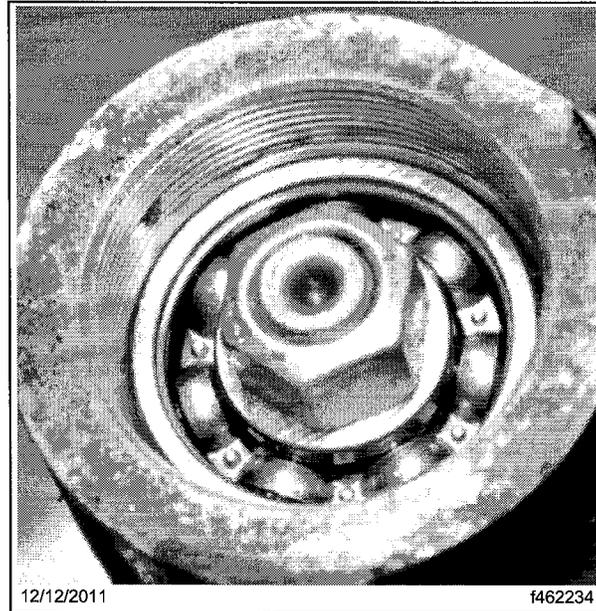
Fig. 3, Acceptable—Ball Bearing and Hexnut

8. Inspect the bearing access cover and ball bearing for corrosion. See Fig. 3.

If any corrosion is found, request pre-approval to replace the steering gear.

9. When pre-approval to replace the steering gear is received, install the bearing access cover back on the gear, then replace the rack and pinion gear. Go to **Rack and Pinion Steering Gear Replacement** below for instructions.
