SUBJECT: SAFETY RECALL OF 2009 - 2011 MCI D SERIES COACHES

Ref.: **NHTSA # 12V-250**
Transport Canada # 2012-173
MCI Service Bulletin 388

Service Bulletin No. 388

MODEL D Series Coaches	TYPE Field Change Program	SECTION/GROUP 7 – Electrical	DATE July 11, 2012
SUBJECT INTERIOR LED LIGHTS			
CONDITIONS

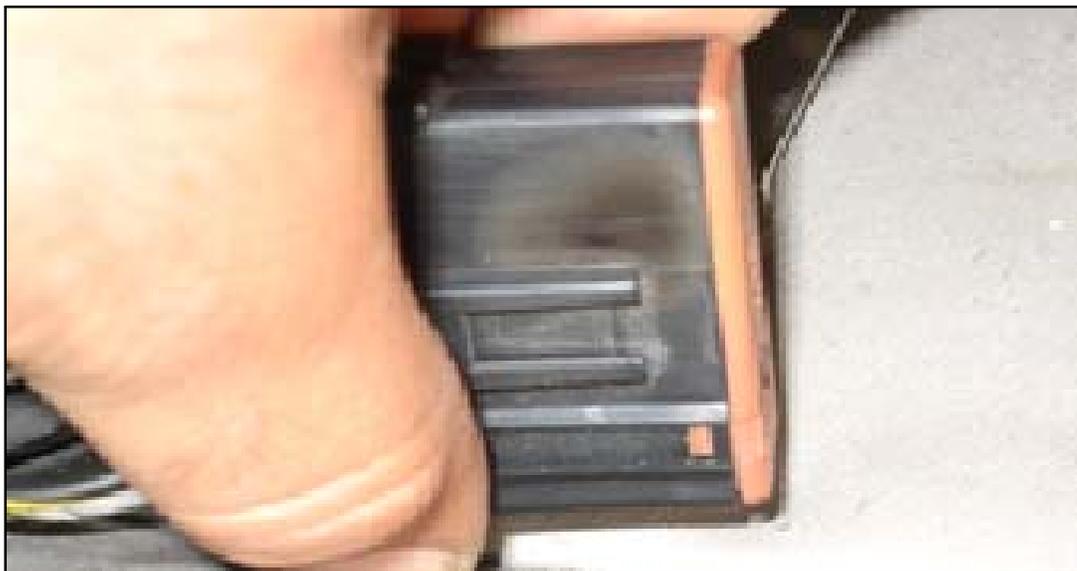
Motor Coach Industries, Inc. ("MCI") has become aware that when the LED lights are in operation in certain 2009–2011 D series coaches equipped with a Vansco or IO multiplex system, the power draw from the LED lights may exceed the design limits of the fuse block terminal and the splice clip connector. In this situation, excessive heat may build up at the fuse block and connector that may cause the components to melt.

Figure 3. Connector S102 (splice clip connector design / brown color).

6. Locate connector S102 (refer to Figures 2 and 3).

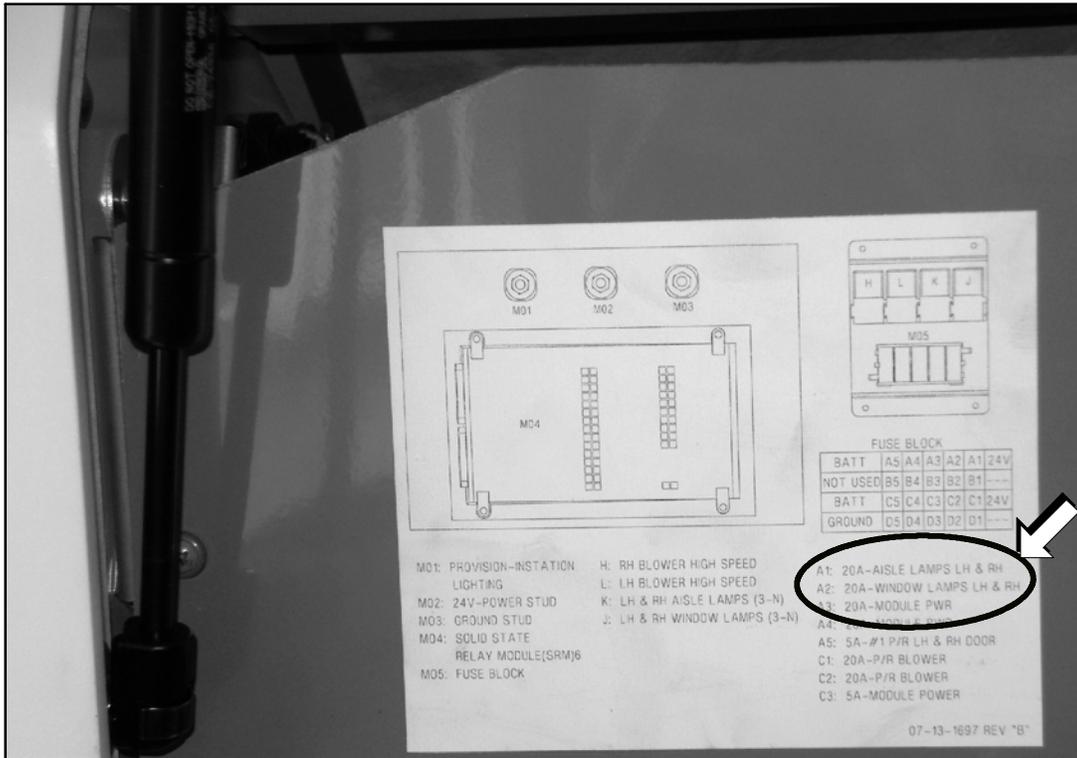
Figure 8. Decal legend location on junction box cover in curbside, parcel rack compartment #1.

- 25. Using the mounting hardware removed in Step 5. , reinstall the junction box cover.
- 26. Using the decals, p/n 07-08-4682, cover locations A1 and A2 on the Decal legend affixed to the junction box cover.
