Michael A. Berardi
Director
Service Engineering Operations
Ford Customer Service Division

July 26, 2012

SUBJECT: Safety Recall 12S37
Certain 2001-2004 Model Year Escape Vehicles with 3.0L Engine and Speed Control
Engine Cover Modification

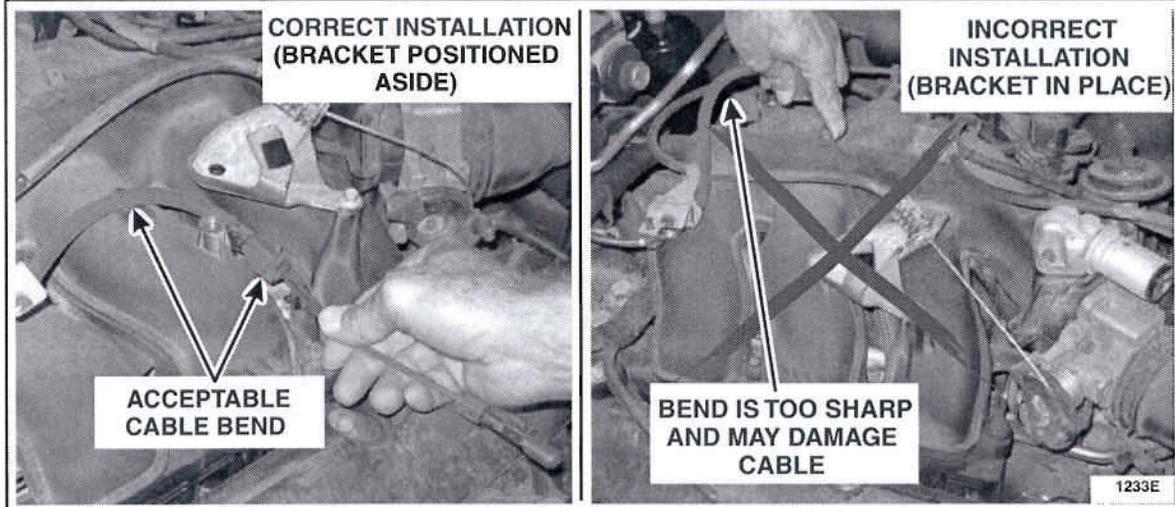
FIGURE 4

NOTICE: Do not bend the speed control cable in order to route it under the throttle cable bracket. The throttle cable bracket must be positioned aside or damage to the speed control cable may occur. See Figure 4.

4. Route the speed control cable under the bracket as shown in "correct installation" below. See Figure 4.
