**NABI Optima: Steering Column Shaft Pinch Bolt**

**SAFETY RECALL #20122**

**Property name and top bus number:** Optima buses manufactured by NABI (NABI Safety Recall #20122; NHTSA #12V-189)

**Issue:** Steering column shaft pinch bolt(s) may be loose or missing

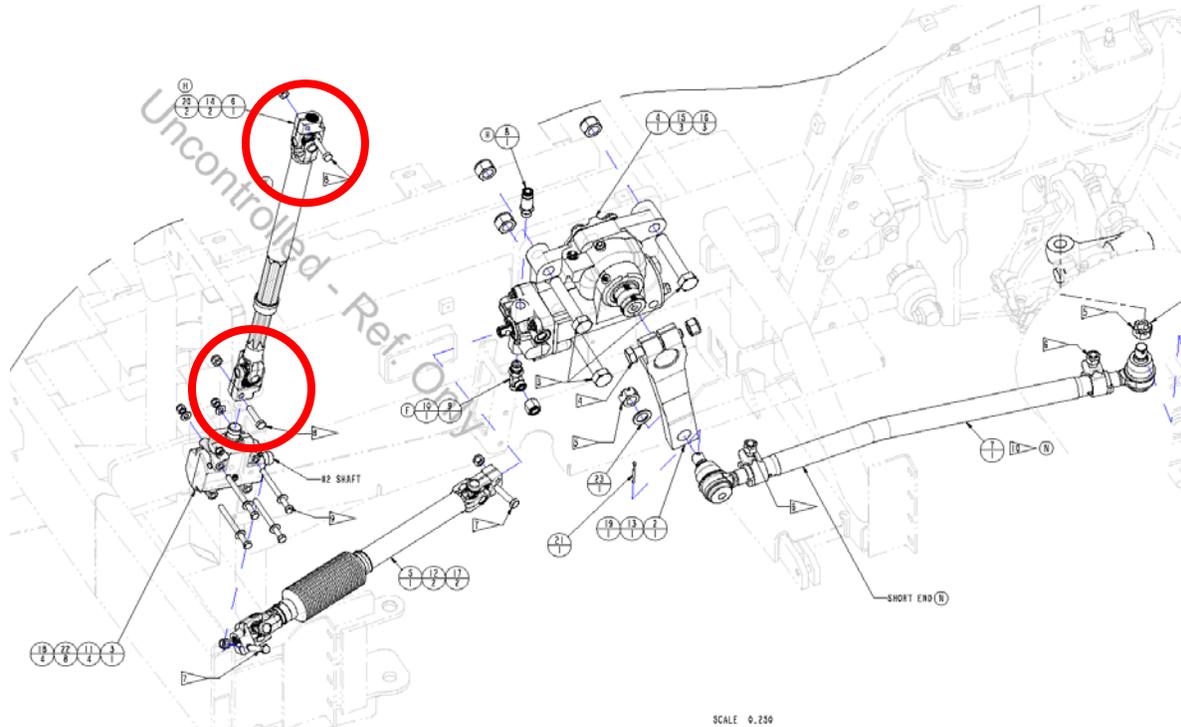
5. Inspect to determine the presence of the 2 (top and bottom) bolts and lock nuts (see below).

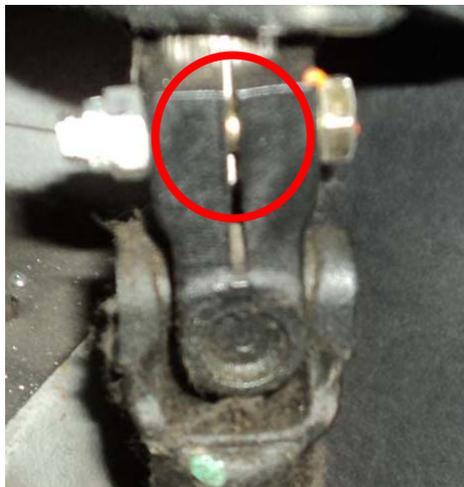
6. If the bolts and nuts are present:
  - Ensure that the bolt is properly installed into the groove of the shaft (see below).

- Torque nuts to 35-39 lb-ft.
- No further action is required.

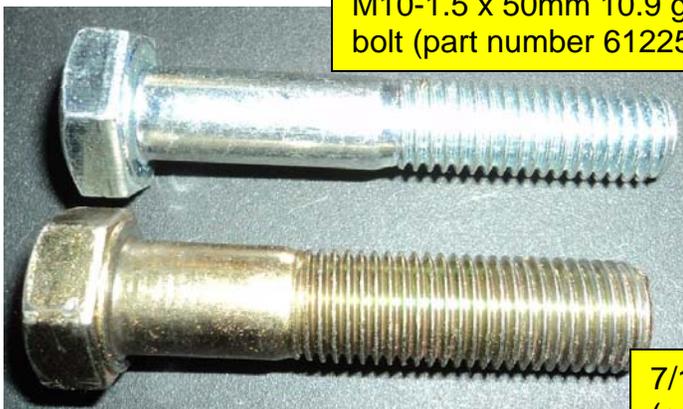
- The vehicle must NOT be operated until correction is made.
- Refer to the Maintenance Manual and Parts Catalog to determine what kind of hardware must be used. Depending upon the date of manufacture, there are 2 different configurations, which require specific hardware:
  - M10-1.5 x 50mm 10.9 grade bolt (part number 61225600) and a M10 x 1.5 nylock nut (part number 64807102), OR
  - 7/16-20x2 Gr8 bolts (part number 60797600) and a 7/16-20 flex-lock nut

- Torque the nuts to 35-39 lb-ft.
  - Apply torque seal the nut.
8. Push battery tray back, secure the tray and close the compartment door.
  9. Reinstall closeout panel of the steering column.
  10. Remove all the tools from work area.
  11. Check for completeness of work.
  12. Please fill the form below and return to NABI, Warranty Dept., 106 National Drive, Anniston, AL 36207 for each inspection and repair.
