Michael A. Berardi
Director
Service Engineering Operations
Ford Customer Service Division

August 22, 2012

SUBJECT: **Safety Recall 12S37 - Supplement #1**
Certain 2001-2004 Model Year Escape Vehicles with 3.0L Engine and Speed Control
Engine Cover Modification

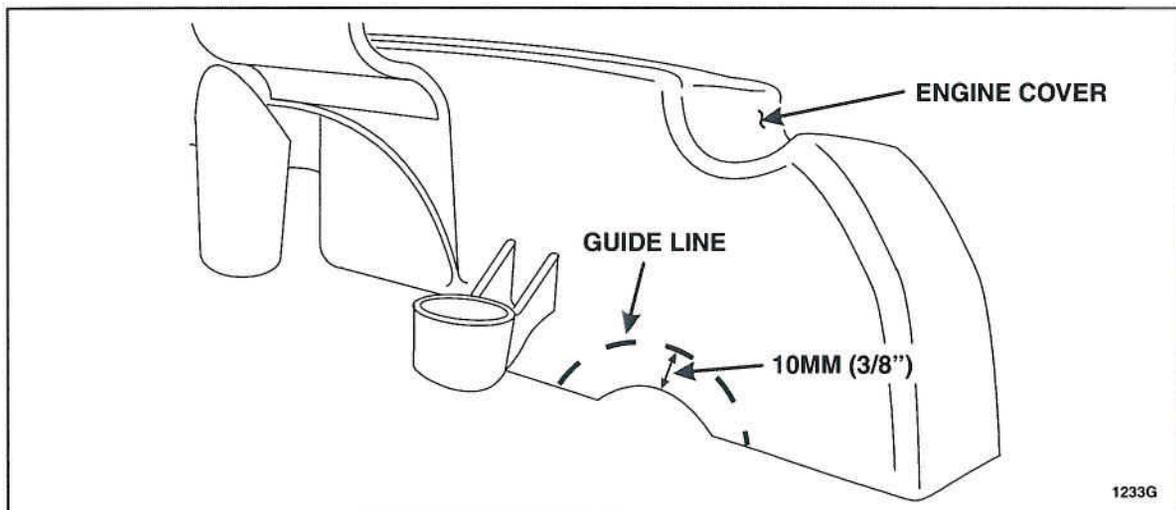
FIGURE 3

NOTE: The engine cover already has a relief to accommodate the drive belt tensioner. This relief needs to be trimmed to provide additional clearance.

4. Mark a guide line on the engine cover that is approximately 10mm (3/8") larger than the original opening. See Figure 3.
