# Recall Bulletin

## F/CMVSS NONCOMPLIANCE RECALL

**SUBJECT:** Possible Missing Secondary Hood Latch

**MODELS:** 2010-2012 Chevrolet Colorado  
2010-2012 GMC Canyon

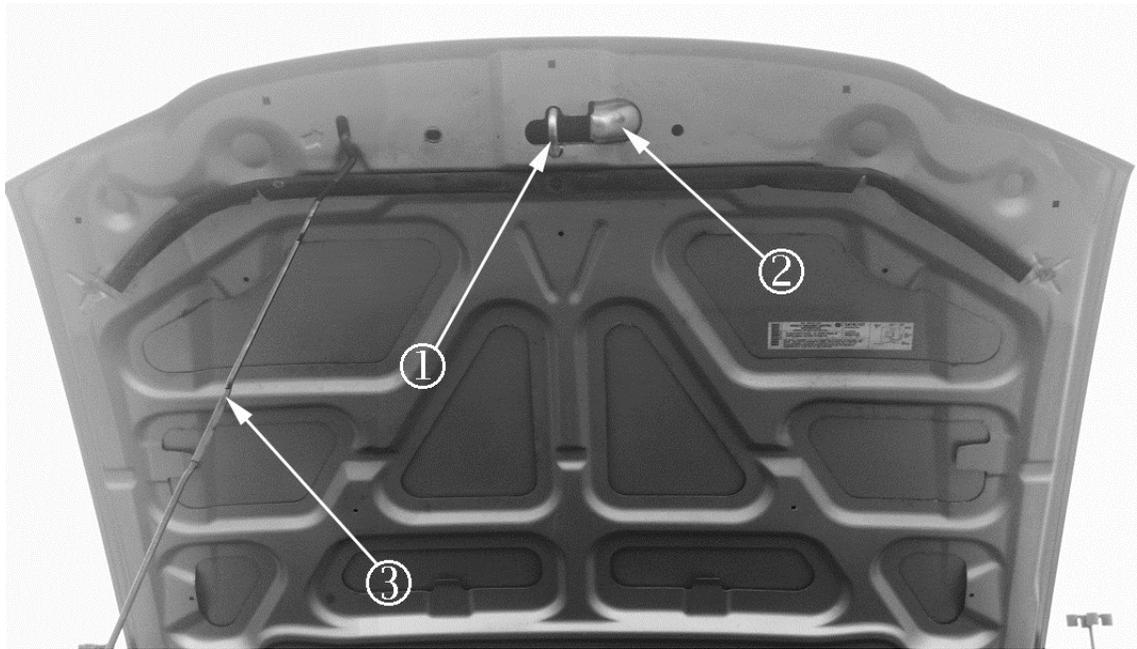
3228827

2. Release the hood prop from its retainer and put the hood prop into the slot in the hood (3).
3. Locate the primary (1) and secondary (2) hood latches. Refer to the illustration.

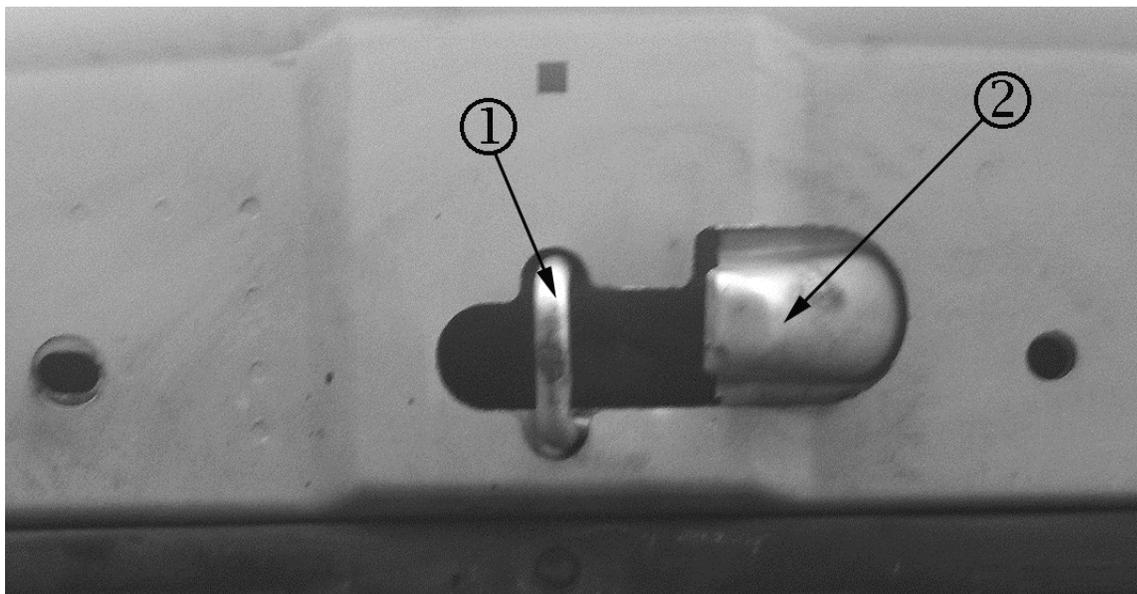
3228830

4. Determine if the hood is assembled with a secondary latch (2).
  - If the vehicle hood is assembled with a secondary latch, no further action is required. Lift the hood to relieve pressure on the hood prop. Remove the hood prop from the slot in the hood and return the prop to its retainer. Lower the hood 25 to 30 cm (10 to 12 in) above the vehicle and release it to latch fully. Check to make sure the hood is closed and repeat the procedure if necessary.
  - If the vehicle hood is NOT assembled with a secondary latch, remove and replace the hood. Refer to *Hood Replacement* in SI for hood removal and installation instructions.

Dealers are to inspect for the presence of the secondary hood latch. If the latch is missing, dealers are to replace the hood.
