12V-602  
(6 pages)

December 26, 2012  
Ref. No.: GR12-075

**RE: Part 573 Defect Information Report – Puddle Light Smoke on certain Subaru Legacy, Outback, Tribeca, and Forester vehicles**

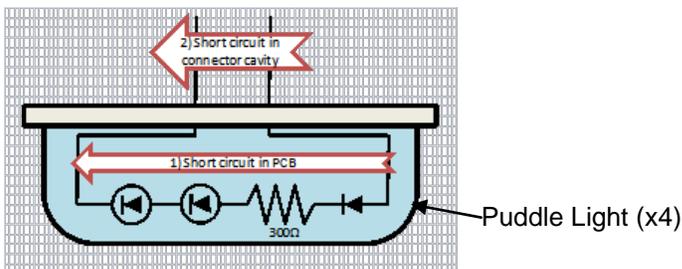
Diagram 1

A short circuit can develop when either the puddle light or connector are exposed to an electrolytic moisture source (i.e. salt water) and it penetrates the circuit board of the puddle light or the pins of the puddle light connector(s).

Over time migration of electrolyte laden moisture into the circuit board and/or into the connector cavity, may result in a short circuit of the puddle light system. This may generate heat which may melt the plastic resulting in smoke or fire.

The puddle light short circuit does not draw sufficient enough current to cause the shared circuit 20 Amp fuse to open. The 20 Amp fuse is not used exclusively for the puddle light circuit.

Path 1) in diagram 1 shows the short circuit on the circuit board internal to the Puddle Light Assembly.  
Path 2) in diagram 1 shows the short circuit in the harness connector cavity external to the Puddle Light Assembly.

(i) The remedy plan calls for dealers to install an additional harness equipped with an inline fuse between the pre-arranged vehicle connector and the puddle light harness on both RH and LH sides of the vehicle. The inline fuse harness incorporates a 250mA fuse which protects the Puddle Light assembly from the effects of a short circuit.
