Vehicle Owner Notification

Subject: VON # 83- Blown Fuse with 100% DRL Low Beam

VEHICLE OWNER NOTIFICATION #83

MODEL: EFX
SUBJECT: BLOWN FUSE WITH 100% DRL LOW BEAM
PAGE: 1 OF 3

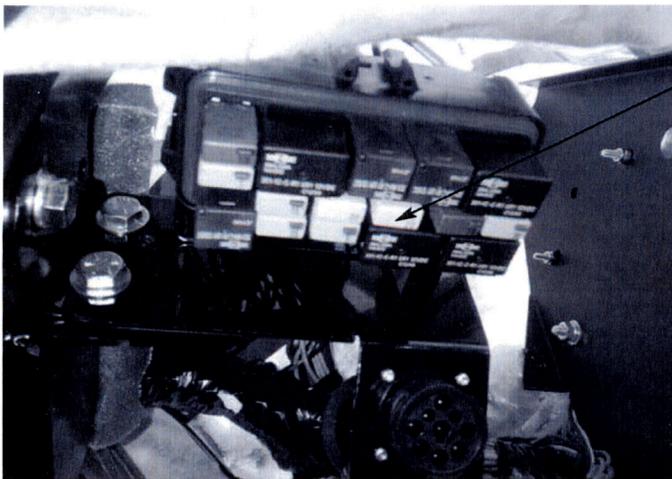
—Figure 1

Some EFX School Buses built between January 2, 2012 to October 4, 2012 ordered with option C3676-24-000 may pop breaker to the headlamps after about 45 minutes causing all headlamps, marker, and cluster lamps to shut off. If these conditions exist, this is the only time breaker should be replaced with 30A Type 1 breaker.

LOCATION OF BREAKER
IF 20A IS PRESENT, REPLACE WITH
30A BREAKER.

4. Remove 20A breaker retain for future use.
5. Install new 30A Type I breaker #TBB 159393 purchased from PDC (only type that is approved).
6. Locate the cover to the PDM that you removed. It should have a label on it telling where each breaker and relay goes in the PDM. **Figure 2**
7. Clean dust and other debris off of the original label for PDM
8. After it is clean, take #TBB 181070 (purchased from PDC) and apply directly over the original label. **Figure 3**
9. Reinstall cover and verify operation of lights.
10. Remove Chocks when done.
