Safety Defect and Noncompliance Report Guide for Equipment  
**PART 573 Defect and Noncompliance Report**<sup>1</sup>

**Part Number:** HUB-3208 **Size:** 2" Drop 8" between Hole Centers. 2" sq. Solid Shank 1 x 3" Flange

### Chronological Summary of Defect in HUB-3208

Report of Hitch Testing  
Performed on a **Ball Mount Design**  
in Accordance with SAE J684  
Exceeds Class 4 – 16,000 lbs. Wt. Carrying  
Model/Part Nos.: **HUB-3208**

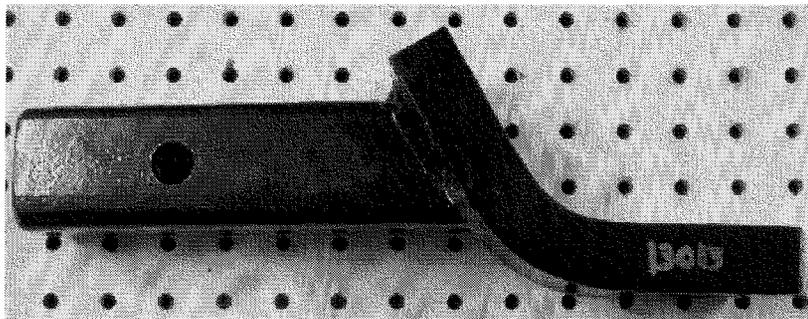
As Received

Specimen No. / Part No.	SAE J684 Rating Proofed to, Pounds	Comments
1 / HUB-3208 Ball mount for 2" receivers	Exceeds Class 4, 16,000 GVWR	<b>Supports all extrapolated load values</b> (Total change in ball axis 0.3°)
