# Recall Bulletin

## F/CMVSS NONCOMPLIANCE RECALL

**SUBJECT:** Possible Missing Secondary Hood Latch

**MODELS:** 2010-2012 Chevrolet Colorado  
2010-2012 GMC Canyon

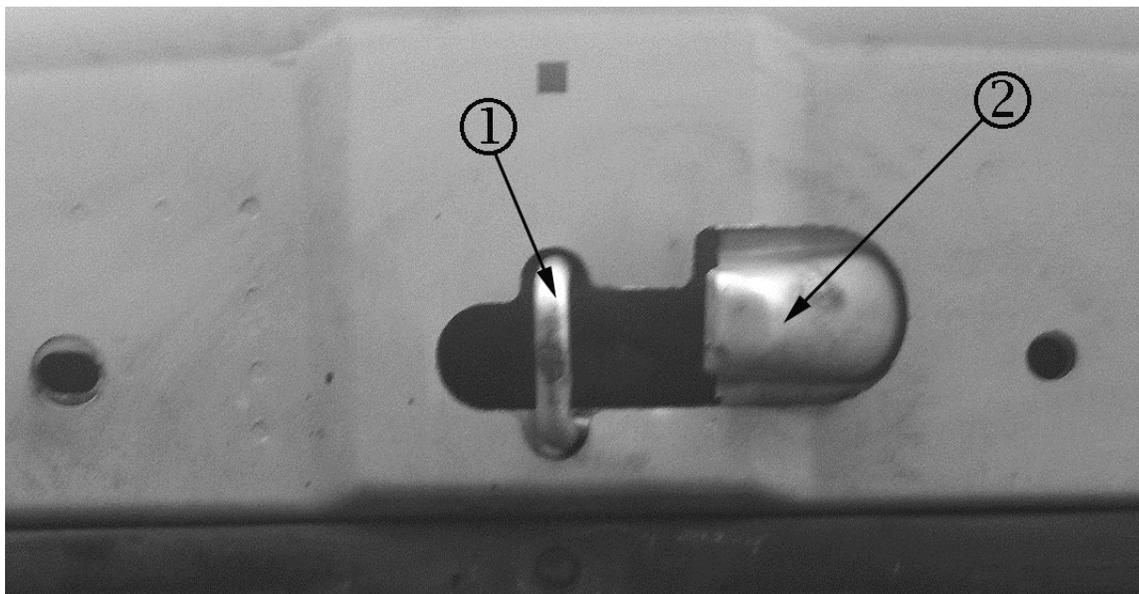
3228830

2. Release the hood prop from its retainer and put the hood prop into the slot in the hood (3).
3. Locate the primary (1) and secondary (2) hood latches. Refer to the illustration.

4. Determine if the hood is assembled with a secondary latch (2).
  - If the vehicle hood is assembled with a secondary latch, no further action is required. Lift the hood to relieve pressure on the hood prop. Remove the hood prop from the slot in the hood and return the prop to its retainer. Lower the hood 25 to 30 cm (10 to 12 in) above the vehicle and release it to latch fully. Check to make sure the hood is closed and repeat the procedure if necessary.
  - If the vehicle hood is NOT assembled with a secondary latch, remove and replace the hood. Refer to *Hood Replacement* in SI for hood removal and installation instructions.

Dealers are to inspect for the presence of the secondary hood latch. If the latch is missing, dealers are to replace the hood.
