**PREVOST****SAFETY
RECALL****SR13-01**

DATE : JANUARY 2013	SECTION : 10-FRONT AXLE
SUBJECT :	RADIUS ROD SUPPORT

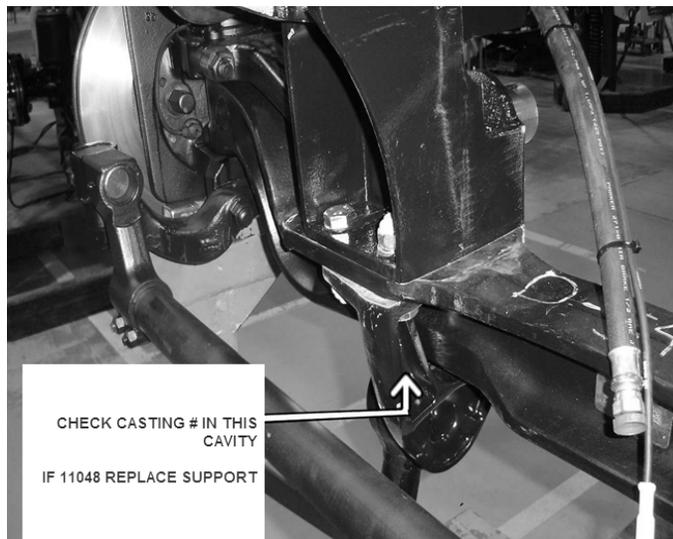
1. On front I-Beam axle, left hand side (road side). Check casting number in cavity of radius rod support 110739.

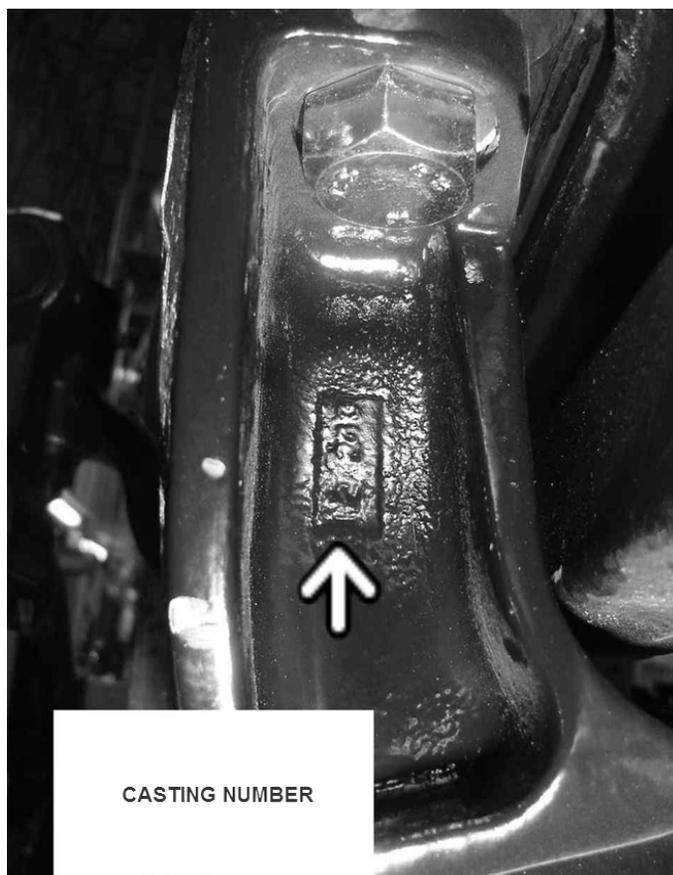
2. If casting number in cavity is **11048**, part must be replaced.
