This Service Information bulletin supersedes SI B11 11 12 dated November 2012.

NEW Recall Campaign 12V-550:: Replace Hex Bolt with Internal Thread for Deflection Pulley

E70 with M57Y engine

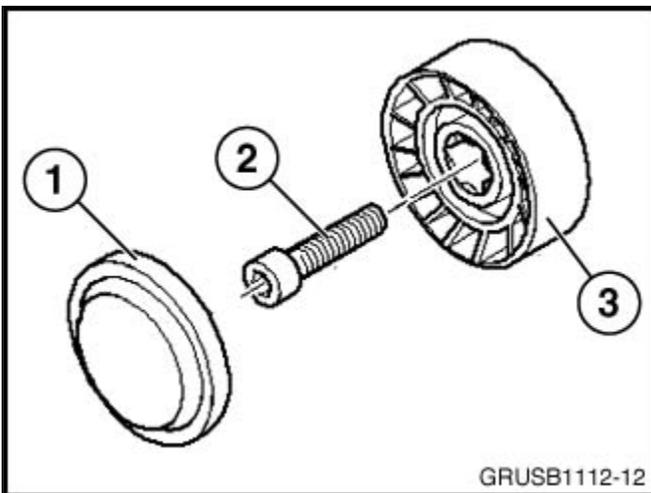
Cover for deflection pulley (1)

Deflection pulley mounting bolt (2)

Deflection pulley (3)

4. **NEW** Remove the deflection pulley mounting bolt (2) to remove the deflection pulley (3).

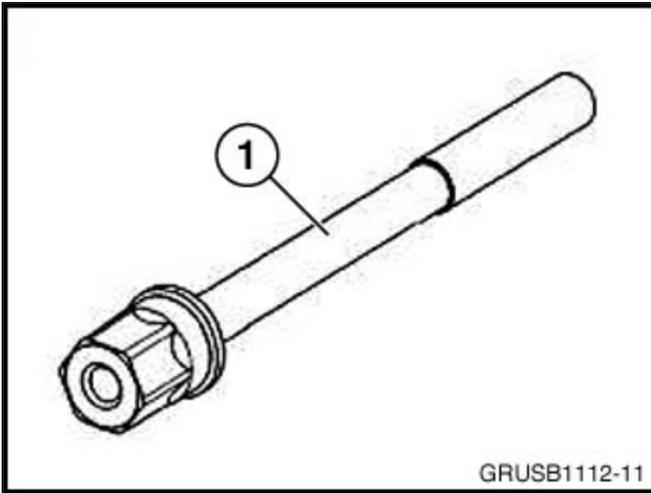
One of the alternator attaching bolts may fail. Subsequently the vehicle may lose power steering assist while driving. If power steering assistance is lost, the vehicle will remain controllable through the mechanical steering system, but with increased steering effort.

5. **NEW** Remove and replace the alternator bolt with P/N 12 31 8 574 809 (M10x125). Do not remove the alternator.

Torque the new bolt to 38 Nm initial torque, and then angle

toque the bolt to an additional 180°.
