March 26, 2013 Ref. No.: GR13-022

RE: Part 573 Defect Information Report – Brake Line Corrosion in Salt Belt States on 2005-2009MY Subaru Legacy and Outback Vehicles

Defect Information Report (49 CFR Part 573.6)

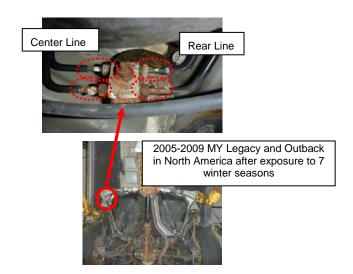
Brake lines collected from twelve (12) 2005-2009MY Legacy and Outback vehicles sold in the North American market showed corrosion. Subaru's investigation determined that these vehicles brake lines could perforate after exposure to 7 or more winter seasons. The perforation could occur at the brake line four-way joint connector, where the center and rear lines are joined and where there is no resin cover installed.

Depending on driving conditions, salt water could splash on the brake lines through a gap in the fuel tank protector, resulting in excessive corrosion of the brake lines. Due to the shape of the fuel tank protector used exclusively on 2005-2009MY Legacy and Outback vehicles, the amount of water which could contact the affected area is significantly more than other Subaru Models/Model Years when driven over 30 kph and passing over puddles 40 mm or more deep.

Brake fluid may leak from the perforated line(s). Since the center and rear brake lines work independently of one another, braking will still be possible if either (but not both) systems fail. The driver will be alerted to a fault in the brake system via illumination of the brake system warning telltale lamp because the fluid level will drop in the system. Failure of either the center or rear brake lines might cause the driver to misjudge the amount of brake pedal travel required to achieve the desired stopping distance.

The remedy plan calls for dealers to inspect and determine the presence of brake fluid seepage around the brake line four-way joint connector. This is accomplished by depressing the brake pedal firmly during engine idle.

- Scenario No. 1: If <u>no</u> brake fluid seepage is observed, the affected area will be rustproofed
 with anti-corrosion wax.
- Scenario No. 2: If brake fluid seepage is observed, the original center and rear brake lines will be replaced with new ones followed by rustproofing with anti-corrosion wax.
