**RE: Defect Information Report – Supplemental Report No. 1
13V-074, FL-639A, SmartPlex Switch Hub Modules
Dealer Notice**

Subject: SmartPlex Switch Hub Module

Models Affected: Specific Freightliner 108SD, 114SD, and Business Class M2 vehicles manufactured December 3, 2011, through December 12, 2012.

April 2013
FL639A
NHTSA #13V-074
Transport Canada #13-088

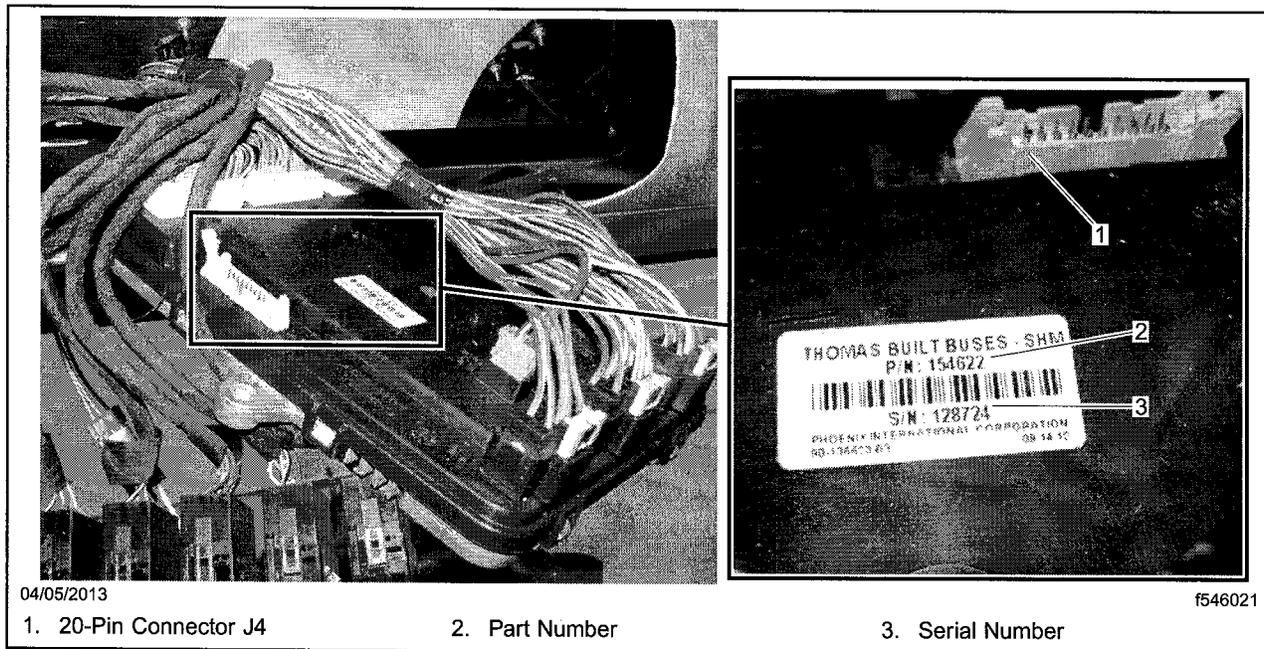
Fig. 2, SHM Label Inspection

If the serial number is 127176 or below, the SHM needs to be replaced. Proceed to the step 6.

If the serial number is 127177 or higher, the SHM does not need to be replaced. Proceed to the Important statement just after step 6.

4. Gently lift the switch hub module from the mounting bracket, then remove it from the overhead console.
5. **Inspect the label on the back of the SHM for the serial number. See Fig. 2.**

6. If replacing the SHM, disconnect all connectors from the SHM and remove it from the vehicle.
