RECALL CAMPAIGN BULLETIN

NTB13-035b

VOLUNTARY SAFETY RECALL CAMPAIGN 2013 PATHFINDER OCS SENSORS

CAMPAIGN ID #: PC216
NHTSA #: 13V-069
APPLIED VEHICLES: 2013 Pathfinder (R52)

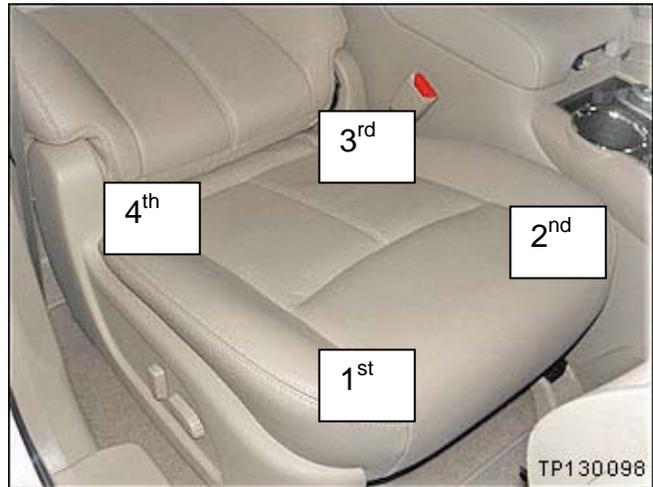
Figure 26

- In steps 18 and 19 you will be tightening the 14 mm nuts that hold the seat frame to the seat tracks.
- Torque the nuts in the order shown in Figure 26.

IMPORTANT:

- **This is a critical torque specification.**
- **Make sure the torque wrench is properly calibrated.**
- **Make sure to torque these nuts as indicated.**

18. From under the front of the seat, torque the front 14 mm nuts:

1st, torque outboard side.

2nd, torque inboard side.

- Torque nuts to:
45 N•m (4.56 kg-m, **33 ft-lb**)

19. From the top of the seat cushion, torque the rear 14 mm nuts:

3rd, torque inboard side.

4th, torque outboard side.

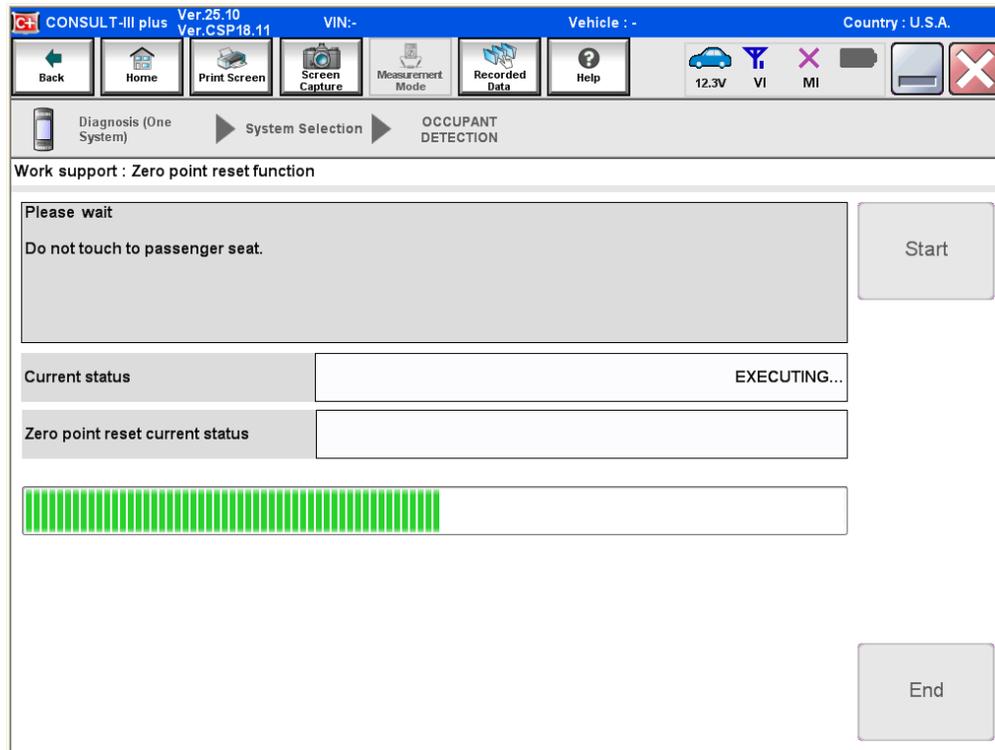
Figure Z6

NOTE: If Zero Point Reset will not complete, it is likely that something in the Service Procedure was not followed exactly as instructed.

NOTE: DTC B1020 is an indication that the 14 mm nuts may be torqued incorrectly.

- a. Turn the ignition OFF.
- b. Make sure all electrical connectors under the seat are **securely connected**.
 - Body harness to seat harness.
 - OCS sensors
 - OCS Control Unit.
- c. Try Zero Point Rest again.
- b. If it still will not complete, an installation process or step was not followed exactly as specified.
 - Recheck / re-perform the OCS sensor installation process.
 - **Pay special attention to the 14 mm nut torque (steps 18 and 19 on page 16).**
