# BOSCH MASTER CYLINDER SAFETY RECALL

Bulletin No: 13082

**SUBJECT: Recall of Master Cylinders (used with Hydro-Max® Booster)**

**MODELS: 2003-2009 Chevrolet Kodiak and GMC TopKick C4/C5 Series  
Serviced with a Suspect Master Cylinder**

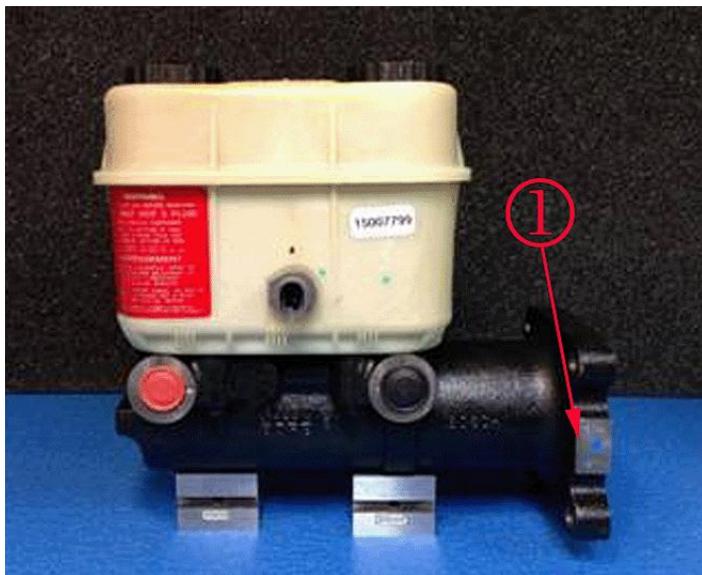
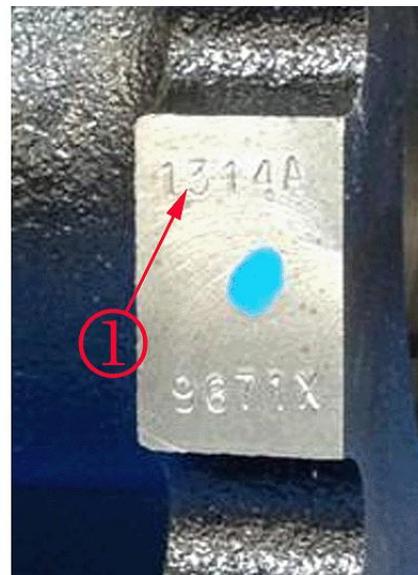
3405417

1. Locate the master cylinder manufacturing date code (1). The manufacturing date code (1) is marked on the upper left side of the master cylinder mounting flange. Refer to the photograph.

**Note:** For purposes of identification, the letter that follows the four numbers is ignored.

- If the manufacturing date code (1) is 1182 through 2103, replace the brake fluid level switch. Proceed to the next step.
- If the manufacturing date code (1) is less than 1182 or greater than 2103, no further action is required.

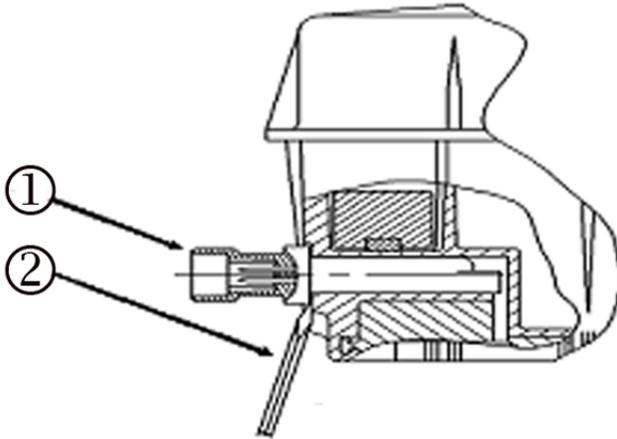
3415395

Sectioned view of reservoir. (1) Fluid Level Indicator Switch (2) Flat Blade Screwdriver

2. Remove the brake fluid level switch from the master cylinder reservoir. Using a flat #2 screwdriver, position the screwdriver tip between the switch face and the reservoir body as shown. Rotate the screwdriver blade tip until the switch breaks free; remove the switch.
3. Install the new brown color brake fluid level switch into the master cylinder reservoir until the tabs click.
4. Install the connector onto the new brake fluid level switch.
