NEWMAR CORPORATION

Date: June, 14, 2013
Re: Newmar Corporation – Motor Vehicle Recall Notification

Subject: Recall Campaign No.: 13V-169

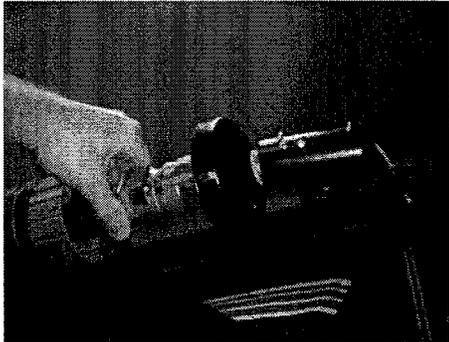
- 4) The motor/drive assembly that needs to be replaced has clear plastic shrink wrap around the motor and wires underneath the shrink wrap as shown below:

- 12) Pull out the motor/drive assembly. It should have clear plastic shrink wrap around the motor.
