PRODUCT SAFETY RECALL

SUBJECT: Passenger Airbag Inflator Weld May Fracture Upon Airbag Deployment

MODELS: 2014 Chevrolet Silverado Crew Cab
2014 GMC Sierra Crew Cab

GM Recall #13230

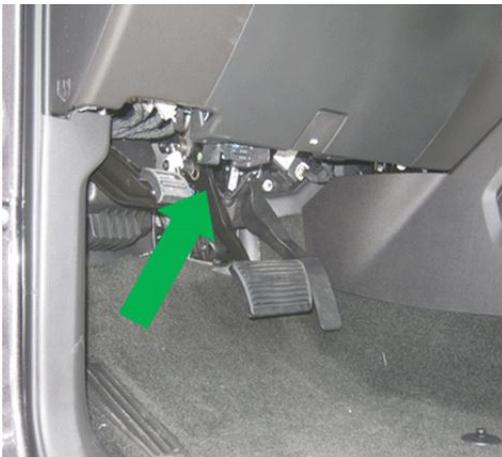
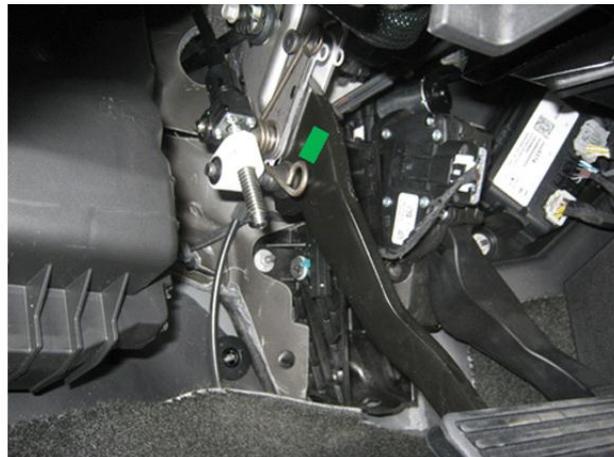
3560199

Determine if the instrument panel airbag has been replaced.

- If there is a green dot/stripe on the painted surface of the outboard side of the brake pedal (the outboard side faces the driver's door), do NOT replace the instrument panel airbag. No further action is required.
- If there is NOT a green dot/stripe on the painted surface of the outboard side of the brake pedal (the outboard side faces the driver's door), replace the instrument panel airbag. Refer to the service procedure in this bulletin.
