SUBJECT: **DEMONSTRATION / DELIVERY HOLD - Compliance Recall 13C02**
Certain 2013 Model Year C-MAX Vehicles Built without a Panoramic Roof
Headliner Head Impact Protection

DEMONSTRATION / DELIVERY HOLD - Compliance Recall 13C02
Certain 2013 Model Year C-MAX Vehicles Built without a Panoramic Roof
Headliner Head Impact Protection

CERTAIN 2013 MODEL YEAR C-MAX VEHICLES BUILT WITHOUT A PANORAMIC ROOF – HEADLINER HEAD IMPACT PROTECTION

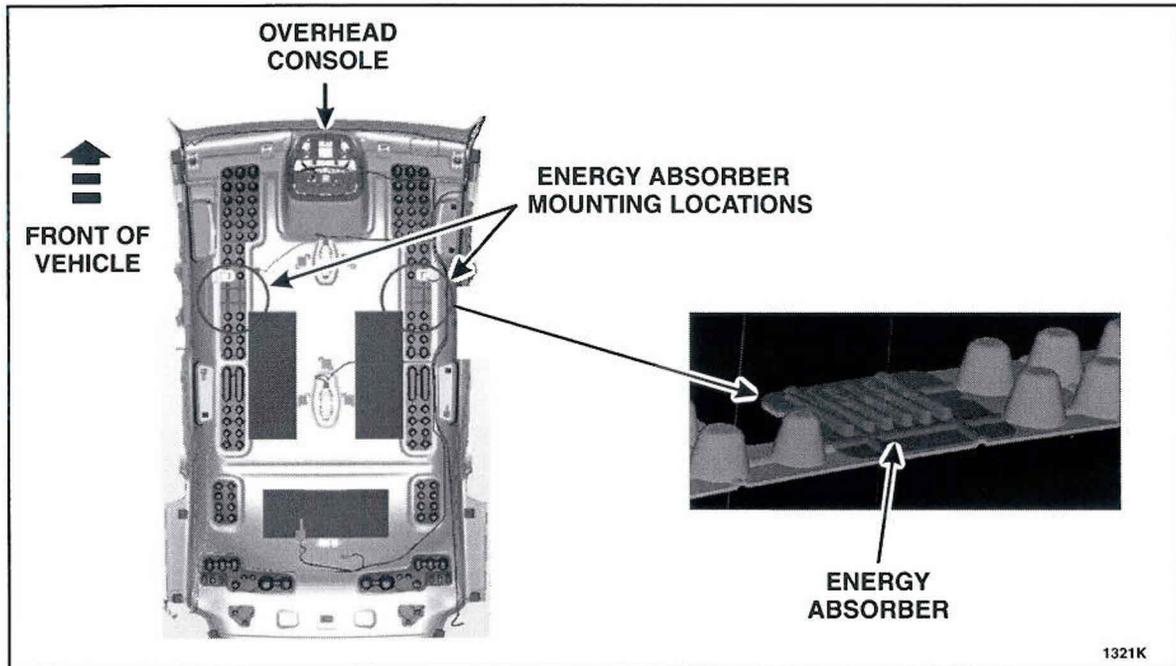
FIGURE 12

NOTE: Energy absorber mounting locations are located directly below the roof brace.

16. Lower the headliner far enough to access the areas where the energy absorbers will be attached. See Figure 12.

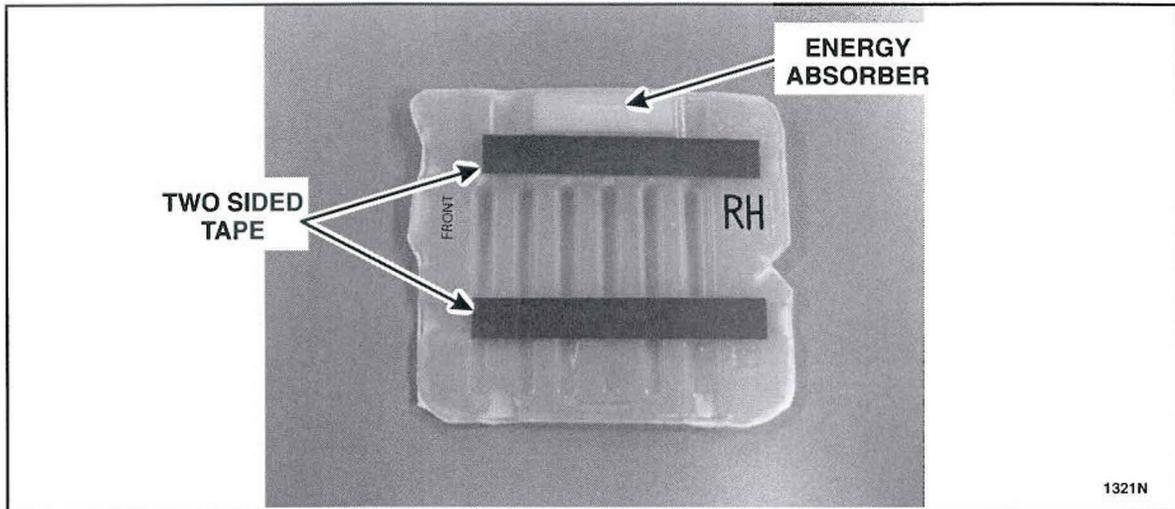
FIGURE 14

NOTE: The energy absorbers have "RH" and "LH" designations stamped on them. There is also a stamping that indicates the "Front" direction on each headliner support. See Figure 14.

18. Cut each length of the supplied two sided tape in half (two pieces per energy absorber). Remove the backing off of one side of the tape and apply to the RH and LH energy absorbers. See Figure 14.
