January 2014

**REGIONAL SAFETY RECALLS 13V-547, 12V-306 AND 10V-436  
BULLETIN UPDATE ANNOUNCEMENT**

This letter and specific bulletin sections are being sent to you to notify you of bulletin updates for Safety Recalls 13V-547, 12V-306 and 10V-436 – Corrosion Affecting the Forward Mounting Point for Rear Suspension Lower Link Brackets on certain Isuzu passenger vehicles.

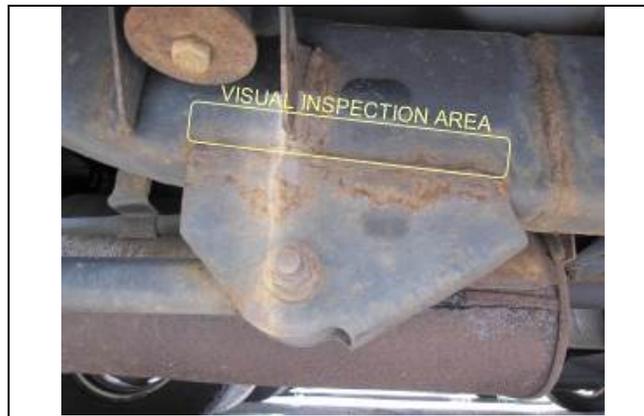
Figure 1 – Visual Inspection Area

2. Using a 3/16" flat punch and a 12-16 oz. hammer, hammer on the locations identified with an "X" in Figure 2. Swing the hammer 10 to 12 inches to be sure enough force is applied to the punch. If a hole is created go to Step 4. If no hole is created, visually inspect the Rear Lower Trailing Link Front Mounting Bracket inspection area. Use the Visual Comparison Photo (P/N 2-90SVA-003-0) or Figure 1 for reference. If most of the frame coating is still in place and very little surface rust is present, apply Noxudol 300 (Go to "Condition One: Apply Noxudol 300" in this bulletin). If most frame coating is missing and excessive rust is present go to the next step.

3. Apply Noxudol 700 and Noxudol 300 (Go to "Condition Two: Apply Noxudol 700 and Noxudol 300" in the appropriate bulletin).
4. Using a 3/16" flat punch and a 12-16 oz. hammer, hammer on the locations identified with an "X" in Figure 3.
  - a. If no hole is created, continue to Condition Three in the appropriate bulletin.
  - b. If the flat punch creates a hole in any one location, continue to Condition Four in the appropriate bulletin.
