NOTICE: Defect Information Report relating to Wheel Ends for Drive Axle Housings with ConMet PreSet Plus Hubs, built on consignment for Daimler Truck North America (DTNA), with missing locking snap rings.

Meritor File: C14-AA

Technical Bulletin

ConMet PreSet Plus™ Hub Lock Ring Inspection and Repair Procedures

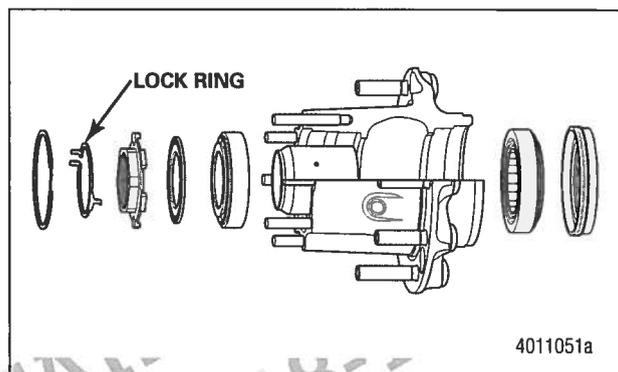
Figure 1

This publication provides the procedure required to check for the presence of the ConMet PreSet Plus™ hub lock ring at each drive axle wheel-end assembly. This inspection only applies to specific axles in a very limited number of vehicles. There is no need to perform this inspection unless specifically contacted by the OEM or Meritor. Figure 1.

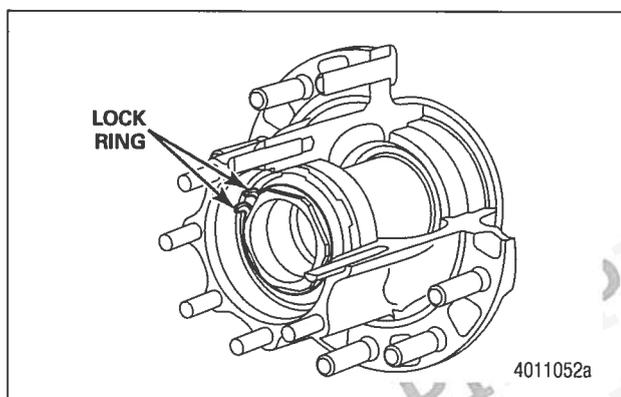
1. Wear safe eye protection. Park the vehicle on a level surface. Block the wheels to prevent the vehicle from moving.
2. Remove the axle shaft fasteners from all drive axle wheel ends.
3. Remove the axle shaft from each drive axle wheel end. Some lubricant will drain from the hub upon axle shaft removal. Use a small drain bucket to catch the lubricant.
4. Check for the presence of the lock ring on all drive wheel axle wheel ends. The lock ring is a bright red color. Refer to Figure 2 for the location of the lock ring.
 - **If the lock ring was present on all drive axle wheel ends:** Continue to the Reassembly procedure.
 - **If one or more lock rings were missing from the drive axle wheel ends:** Continue to the Missing Lock Ring Procedure.

1. Check that the spindle nut torque is 500 lb-ft (677 N·m) on each wheel end missing a lock ring.
 - **If the spindle nut torque is correct:** Install a lock ring in the correct orientation per the OEM's or ConMet's assembly guidelines.
 - **If the spindle nut torque is not correct:** Replace the ConMet PreSet Plus™ hub assembly on the wheel end.
2. Continue to the Reassembly procedure in this publication.
