SUBJECT: DEMONSTRATION / DELIVERY HOLD / DO NOT DRIVE – SAFETY RECALL 14S09
Certain 2014 Model Year F-150 Equipped with Electronic Power Assist Steering
Steering Gear Replacement

**DEMONSTRATION / DELIVERY HOLD / DO NOT DRIVE
SAFETY RECALL 14S09**

Certain 2014 Model Year F-150 Vehicles Equipped with Electronic Power Assist Steering
Steering Gear Replacement

CERTAIN 2014 MODEL YEAR F-150 VEHICLES WITH ELECTRONIC POWER ASSIST STEERING — STEERING GEAR REPLACEMENT

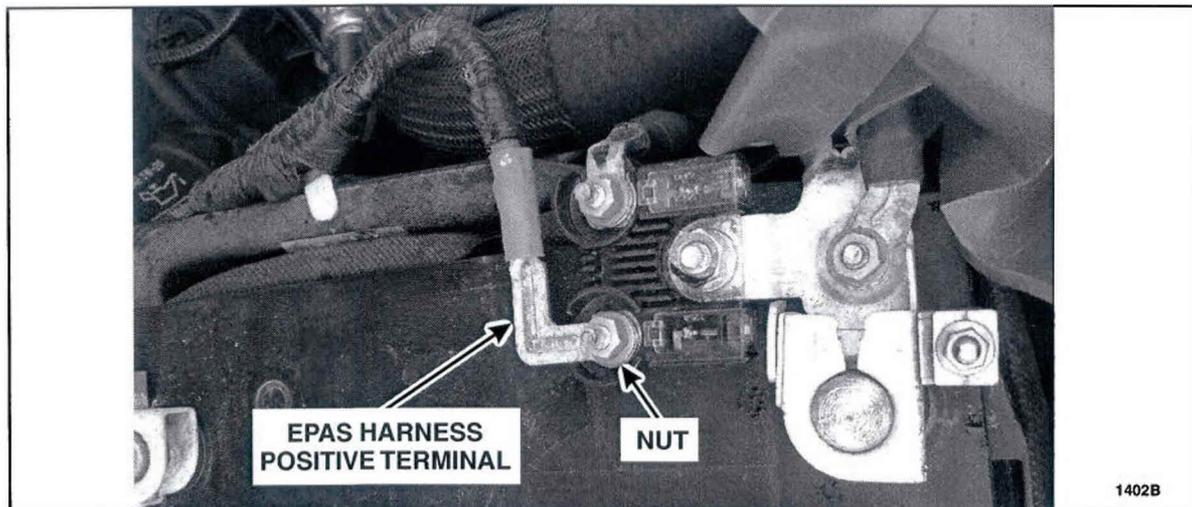
FIGURE 1

1. With the key in the OFF position, remove the EPAS harness positive terminal from the battery. See Figure 1.
 - a. Remove the nut from the EPAS harness positive terminal.
 - b. Remove the EPAS harness positive terminal from the battery.
 - c. Tape the exposed end of the EPAS harness positive terminal and secure the harness away from the battery to prevent contact with battery voltage.

1. Once in the service bay, reconnect the EPAS harness positive terminal to the battery prior to module configuration. See Figure 1.
 - a. With the key in the OFF position, install the EPAS harness positive terminal onto the battery.
 - b. Install the nut onto the EPAS harness positive terminal.
 - Tighten nut to 9 Nm (80 lb-in).
2. Replace the steering gear. For additional information, refer to Workshop Manual (WSM) Section 211-02.
