TO: All Mazda Dealership General Managers, Service Managers, and Parts Managers
DATE: April 2014
SUBJECT: 2010-2012 Mazda6 2.5L Engine Fuel Tank Safety and Emission Recall 7214C

ATTACHMENT I - DEALER INFORMATION
Safety & Emission Recall 7214C

2010-2012 MAZDA6 2.5L ENGINE FUEL TANK SAFETY AND EMISSION RECALL 7214C

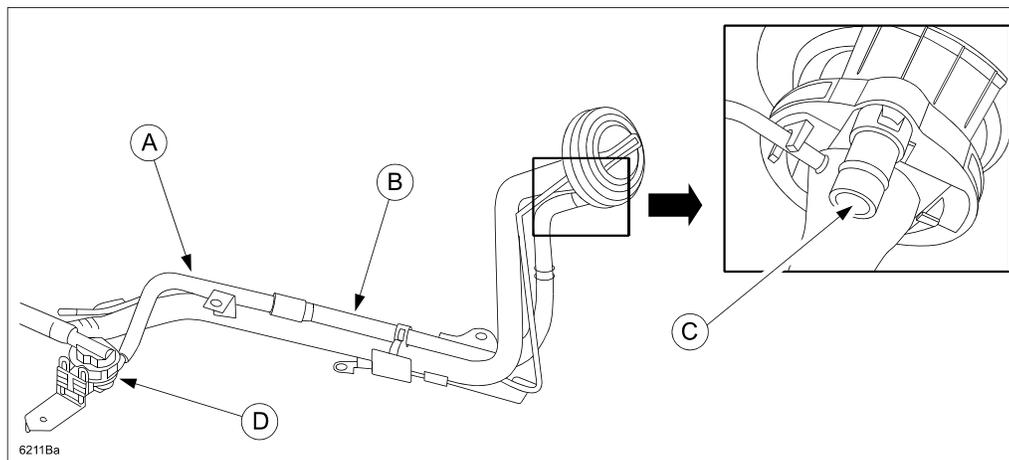
Using the Spider Brush SST, inspect the short ventilation hose (A), long ventilation hose (B), vent port nipple (C) and evaporative chamber (D) for spider webs.

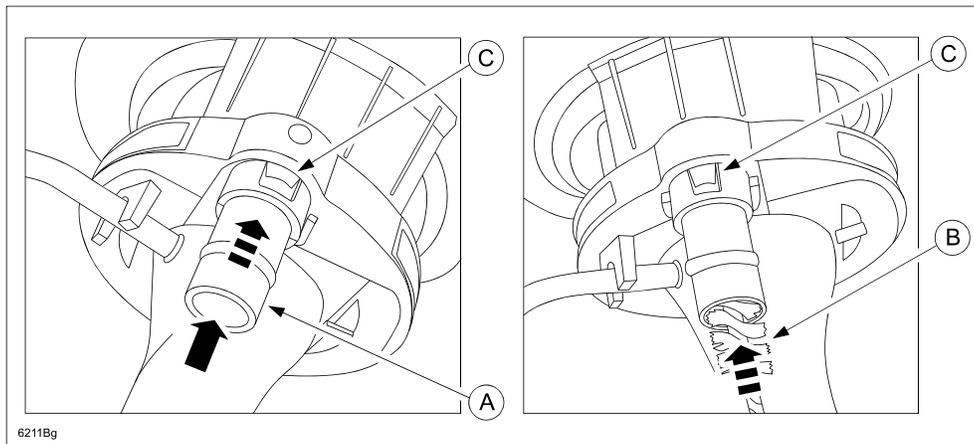
- a. Visually check inside of the vent port nipple (A) to see if spider webs are present or not.
- b. Insert the brush (B) into the vent port (C) and pull it out. Check the brush to see if spider webs are present or not.

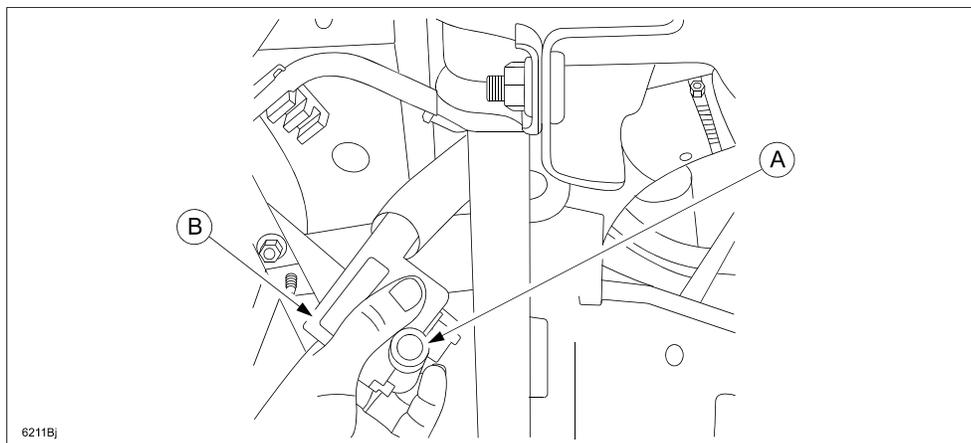
- a. Visually check location (A) inside of the evaporative chamber (B) and verify if spider webs are present or not.

- If spider webs ARE NOT FOUND in any one of the above inspections, proceed to and complete "D. PCM REPROGRAMMING" only.
- If spider webs ARE FOUND in any one of the above inspections, proceed to and complete "D. PCM REPROGRAMMING" and "E. FUEL TANK AND EVAPORATIVE CHAMBER REPLACEMENT".
