Updated 10/27/2014: Op. Codes Added.
Updated 10/22/2014: Part Ordering Section update to clarify correct part for corresponding location

To: All Toyota Dealer Principals, Service Managers, and Parts Managers

Subject: **Safety Recall E04 – For Areas of High Absolute Humidity**
Certain 2003 – 2005 Model Year Corolla, Corolla Matrix, and Tundra Vehicles
Certain 2002 – 2005 Model Year Sequoia Vehicles
Front Passenger Air Bag Inflator Module

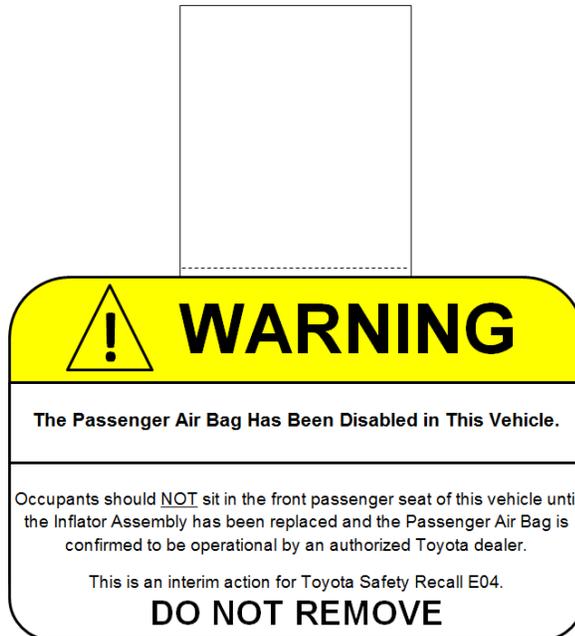
Your dealership will be sent a package of Glove Box Reminder Hang Tags; a sample is shown below for your reference.

Please ensure these are applied to any vehicle where the passenger air bag is temporarily disabled. Additional glove box reminder hang tags can be ordered from the Material Distribution Center.
