PRODUCT SAFETY RECALL

SUBJECT: Front Passenger Air Bag Inflator Module

MODELS: 2003-2005 Pontiac Vibe
Currently Registered or Previously Registered in Alabama, Florida, Georgia, Hawaii, Louisiana, Mississippi, Texas, Guam, Puerto Rico, Saipan, U.S. Samoa or U.S. Virgin Islands

GM Recall Number: 14735

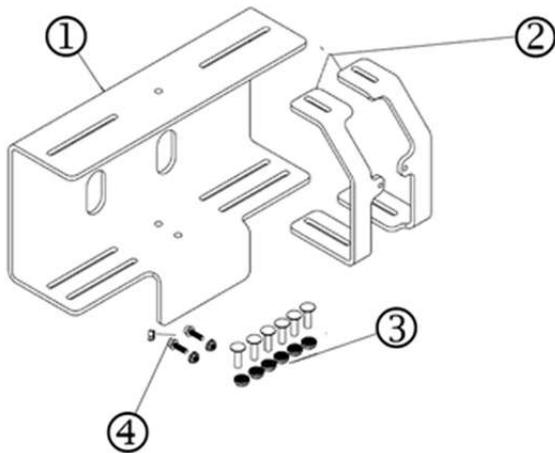
4006668

(1) Mounting Bracket (2) Support Bars (3) Support Bar Hardware (4) Air bag Mounting Hardware.

Note: Dealers are required to use the air bag mounting bracket, shown below, to perform the front passenger air bag inflator module replacement procedure. These brackets were previously provided to all registered Pontiac Service Stations and certain Chevrolet dealers for product safety recalls 13112 and 14491. If your dealership does not have the air bag mounting bracket, provide courtesy transportation to the customer until an air bag mounting bracket is obtained and the required repair is completed. A list of the dealers that were shipped this special tool is available in the GM GlobalConnect Library. Check this list to identify a dealer in your area that has the tool and request to borrow the air bag mounting bracket. Your GM District Manager – Aftersales can also assist with obtaining the air bag mounting bracket if the tool is not locally available from another dealer.

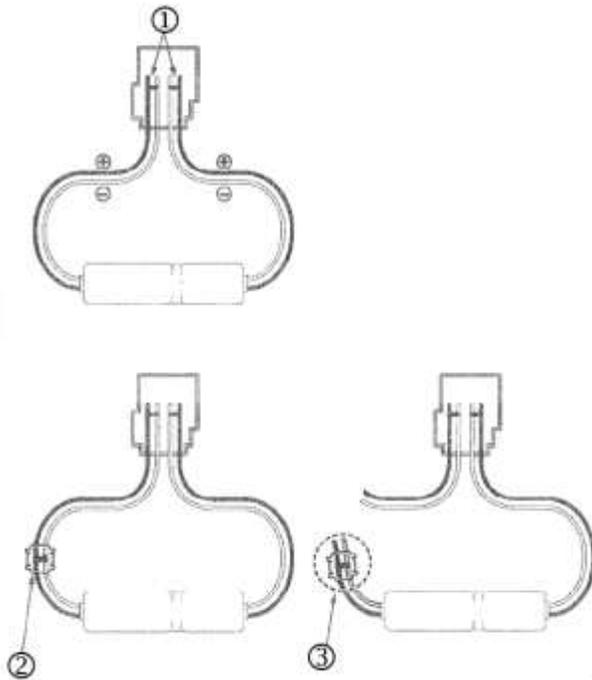
3470510

Note: The connector of an air bag inflator has a short-circuiting mechanism that eliminates voltage difference when disconnected (1). To allow for the replacement of the inflator module, a new short circuit using an electro tap (2) **MUST** be created **BEFORE** cutting the wires (3) and removing the inflator.

- 7. Create a short circuit before disconnecting the inflator wire harness.

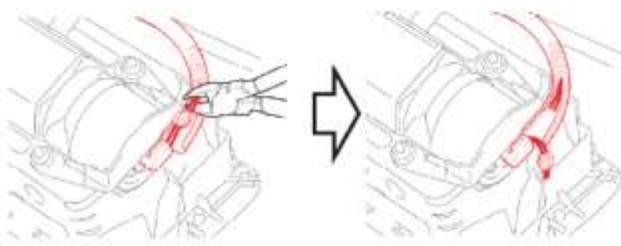
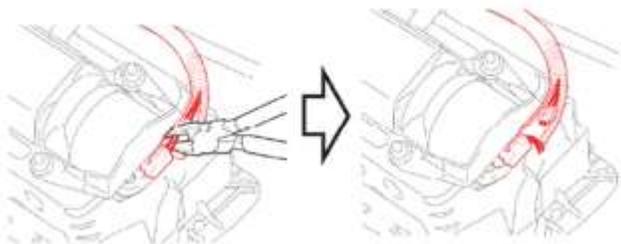
OK: Cut wires at opposite side to inflator. NG: Do NOT cut at inflator side.

Caution: Ensure to cut the two wires at the correct location. Refer to the illustration.

8. Cut the two wires at the side of the electro tap opposite to the inflator (the side of the electro tap that is farthest away from the inflator).

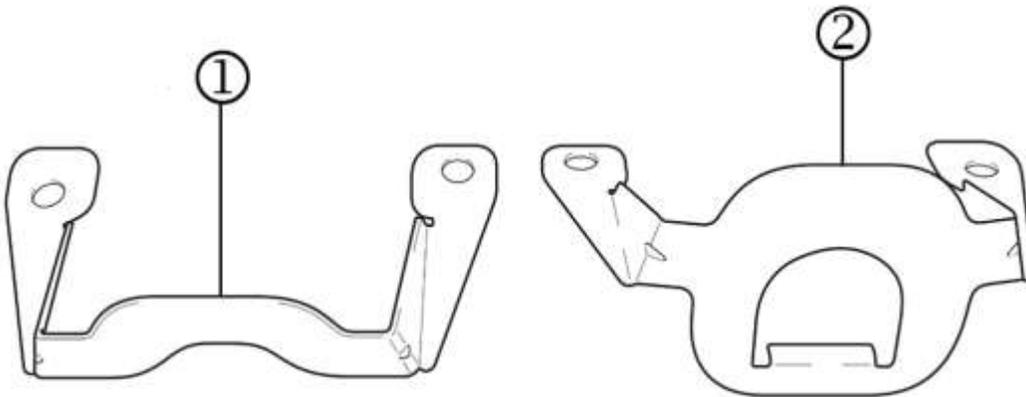
3607880

14. Confirm the identification of the stopper and the position determining plate. **THEY ARE DIFFERENT.** Refer to the illustration: (1) Stopper Plate (2) Position Determining Plate.

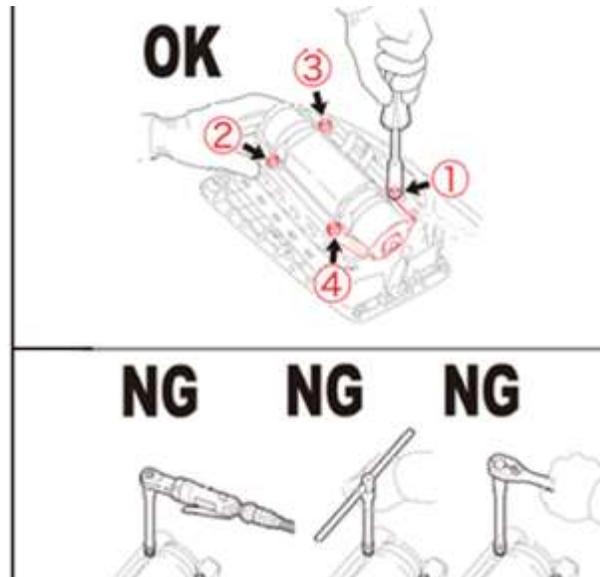
3610416

Caution: There will be some resistance when tightening the nuts because they are self-locking. Confirm the nuts are tightened correctly. **DO NOT** use a power tool, T-handle, or ratchet when tightening the nuts to avoid over-torqueing.

18. Tighten four (4) **NEW** plate nuts evenly in several increments in the order shown in the illustration using a 10 mm socket driver while pushing the inflator. (You will encounter some resistance during tightening because these nuts are self-locking nuts.)

Torque Specification: 3.9 Nm (35 in-lb)
