Technical BULLETIN

SAFETY RECALL

ALL 2014 FZ09 MODELS

FACTORY MODIFICATION CAMPAIGN – Headlight Does Not Work

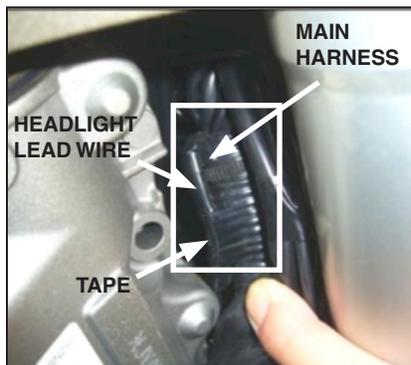
Non-modified Unit

Headlight lead wire is fixed to main harness with tape.

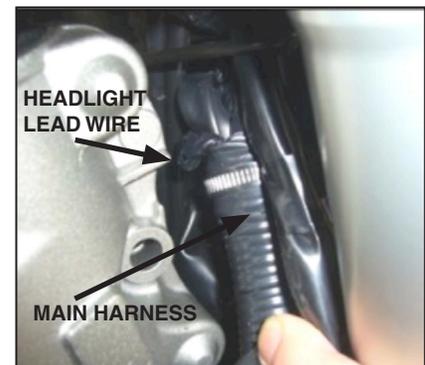
Modified Unit

Headlight lead wire is not fixed to main harness.
