December 17, 2014

SUBJECT: **Safety Recall 14S19 – Supplement #1**
Certain 2005 through 2008 Model Year Escape and Mariner Hybrid Vehicles
Motor Electronics Coolant Pump Replacement

REF: **Safety Recall 14S19**
Dated September 2, 2014

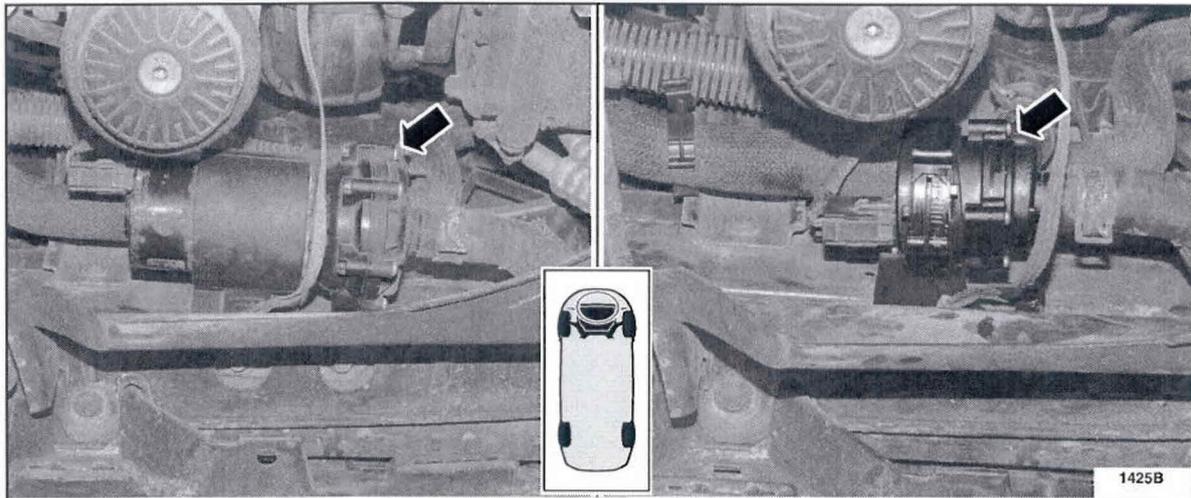
**FIGURE 1a (Brush-Type)
REPLACE**

1. Position the vehicle on a hoist. For additional information, refer to Workshop Manual (WSM) Section 100-02.
2. Inspect the MECP located behind the radiator support near the oil filter (see Figure 1a and 1b). Reference the flowchart on Page 2 for inspection and repair criteria.

3. If directed by the flowchart, install the updated brushless-type MECP (Figure 1b) using the MECP service kit. For additional information, refer to WSM Section 307-02B.
