# Recall Bulletin

**SUBJECT:** Ignition Lock Cylinder Binding

**MODELS:** 2011-2012 Cadillac Escalade, Escalade ESV, Escalade EXT  
2011-2012 Chevrolet Avalanche, Silverado, Suburban, Tahoe  
2011-2012 GMC Sierra, Yukon, Yukon XL

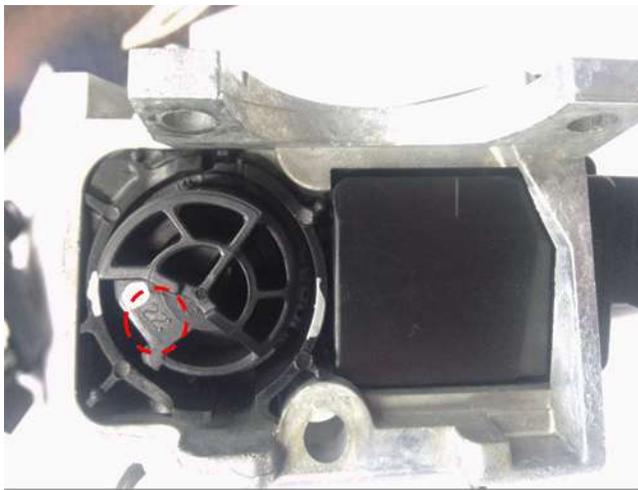
4064725

2. Inspect the inboard side of the housing for the mold cavity number, at the location shown circled in the graphic above:

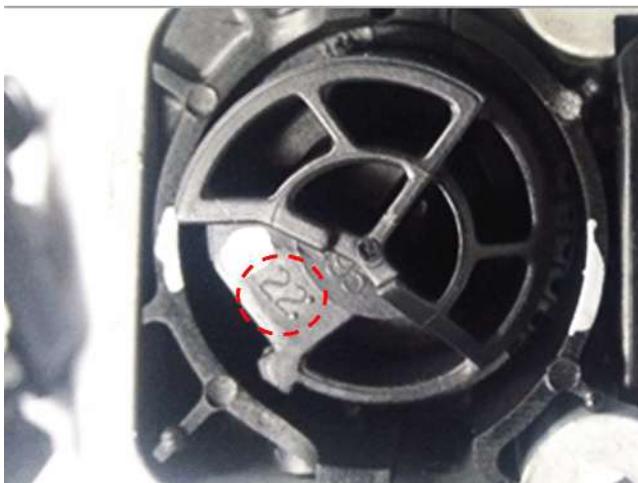
4064727

- If the cavity number reads “22”, the ignition lock cylinder case MAY contain the failure issue and you should move directly to the Service Procedure below.

- If the cavity number reads anything other than “22”, the case can be reinstalled and no further action is required. For reinstallation, refer to Ignition Lock Cylinder Case Replacement in SI.
