Industrial Axle Company, LLC

SAFETY RECALL NOTICE

Manufacturer recall of 6 bolt hub/drum using ½-20 zinc coated wheel studs

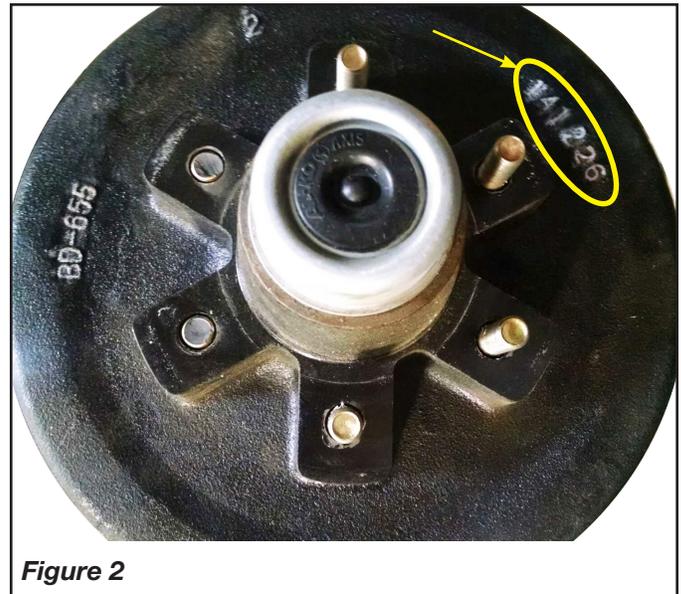
Figure 2

- ▶ Once axles are identified by the customer purchase order number, check hub/drums to determine if it has a suspect hub/drum date code as depicted in figure 2.

- Affected hub/drum part number is 363239.9.
- Suspect hub/drums have the date code of 141224, 141225, 141226, and 141227. Axles with date codes on the hub/drums outside these dates are OK to use. (See figure 2 on where to find the date code.)

- An example of where to find the the date code is shown in figure 2:

141226
year month day

- If you find any axles with a date on the hub/drum that matches the designated date range, please contact IAC at 1-800-400-2164 or via email (IACwarranty@industrialaxles.com) for a replacement(s) and to return suspect hub/drums. Please have the axle serial number when contacting us.

- In the event a suspect hub/drums is identified, please contact IAC for a replacement hub/drums kit (kit number 1684787).
- Labor allowance is 0.5 hour to jack the trailer up, remove the wheels, and check hub/drums date. Prior to removal of the wheels, check the axle tag to determine if the axle falls in the suspect purchase order group. If replacement is needed, 1.0 hour per axle will be allowed. Labor will be allowed at your posted hourly rate.

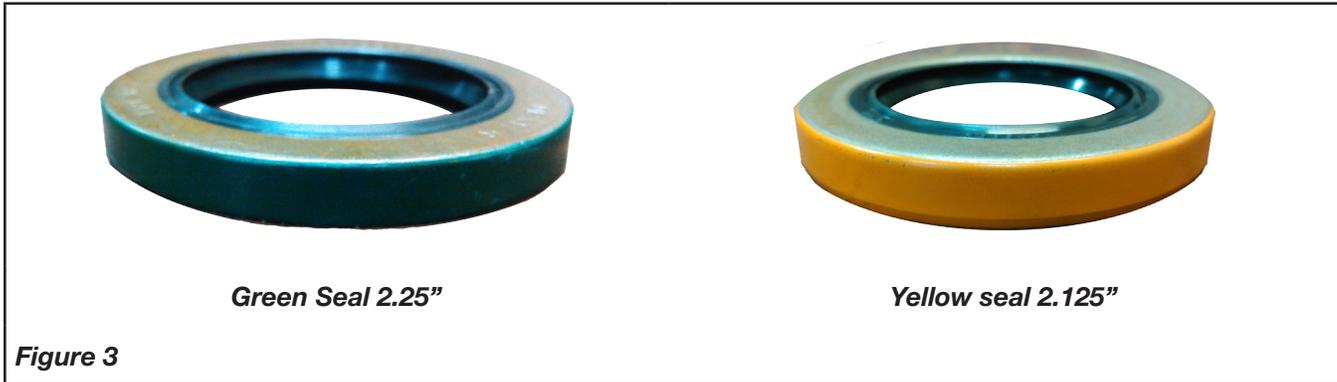
Replacement hub/drums will be shipped as part of a kit that includes a 2.25" green grease seal and a 2.125" yellow grease seal. See figure 3 of how to determine the correct seal needed for your hub/drums. The kit will also include a cotter pin, an Ultralube® tang washer plus a new grease cap (one for standard grease and one for the Ultralube® style).
