SUBJECT: **DEMONSTRATION / DELIVERY HOLD - Safety Recall 15S02 – Supplement #2**
Certain 2010-2013 Model Year Taurus and Police Interceptor Sedan, and 2011-2013 Model Year MKS Vehicles
Interior Door Handle Inspection and Repair

DEMONSTRATION / DELIVERY HOLD - Safety Recall 15S02 – Supplement #2

Certain 2010-2013 Model Year Taurus and Police Interceptor Sedan,
and 2011-2013 Model Year MKS Vehicles
Interior Door Handle Inspection and Repair

CERTAIN 2010-2013 MODEL YEAR TAURUS AND POLICE INTERCEPTOR SEDAN AND 2011-2013 MODEL YEAR MKS VEHICLES — INTERIOR DOOR HANDLE INSPECTION AND REPAIR

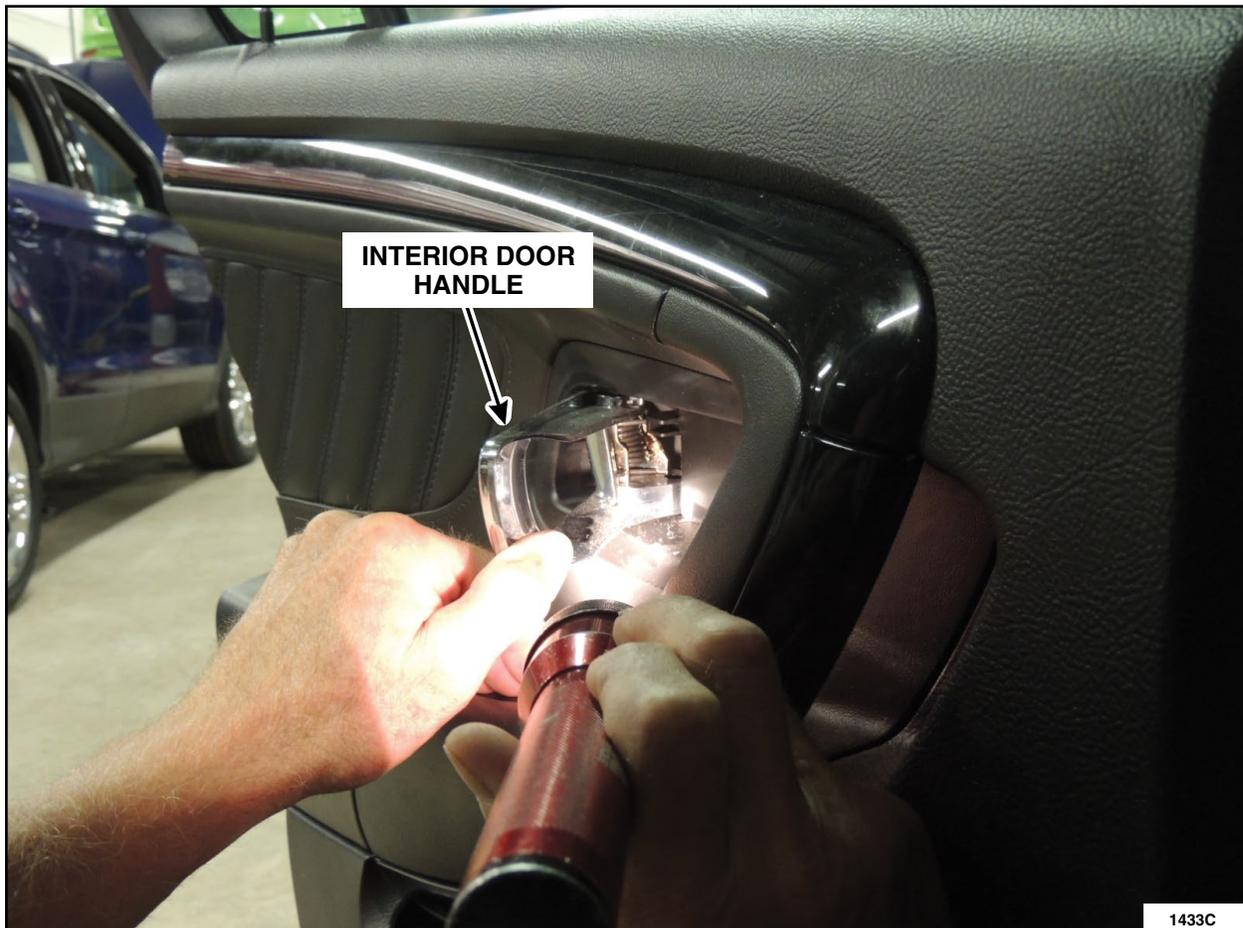
FIGURE 1

1. Hold the interior door handle in the open position. Using a flashlight, locate the return spring and return spring retainer wall. See Figure 1 below and Figure 2 on Page 2.

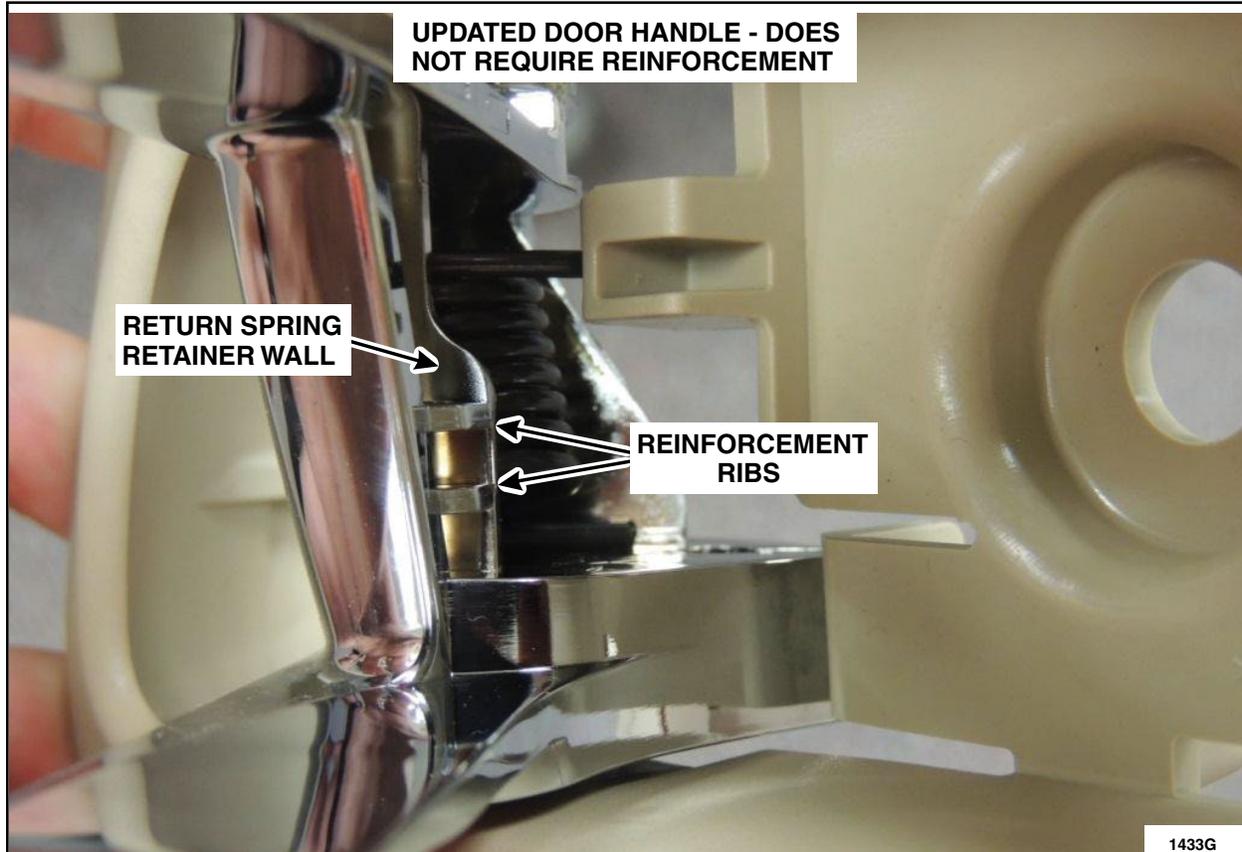
FIGURE 3

3. Interior door handle is equipped with two (2) reinforcement ribs on the return spring retainer wall. See Figure 3.

- No service is required on this interior door handle design.

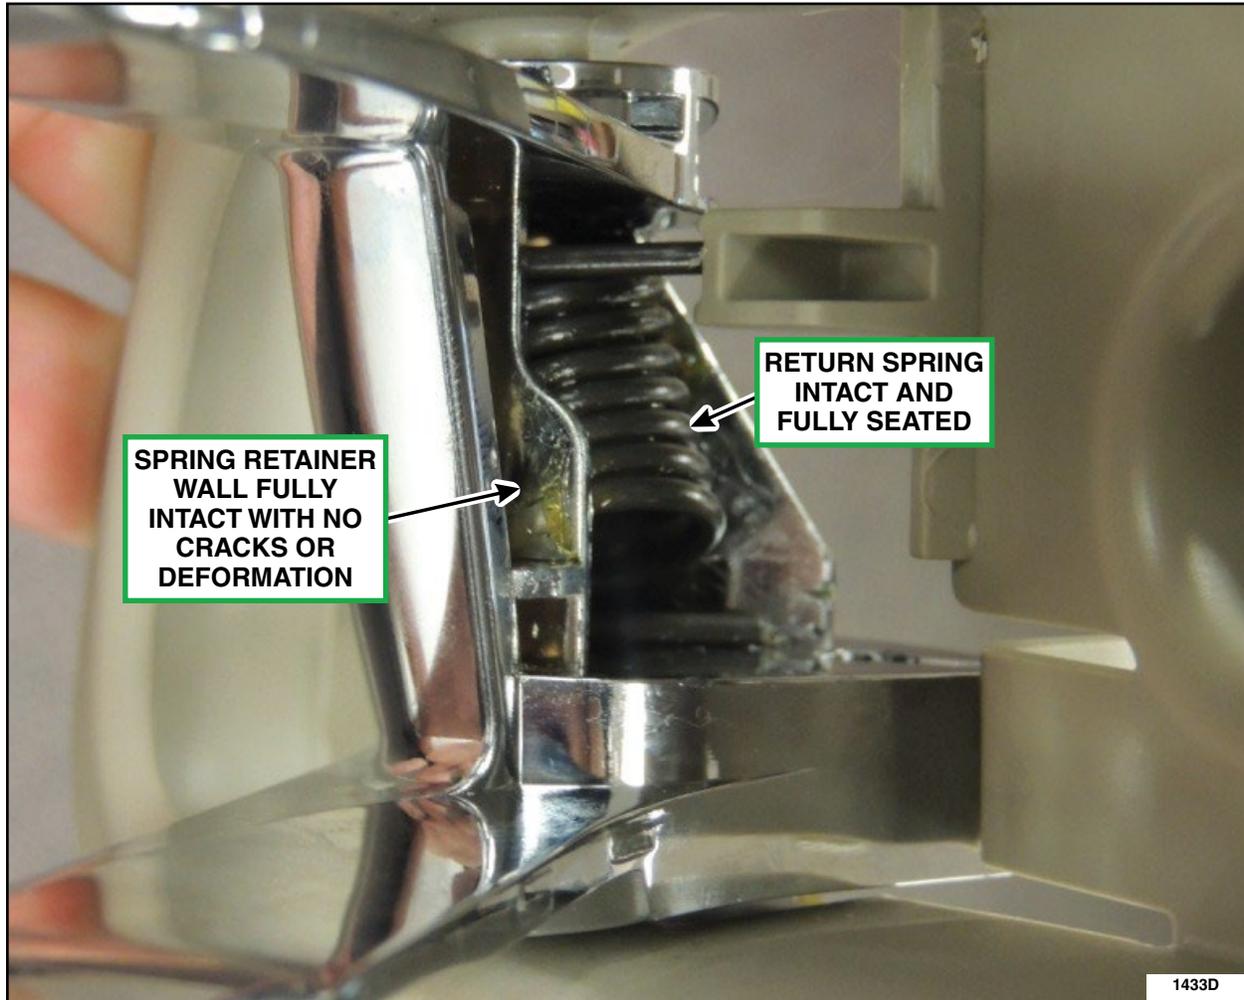
FIGURE 4

4. Return spring is intact and fully seated. The spring retainer wall is not deformed and is fully intact with no cracks. See Figure 4.

- Proceed to step 8.

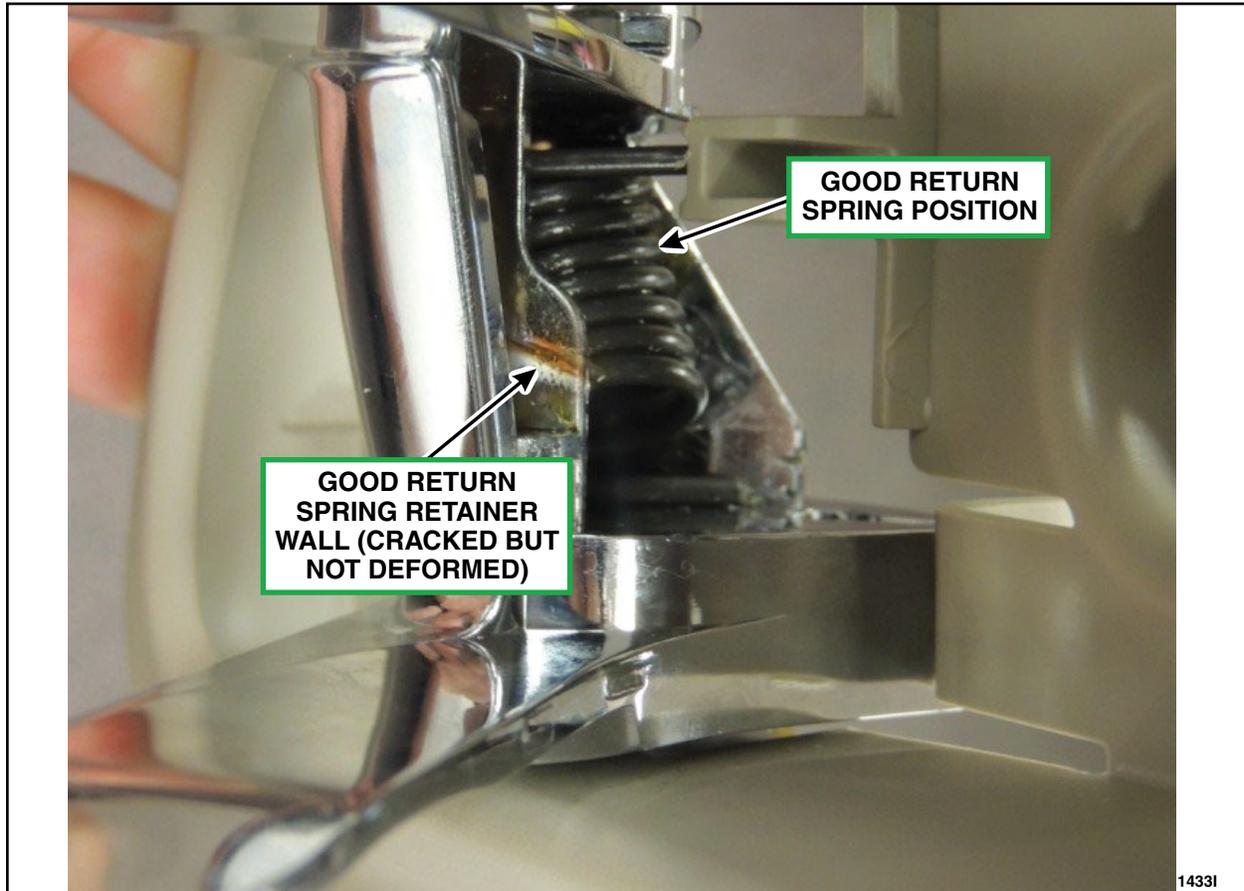
FIGURE 5

5. Return spring is intact and fully seated. The spring retainer wall has a single crack, but is not deformed and is fully intact. See Figure 5.

- Proceed to step 8.

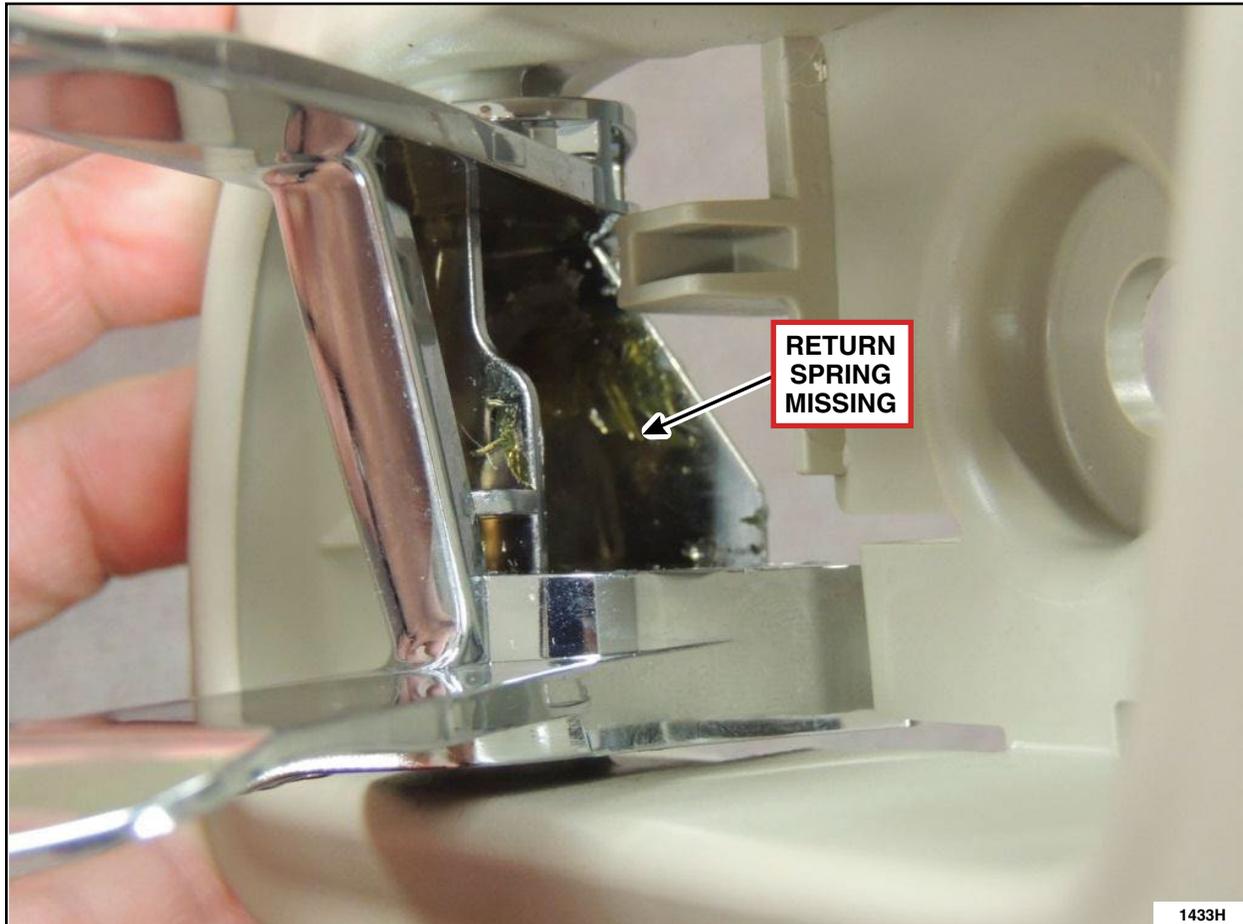
FIGURE 6

6. Return spring is loose, out of position, or missing. See Figure 6.

- Replace the interior door handle. Please follow the Workshop Manual (WSM) procedures in Section 501-14.

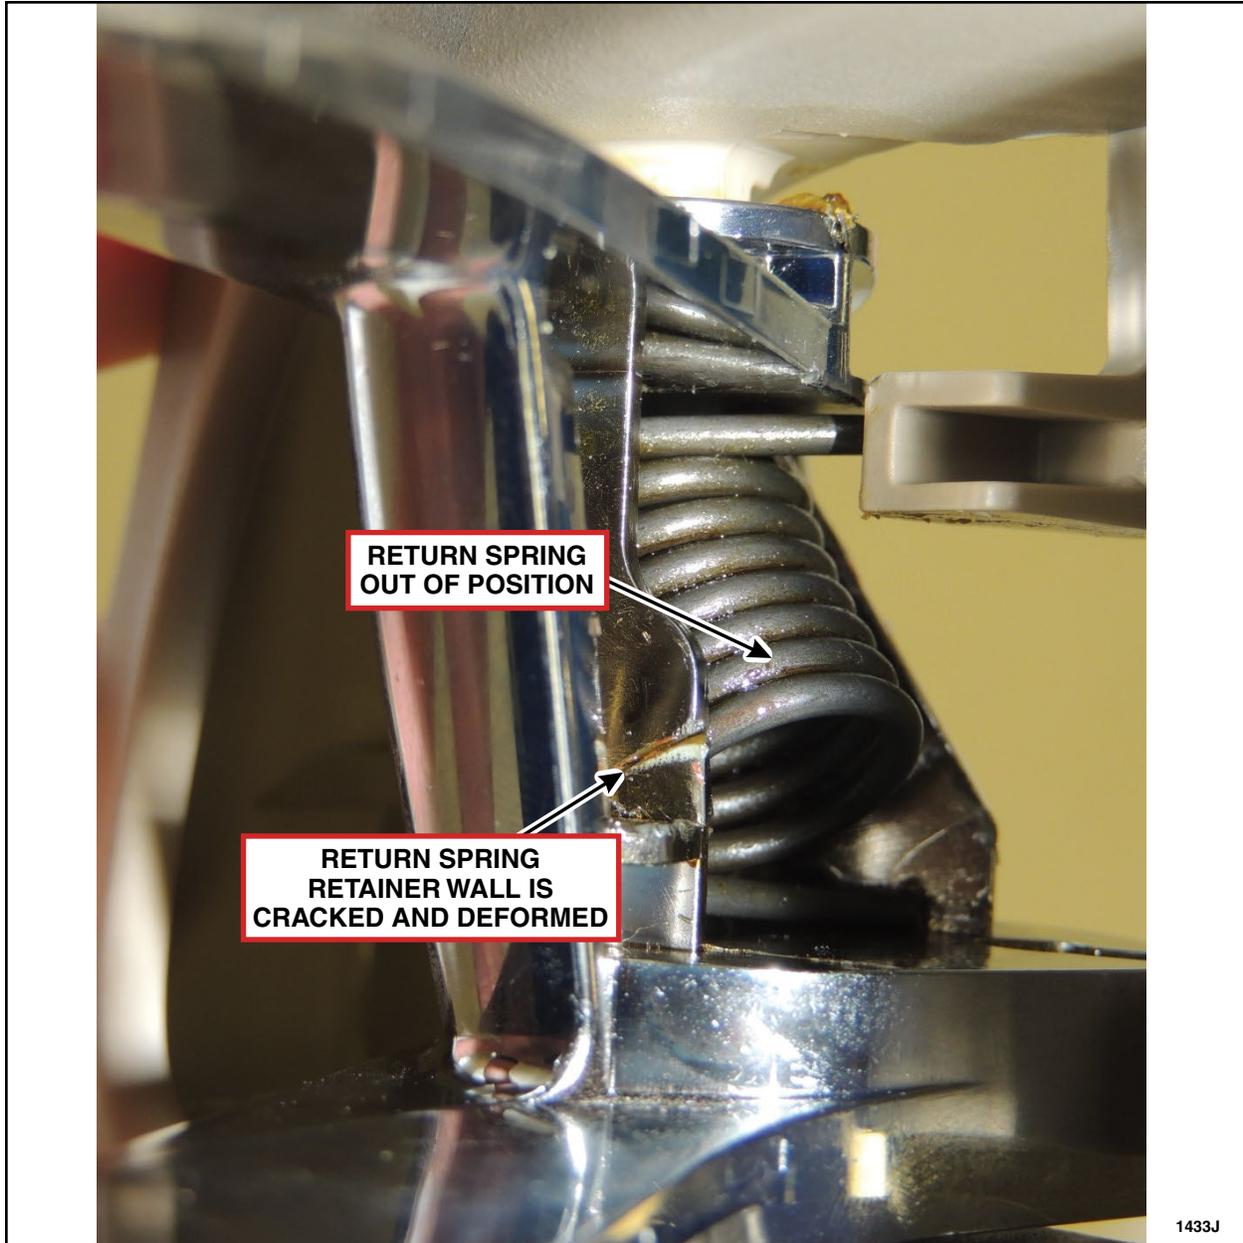
FIGURE 7

7. Spring retainer wall is missing, deformed, or broken. See Figure 7.

- Replace the interior door handle. Please follow the WSM procedures in Section 501-14.
