Michael A. Berardi
Director
Service Engineering Operations
Ford Customer Service Division

August 31, 2015

SUBJECT: **DEMONSTRATION / DELIVERY HOLD - Compliance Recall 15C08 - Supplement #2**
Certain 2015 Model Year MKT Town Car Vehicles with Livery Package
Incomplete Livery Configuration

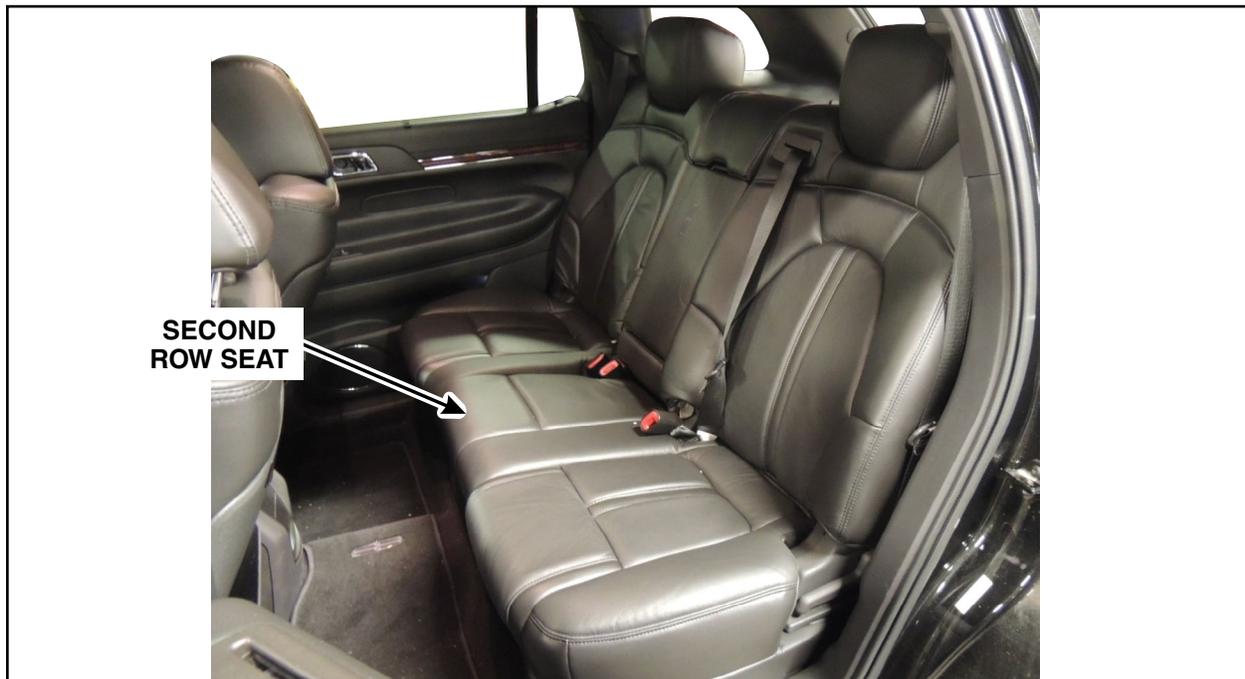
FIGURE 1

On some of the affected vehicles, the livery configuration process may not have been completed, resulting in vehicles being shipped without the second row seat. Affected vehicles are labeled for five passenger occupancy, and if equipped with only two designated seating positions, do not conform to the requirements specified by Federal Motor Vehicle Safety Standard (FMVSS) No. 110 regarding designated seating capacity or FMVSS No. 225 regarding child seat tether anchorages.

- a. Second row seat (See Figure 1). *If missing, install a new second row seat. For second row seat installation information, refer to Workshop Manual (WSM) Section 501-10.*
- b. Cargo area cover (See Figure 2). *If missing, install cargo area cover.*
- c. Cargo load floor (See Figure 2). *If missing, install cargo load floor.*
- d. Optional full size spare tire (if ordered - refer to the vehicle's Monroney label) (See Figure 3). *If missing, install a new full size spare tire. For tire and wheel assembly information, refer to WSM Section 204-04A.*

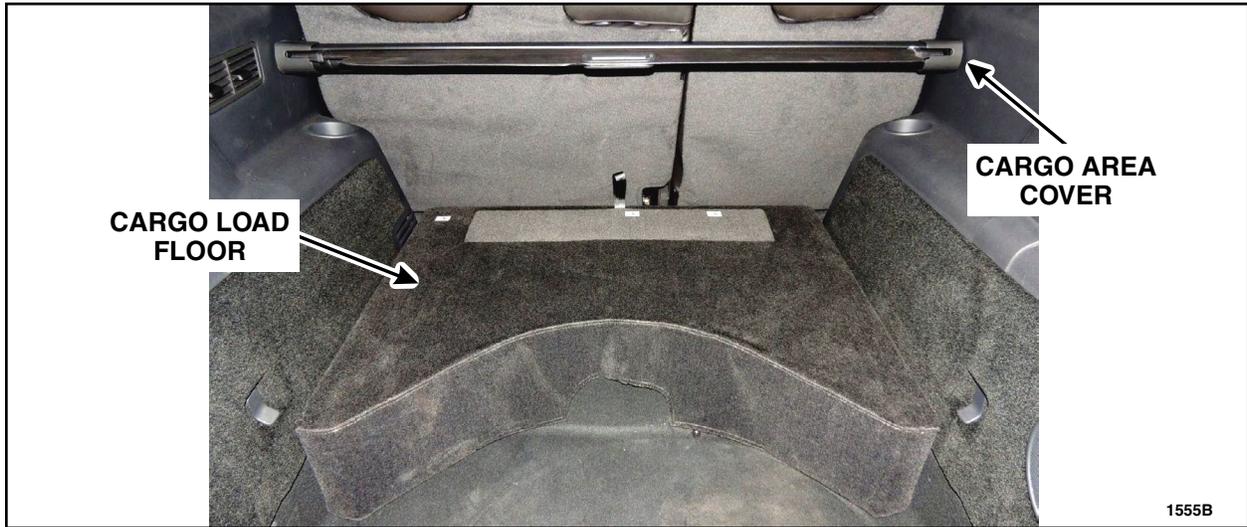
FIGURE 2

Additionally, some of the affected vehicles may have been shipped without the cargo area cover, cargo load floor, or the optional full size spare tire (if ordered).
