Re: Engineering Analysis (EA02-018)

**Engineering Analysis – EA02-018  
Eaton Corporation – Information for Section 1**

**Engineering Analysis – EA02-018**  
**Eaton Corporation – Information for Section 2**

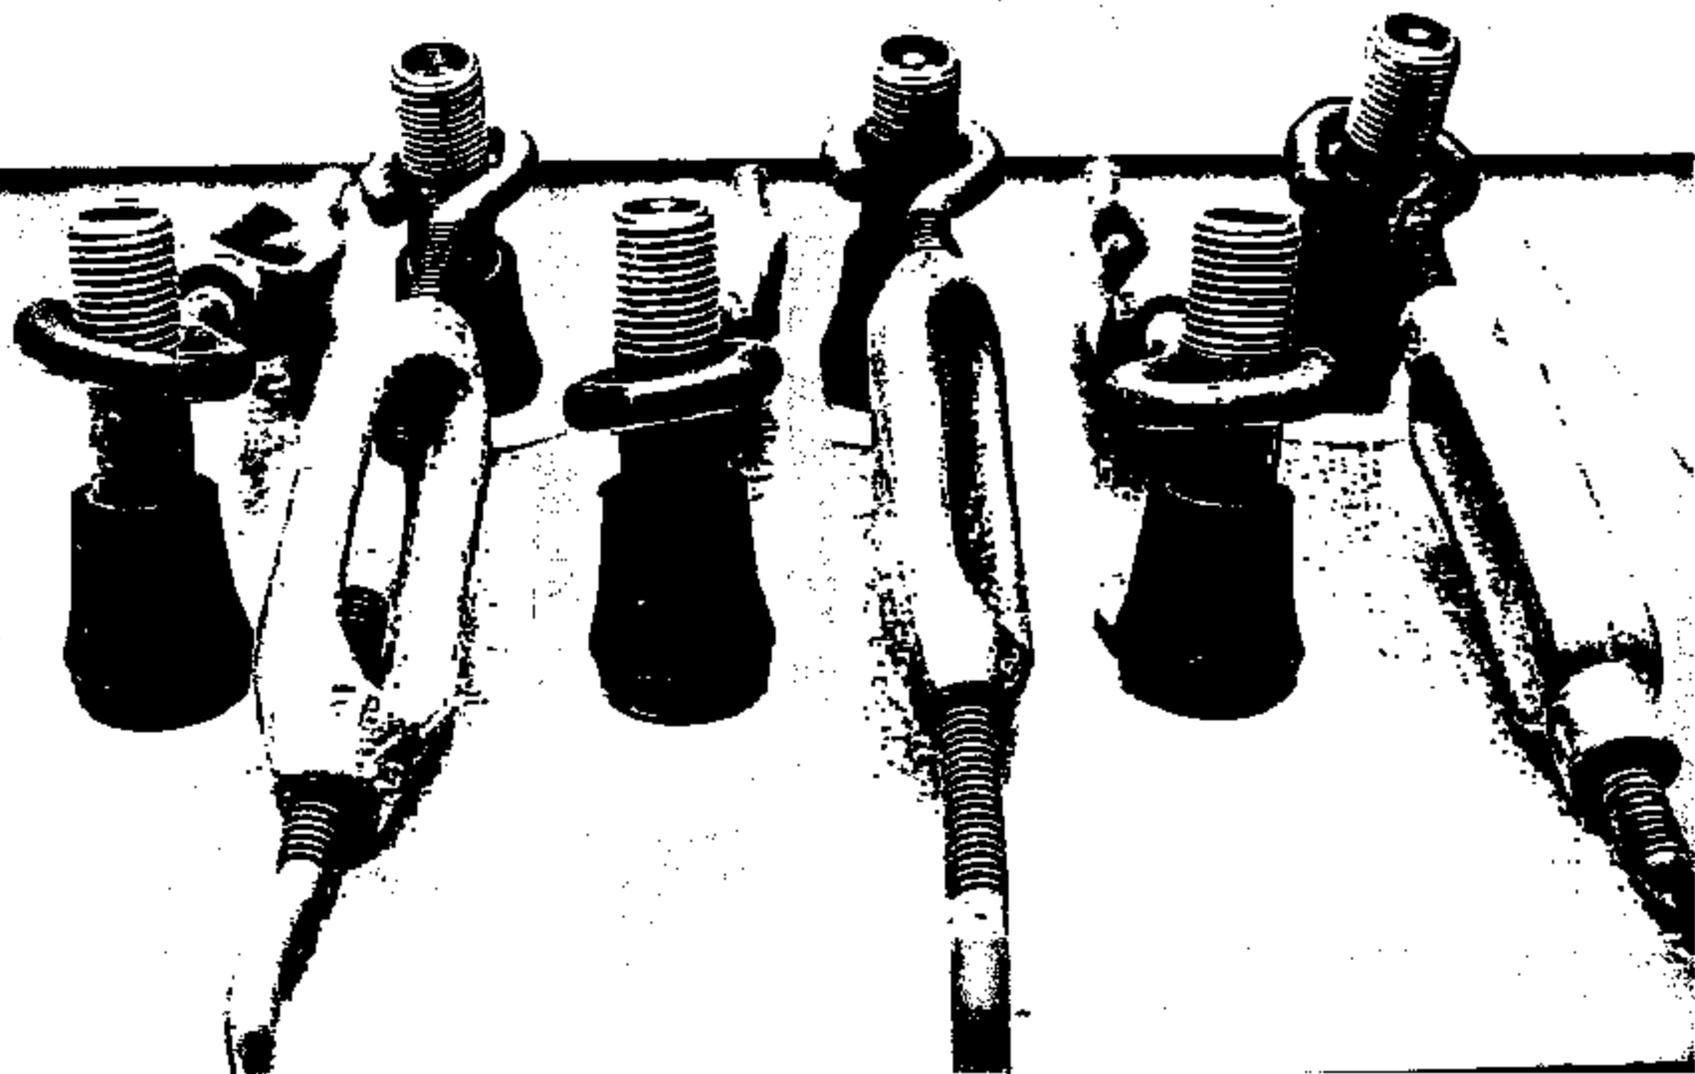
**Returned TR-600-HP From  
Alabama Power after Ozone Test**

Pictures of valves after test was run accompany this report.
