Subject: 08091 - Product Safety Recall
Windshield Wipers May Become Inoperative
Under Heavy Snow and Ice Loads

Models: 2008 Buick Enclave
2007-2008 GMC Acadia
2007-2008 Saturn Outlook

SUBJECT: Windshield Wipers May Become Inoperative Under Heavy Snow and Ice Loads

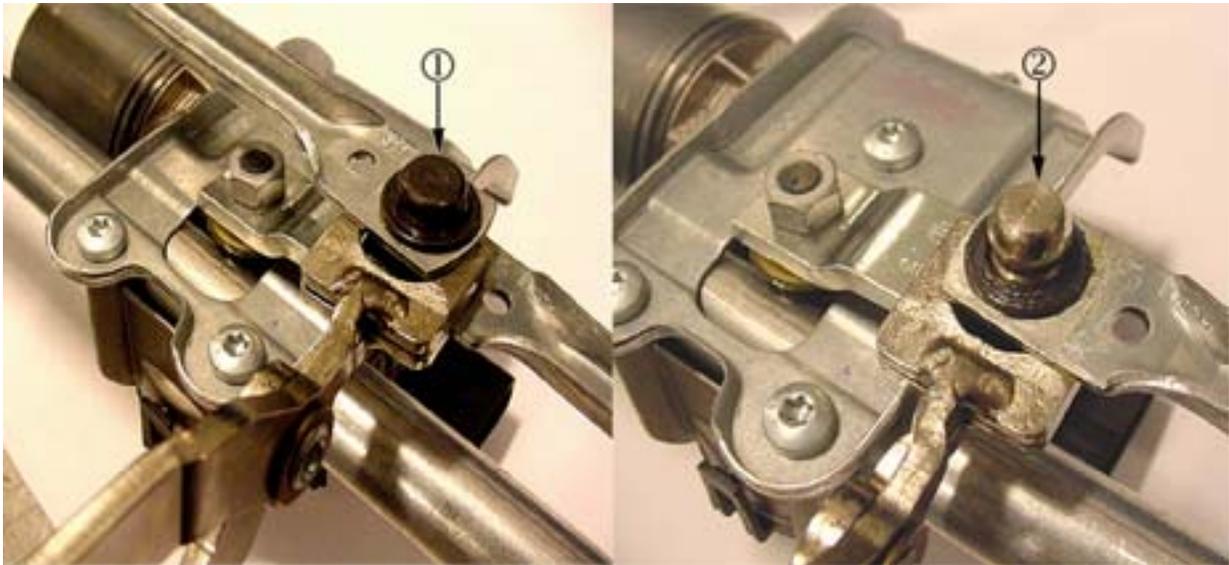
2180789

1) Closed Plastic Socket

(2) Open Plastic Socket

5. Using the J 39232, Wiper Linkage Separator or an equivalent tool, detach the links from the motor crank arm. Remove the closed plastic socket first and then followed by the open plastic socket.
6. After removal of the closed socket of the passenger-side (PS) link, check for any crack or damages. If cracks or any deformation are present on the socket, the entire wiper system module must be replaced.

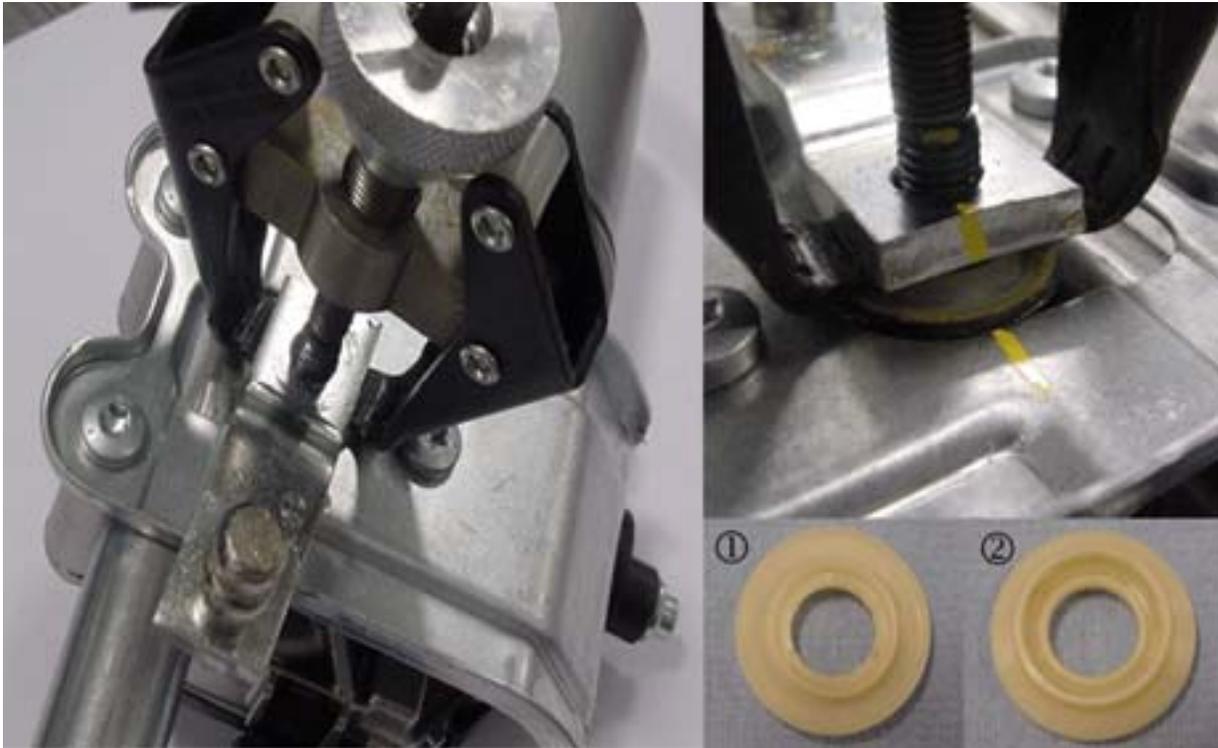
2180779

Undamaged Water Cap
(1) Top View
(2) Bottom View

- 10. Remove the motor crank arm with J 39822, Wiper Arm Puller or an equivalent tool. Make sure not to damage the water cap (white plastic). Any crack or deformation on the water cap is not allowed. If this is damaged, a new motor must be used. Discard the motor crank arm.

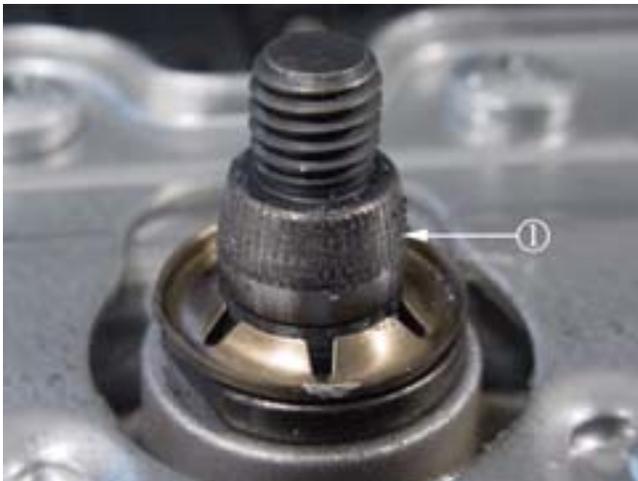
2180792

- 11. Clean the motor shaft splines (1) with a wire brush to remove any residue. If there is any glue or epoxy residue on the shaft thread, remove as much material as possible. Do NOT use any chemical or cleaning agent, or any tool other than a manual wire brush.

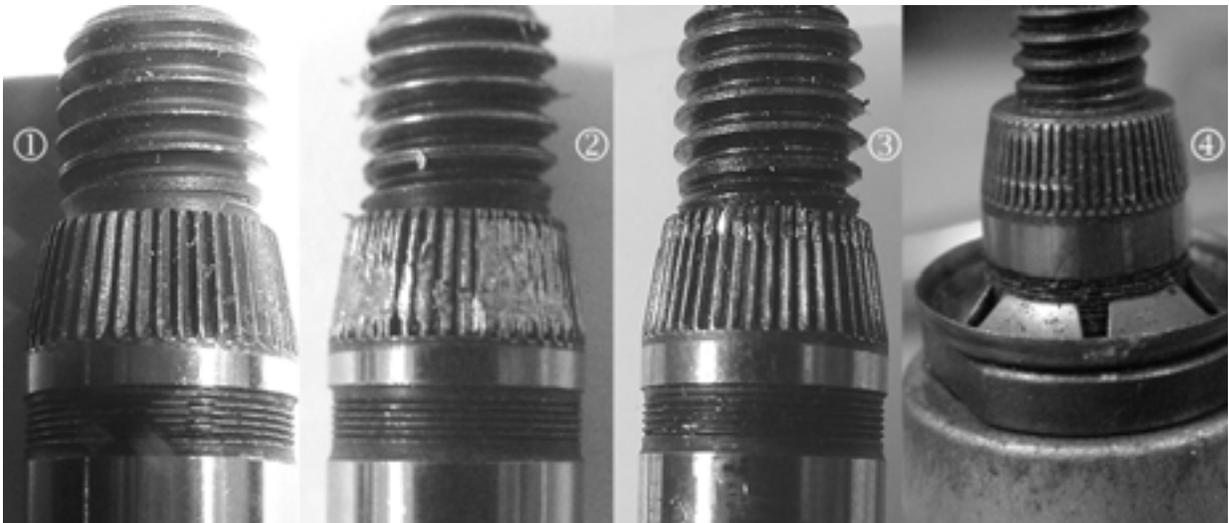
2180798

Shaft Conditions:

- (1) Good motor shaft. Sharp splines with no damage or dirt between teeth. Re-use wiper motor.
 (2), (3), and (4) Damaged motor shaft splines. Broken, cracked, rounded or worn teeth. Discard wiper motor.

12. After cleaning the motor shaft, check the physical characteristics of the shaft splines (teeth) and thread. Both should be clean and free from any damage or deformations. If deformations are present, the motor is to be discarded and a new one is to be used.
13. Prior to re-assembly of the wiper module, check for any contamination or dirt on the sockets. Make sure that the grease is clean and present on all the sockets and ball studs.
