WORKHORSE CUSTOM CHASSIS SERVICE BULLETIN

BULLETIN NO: 20801-C

SUBJECT: Pitman arm castle nut

MODELS: Certain 2006, 2007, and 2008 W42 and W18 models

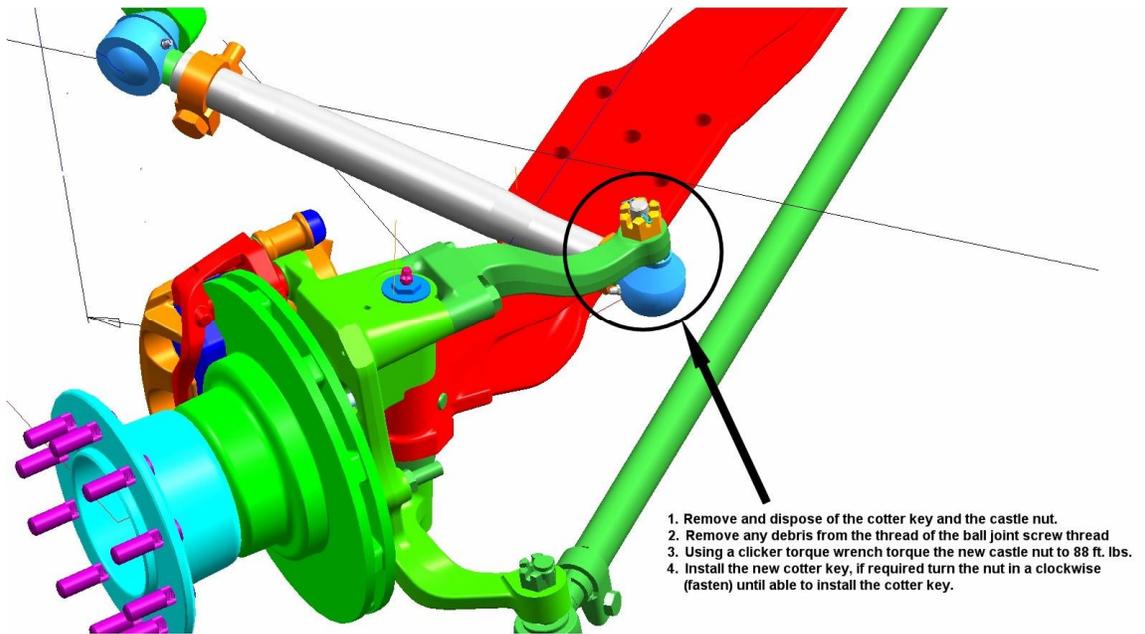
It is possible that the above models may have had a drag link to pitman arm castle nut stripped from an over-torque condition. If the castle nut is stripped, it can become loose from the drag link stud allowing the drag link to separate from the pitman arm. This will result in a loss of steering control and a possible vehicle crash.

- 1. Refer to the appropriate Service Repair Manual for general information involving steering system repairs.**
- 2. Remove existing castle nut and cotter pin as shown in graphic below.**
- 3. Check ball joint threads for any metal contamination from the nut and clean as necessary. (The ball threads are very hard material and the castle nut is soft material. A stripped nut will not damage the ball joint threads, but may contaminate the threads.)**
- 4. Install new castle nut and torque to 88 ft-lbs. (120 nM).**
- 5. USE CLICKER WRENCH TO TIGHTEN**
- 6. Install cotter key. If necessary, turn nut clockwise (tighten) until nut slots align with cotter pin hole.**
