ODI RESUME

INVESTIGATION: EA99-013

SUBJECT: Post-Collision Fuel System Integrity

MODEL(S): NS-Minivans (Dodge Caravan/Grand Caravan; Plymouth Voyager/Grand Voyager; Chrysler Town and Country)

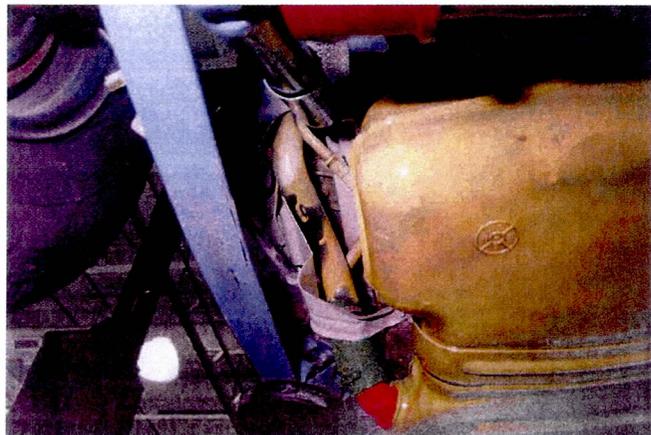
Figure 1 Filler hose connection to fuel tank

System Description: The subject filler neck assembly is routed from the filler door through the forward portion of the left-rear wheelhouse. A plastic liner covers the assembly in the wheelhouse. The assembly extends forward from the bottom of the wheelhouse, through a space between the inner sill wall and the left rail structural member, to the fuel fill and vent fittings of the fuel storage tank (See Figure 1). The tank is mounted inboard of the left rail structural member forward of the rear axle. The filler neck assembly consists of the fuel filler tube and the fuel tank vent tube. A 5-inch long rubber hose (painted green in Figure 1) connects the steel filler tube (yellow) to a 1.6 inch, inner diameter high-density polyethylene (HDPE) nipple or spud (orange/red) on the side of the tank. The hose extends over the spud about 1 $\frac{3}{4}$ inches and over the steel tube about 1 $\frac{3}{4}$

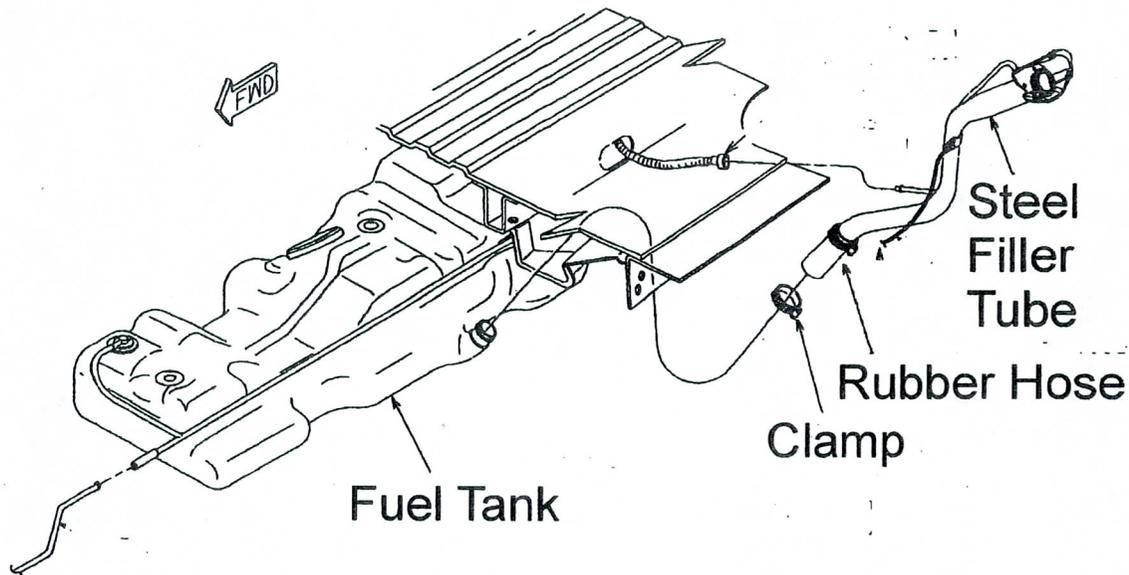
Figure 2 Fuel tank and filler pipe

inches. The rubber hose is secured to the filler tube and tank spud by standard worm drive type hose clamps (see Figure 2).

Several aspects of DaimlerChrysler's design of the filler neck assembly for the subject minivans contribute to an overall lack of robustness in the design to withstand either a high tensile load or significant displacement input during a moderate to severe crash. This is confirmed by NHTSA's evaluation of data collected from other manufacturers of minivans (NHTSA sent peer information request letters to five other manufacturers to obtain information about their filler neck assembly designs). For example, the rubber hose connected to the fuel tank inlet is significantly shorter than the hose on other peer minivans (giving rise to higher tensile load for a given amount of displacement), and the bead on the tank spud (which provides resistance to pull-off force) is ramped with a shallower angle than peer minivans. The location of the filler neck assembly and the surrounding vehicle structure does not isolate the filler neck from crash forces as well as other minivans. For this reason, the filler neck assemblies of some other minivans will experience less loading and displacement on the filler neck during a crash. Also, DaimlerChrysler did not reinforce the tank spud on the subject minivans with a metal liner, as some other manufacturers did on their minivans, which would have reduced compression deformation of the tank spud during high tensile loading. Finally, DaimlerChrysler does not have performance specifications for the minimum pull-off force of the rubber hose from the filler pipe or fuel tank spud as do some other minivan manufacturers, and the company did not test the capability of the hose to withstand such a force during development of the subject minivans.
