U.S. Department
of Transportation

National Highway
Traffic Safety
Administration

ODI RESUME

INVESTIGATION: EA99- 013
 SUBJECT: Post-Collision Fuel System Integrity
 PROMPTED BY: PE99-010
 PRINCIPAL ENGINEER: J. L. Quandt

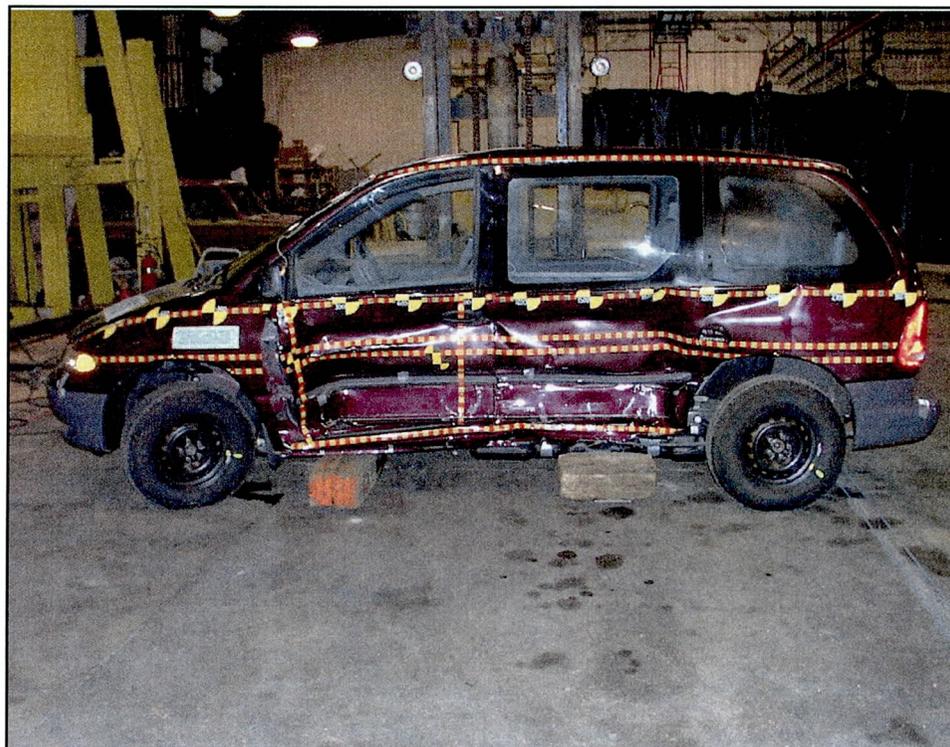
SUMMARY: On January 5, 1999, a 1999 Dodge Caravan 3-door minivan was crash tested at the MGA Proving Ground in Burlington, Wisconsin to assess compliance with Federal Motor Vehicle Safety Standard No. 214, Side Impact Protection, NHTSA No. CX0305 (Figure 1). During the crash test the fuel filler assembly hose separated from the fuel tank fill nipple allowing approximately 11 gallons of test fuel to spill from the tank assembly (Figure 2). The tank, which has a nominal capacity of 20 gallons, had been filled with 18.43 gallons of Stoddard solvent for the test.

Figure 1 - Post-Test Body Crush (CX0305).

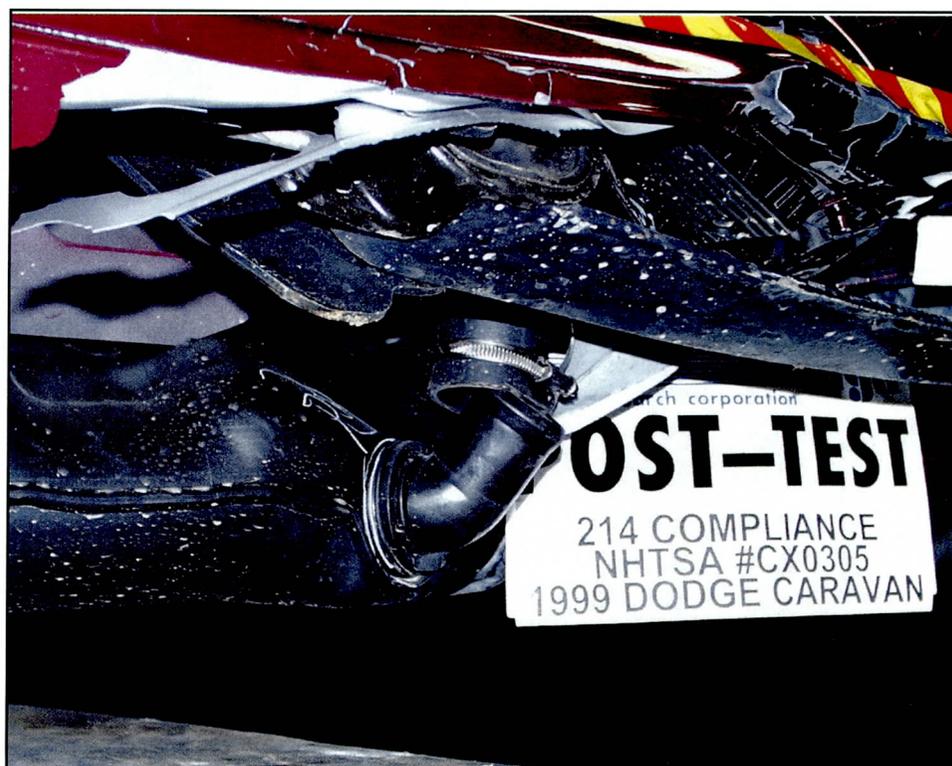
Figure 2 - Post-Test Filler Hose Separation (CX0305).

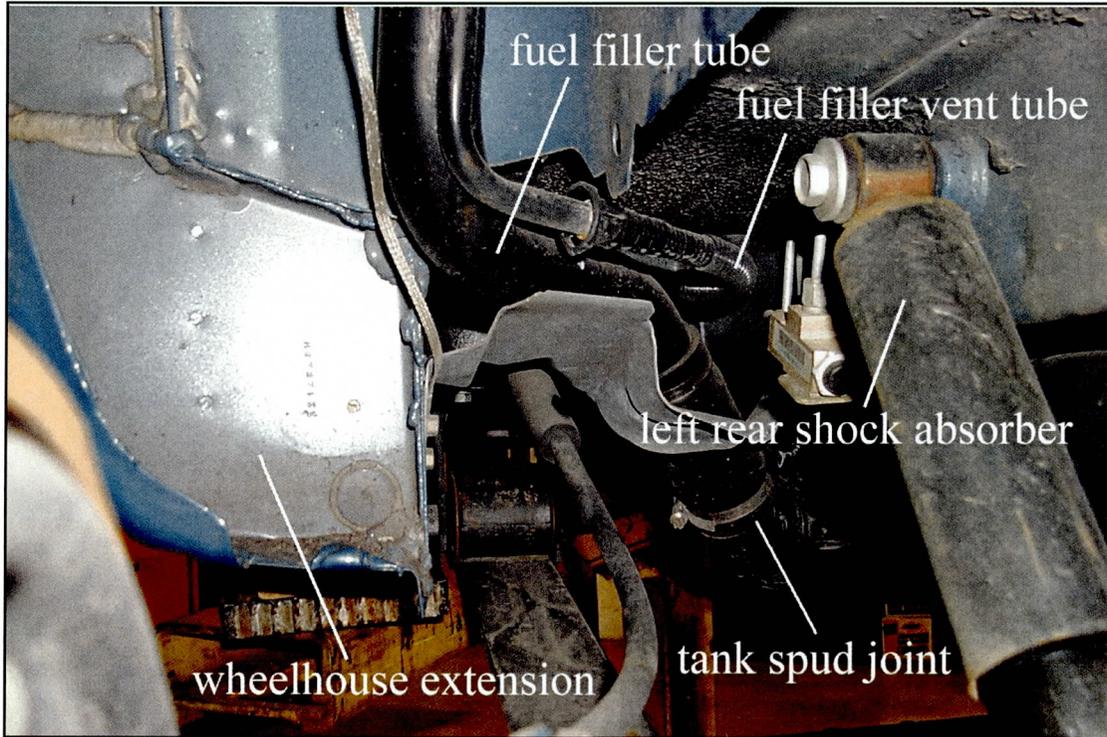
The subject filler neck assembly is routed from the filler door through the forward portion of the left-rear wheelhouse. A plastic liner covers the assembly in the wheelhouse. The assembly extends forward from the bottom of the wheelhouse, through a space between the inner sill wall and the left rail structural member, to the fuel fill and vent fittings of the fuel storage tank (Figure 3). The tank is mounted inboard the left rail structural member forward of the rear axle.

Factors believed to contribute to the risk of hose separation are: (1) the packaging/routing of the filler neck assembly near body components which experienced substantial crush deformation in the crash; (2) the relatively short length of the filler hose (approximately 3¼ inches from clamp to clamp) resulting in greater joint loads per unit displacement between the spud and filler tube; and (3) several aspects of the tank spud hose joint design and manufacture which reduce its ability to resist hose pull-off forces, including low spud modulus, spud bead design, and the use of lubricants as assembly aids.

Figure 3 - Filler Neck Assembly Packaging/Routing (Exemplar Vehicle).

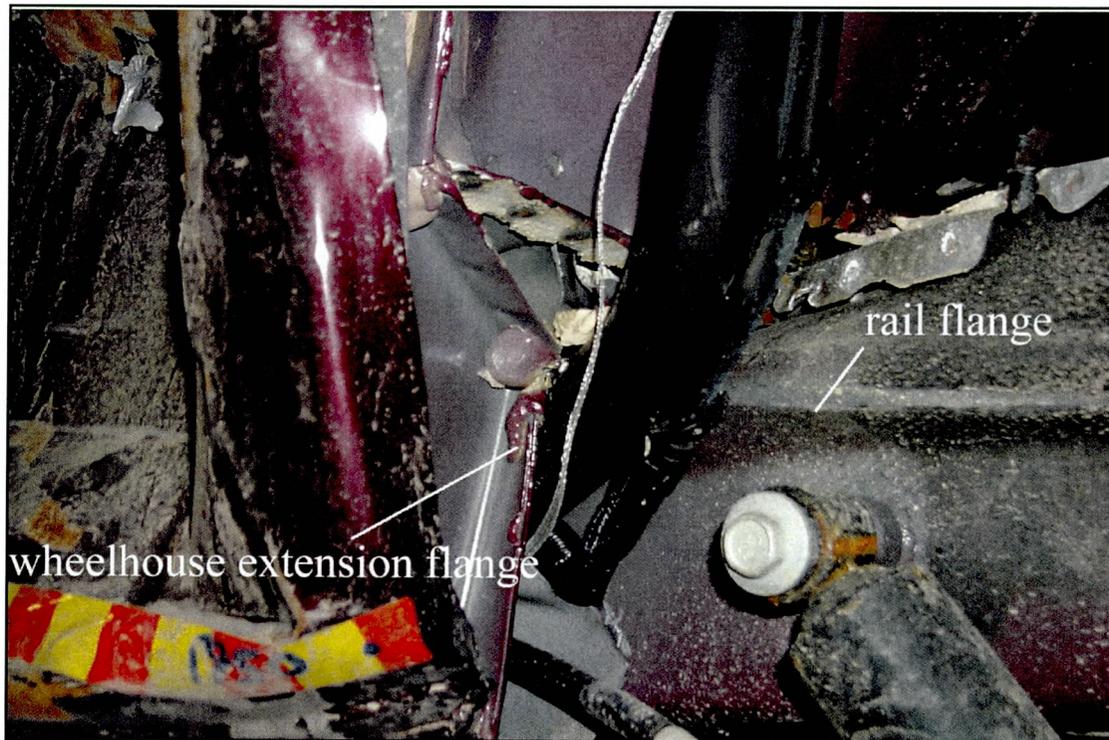
ODI's analysis of the filler hose separation incident finds that the crash resulted in substantial collapse/buckling of the sill. Sill buckling resulted in collapse of the front wheelhouse structure and some torsional deformation of the rail member. Wheelhouse collapse forced the filler neck assembly into the rail member (Figure 4) and pushed the park brake cable tight against the lower section of the filler tube (Figure 5). Some downward displacement of the tank spud was also evident, apparently resulting from rail deformation. The relative displacement of the filler tube and tank spud produced a tensile load in the connecting hose (i.e., stretched the hose) which was great enough to cause the hose to slide up the tank spud and off the bead (Figure 7).

Figure 4 - Filler Tube Loading from Wheelhouse Extension (CX0305).

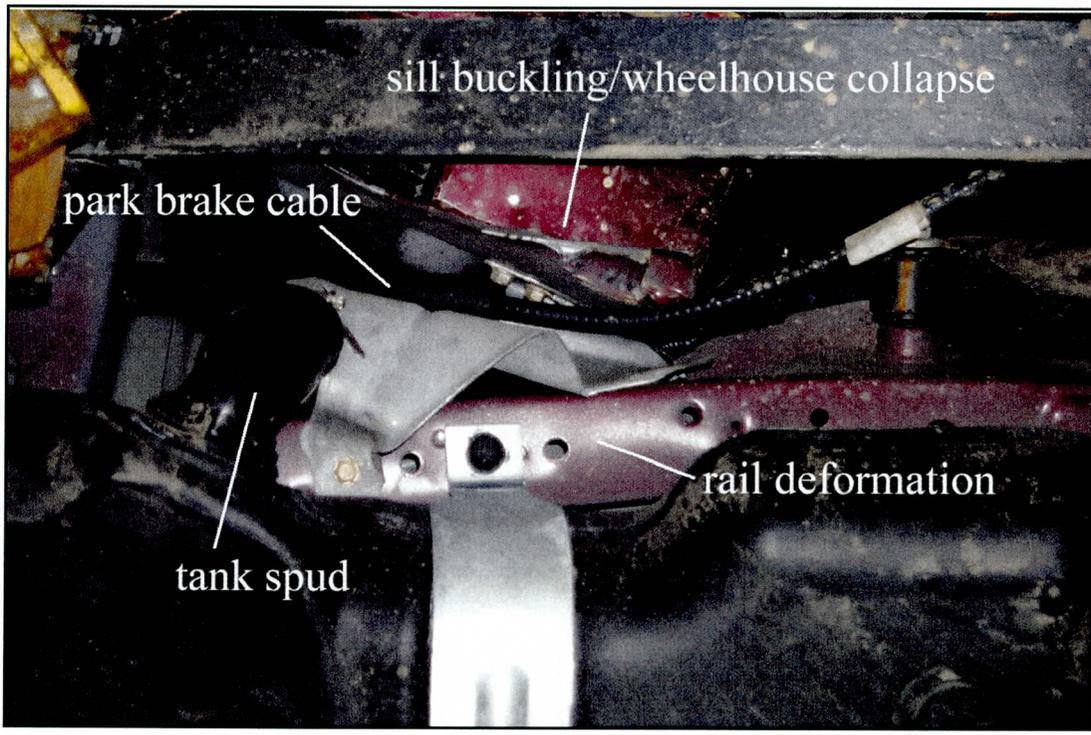
Figure 5 - Filler Tube Loading from Sill/Wheelhouse Collapse and Park Brake Cable (CX0305) - Bottom View, Filler Tube Hidden from View.

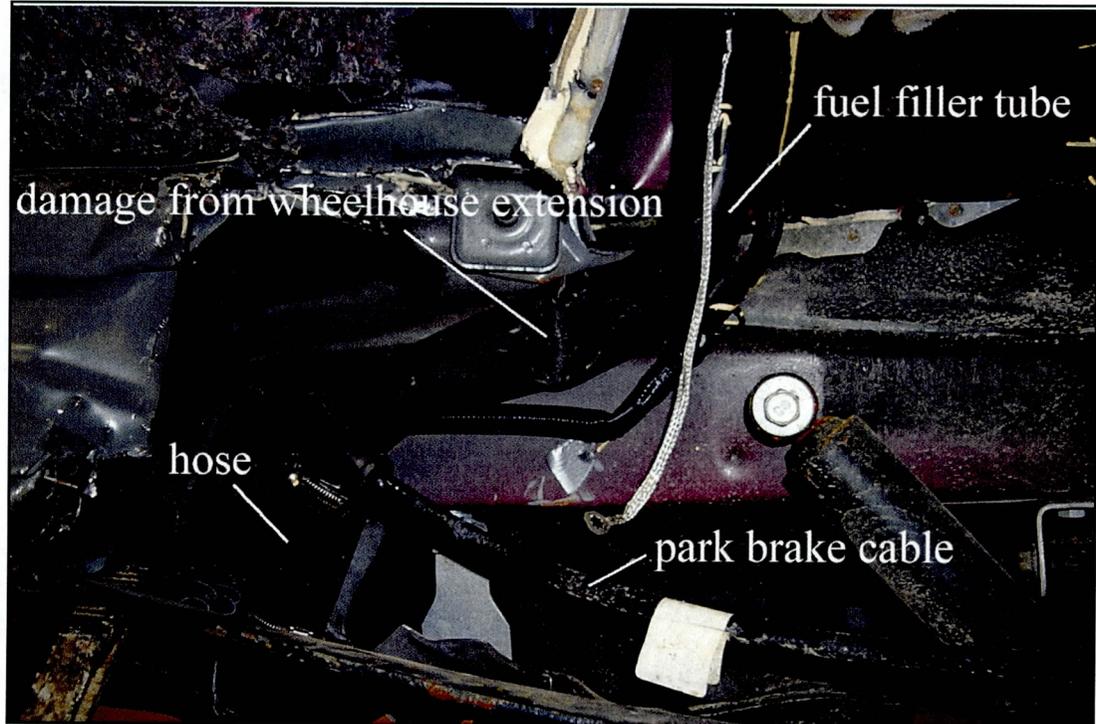
Figure 6 - Filler Neck Assembly Position/Damage (CX0305) - Side View, Body Sheet Metal Removed.

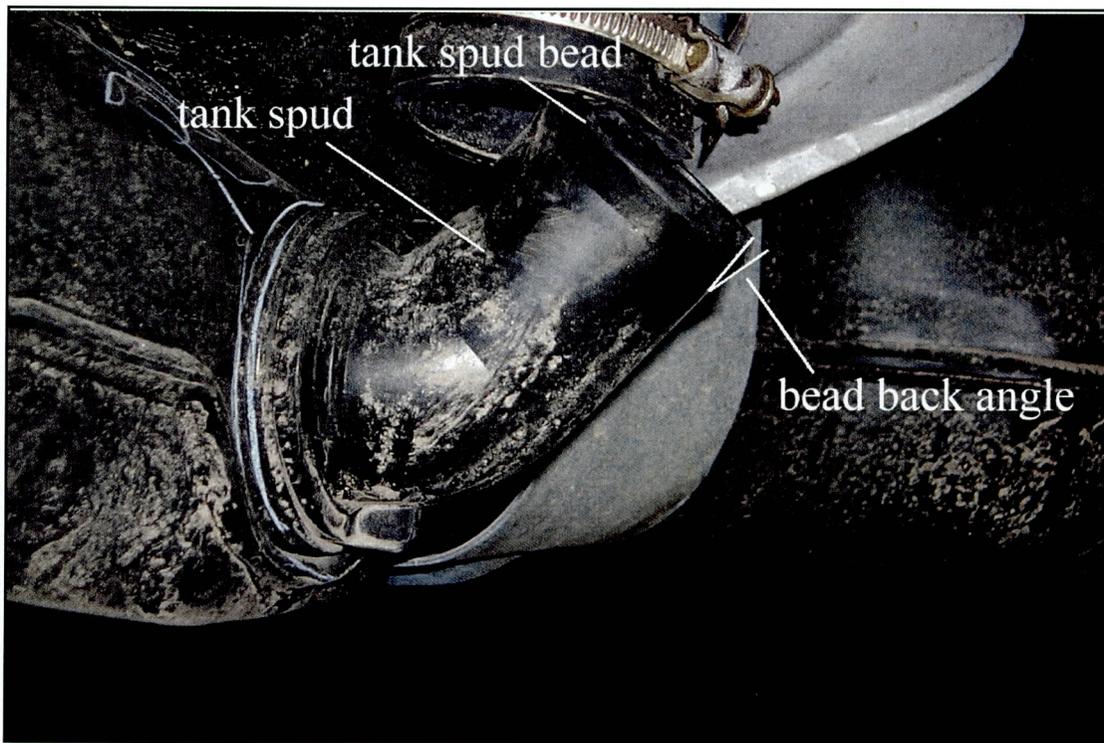
Figure 7 - Fuel Tank Spud (CX0305).

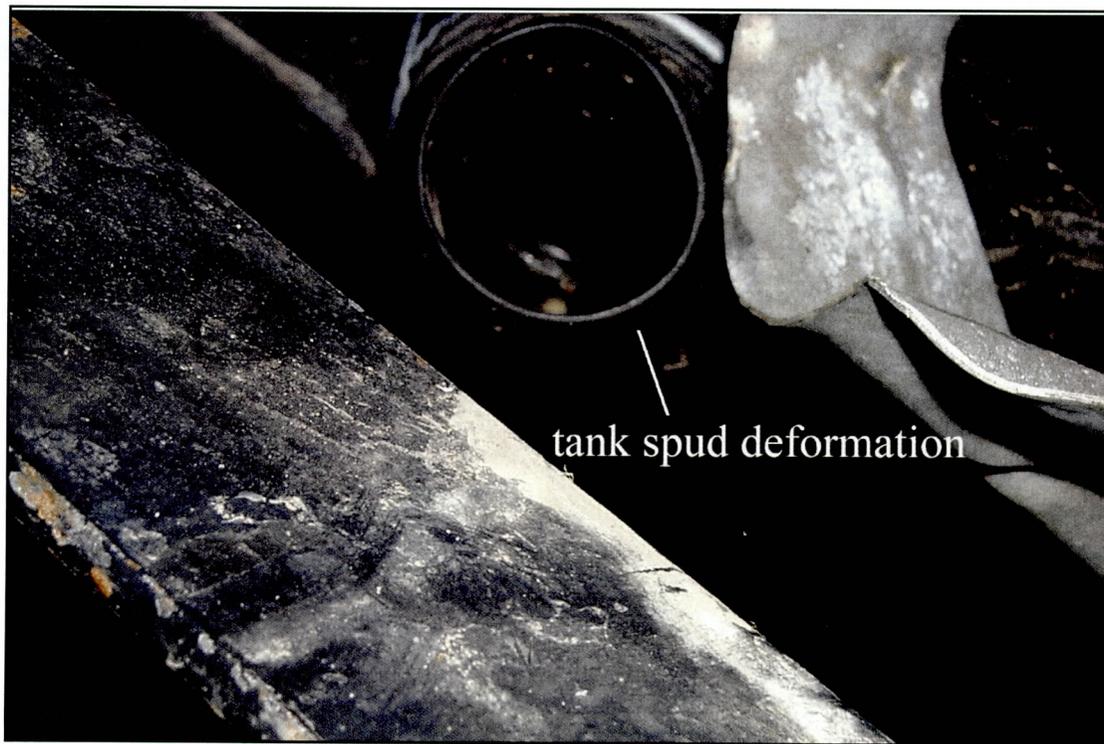
Figure 8 - Tank Spud Deformation - Axial View (CX0305).
